Subject: **Recall Campaign 16V-XXX: ISOFIX Child Restraint System Anchors**

Bulletin: SI B41 01 16

**Vehicles affected:** F25 (X3), F26 (X4)

**Model Year 2011-16 BMW X3 SAV, X4 SAC  
ISOFIX Child Restraint System Anchors  
Safety Recall 16V-xxx**

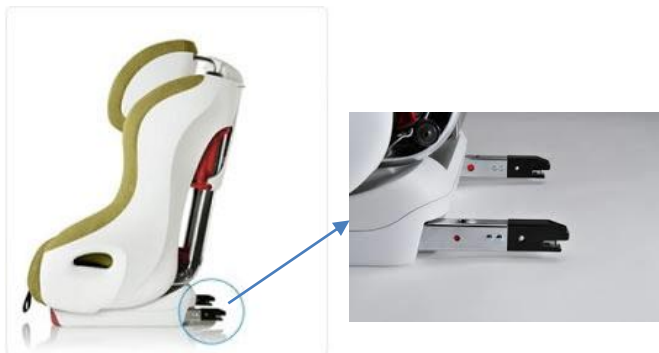
When specifically used with ISOFIX-type rigid-style connector child restraint systems, the lower anchor bars could become damaged over the lifetime of the vehicle. This rigid-style connector is mainly used in Europe but it is available in the US.

See the image below illustrating the rigid-style connectors.
