August 2016  
FL711A-D  
NHTSA #16V-321

## Subject: Motorhome Throttle Pedal Return

**Models Affected:** Specific Freightliner Custom Chassis XCL, XCM, XCP, and XCR chassis manufactured January 23, 2012, through April 10, 2014, and equipped with certain Williams Control throttle pedal assemblies.

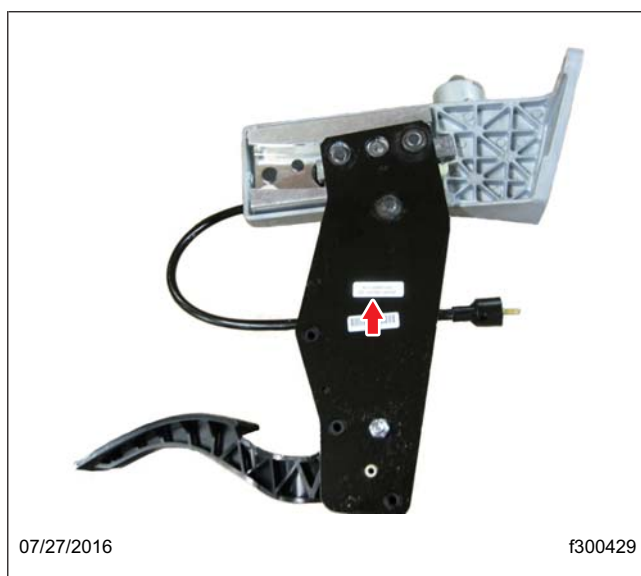
**Fig. 1, Location of the Throttle Pedal Identification Label**

3. Inspect the throttle pedal identification label, shown in [Fig. 1](#). Each label has a serial number, shown in [Fig. 2](#), which indicates the manufacture date. In this example, the manufacture date 160725 of the throttle pedal is July 25, 2016.

If the manufacture date is March 18, 2014, or later, no further work is needed. Go to step 10.

If the manufacture date is before March 18, 2014, continue with the next step to replace the throttle pedal.
