# SERVICE CAMPAIGN BULLETIN

SUBJECT:			No: <b>SC-15-004REV</b>
<b>POTENTIAL TRANSMISSION SHUDDER/SURGE – SERVICE CAMPAIGN – REVISED</b>			DATE: <b>October, 2016</b>
			MODEL: <b>2016 Outlander</b>
CIRCULATE TO:	<input checked="" type="checkbox"/> GENERAL MANAGER	<input checked="" type="checkbox"/> PARTS MANAGER	<input checked="" type="checkbox"/> TECHNICIAN
<input checked="" type="checkbox"/> SERVICE ADVISOR	<input checked="" type="checkbox"/> SERVICE MANAGER	<input checked="" type="checkbox"/> WARRANTY PROCESSOR	<input checked="" type="checkbox"/> SALES MANAGER

***This bulletin supercedes SC-15-004, issued December 2015, to provide clarification regarding vehicles covered by both SC-15-004 and SR-16-006 “CVT Hesitation – Safety Recall Campaign.” Revisions are italicized and indicated by ◀.***

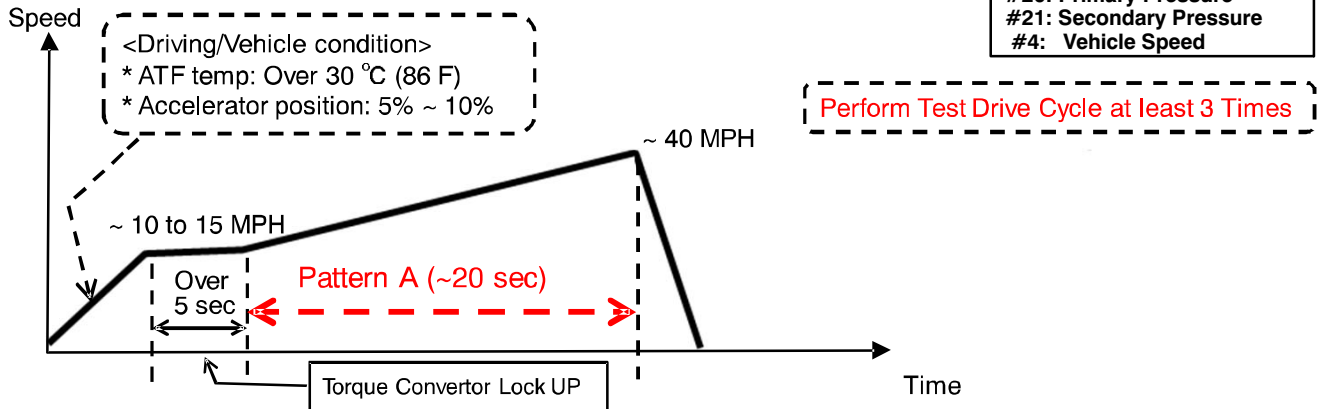
**FIGURE 1. Test Drive Procedure for Duplicating CVT-8 Shudder**

Drive Record Items:  
#15: Accelerator Position  
#20: Primary Pressure  
#21: Secondary Pressure  
#4: Vehicle Speed

Condition	Driving Criteria	Judgment Criteria
<b>Pattern A</b> (Slow acceleration)	Shudder	<ul style="list-style-type: none"> <li>Slow &amp; gentle acceleration</li> <li>10 to 40 MPH</li> <li>Constant acceleration</li> <li>Approximately 10% throttle angle</li> <li>Slight uphill grade or flat road</li> </ul>	<ul style="list-style-type: none"> <li>Vehicle shuddering is felt</li> <li>Can be described also as a "bucking"</li> <li>Can also be described as a "judder" or repeated "jerking"</li> </ul>

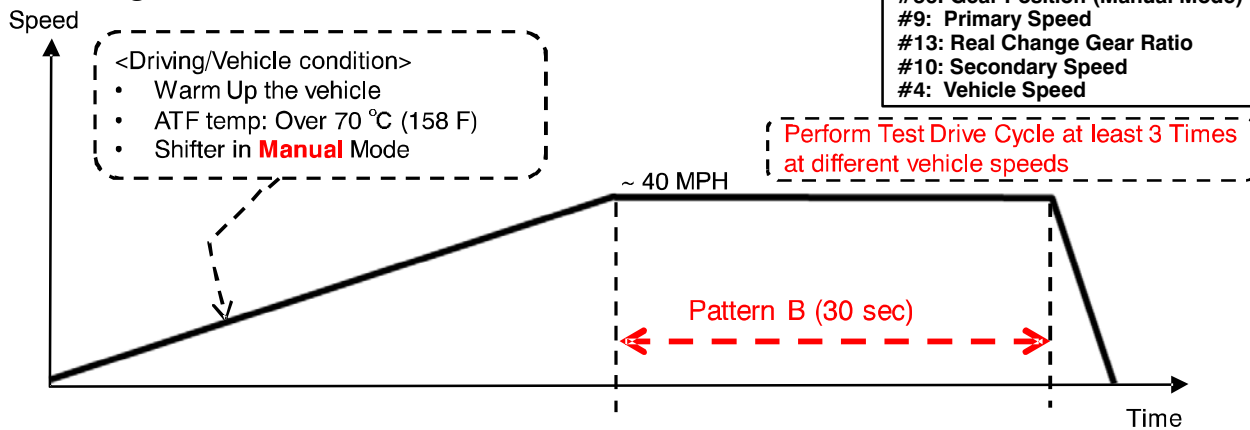
**FIGURE 2. Test Drive Procedure for Duplicating CVT-8 Surge/Flare**

Drive Record Items:  
#11: Engine Revolution  
#56: Gear Position (Manual Mode)  
#9: Primary Speed  
#13: Real Change Gear Ratio  
#10: Secondary Speed  
#4: Vehicle Speed

Condition	Driving Criteria	Judgment Criteria
<b>Pattern B</b> (Constant Vehicle Speed)	Surge/Flare	<ul style="list-style-type: none"> <li>Steady speed highway driving (follow all applicable laws) <ul style="list-style-type: none"> <li>~ 40 MPH</li> <li>~ 50 MPH</li> <li>~ 65 MPH</li> </ul> </li> <li>ATF Temp &gt; 158 F (warmed up)</li> <li>Shifter in <b>Manual</b> Mode</li> </ul>	<ul style="list-style-type: none"> <li>Engine RPM surging or flaring (more than 200 RPM from base) at steady state vehicle condition</li> </ul>
