## **CONDITION OF CONCERN**

# PARTS AND WARRANTY INFORMATION Safety and Emission Recall 0416J

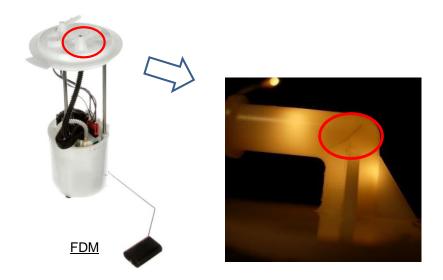
The Fuel Delivery Module (FDM) may develop a crack in the vertical portion of the fuel supply port that could result in a fuel leak.
