IMPORTANT SAFETY RECALL RECALL NO. 17E061

December 2017

This campaign involves the supercharger mounting bracket (Part Nos. AB037A-100, AB037A-100P, AB037A-100B) in ProCharger supercharger systems and kits, intended for installation on Model Year 2012 – 2017 Jeep Grand Cherokee SRT8/SRT vehicles in the US and Canada. These mounting brackets were included with the following kits:

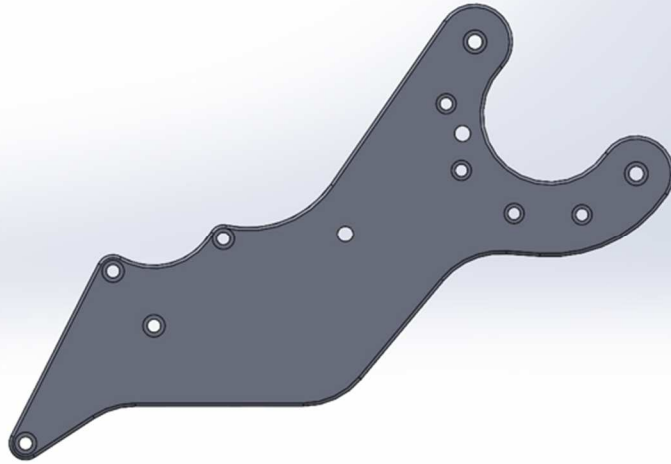
RECALLED BRACKET

ProCharger has discovered that the compressor housing for the above listed applications may, over time, contact the ABS brake lines due to insufficient clearance afforded by the mounting. Contact with the brake lines could compromise the integrity of the line. This contact between the bracket and brake line can occur under a variety of circumstances including improper bracket installation, variation in the engine mount positions within the vehicle manufacturer's specifications (which potentially results in the bracket being placed close to the ABS line), and/or possible degradation of the motor mount over time that may increase movement of the engine. If this condition remains undetected, the compromised integrity of the ABS brake line could eventually result in loss of brake fluid and degraded braking performance, increasing the risk of a vehicle crash.
