Product Safety Recall

17009 Front Passenger Air Bag Inflator

Reference Number: N162017009

Release Date: February 2018

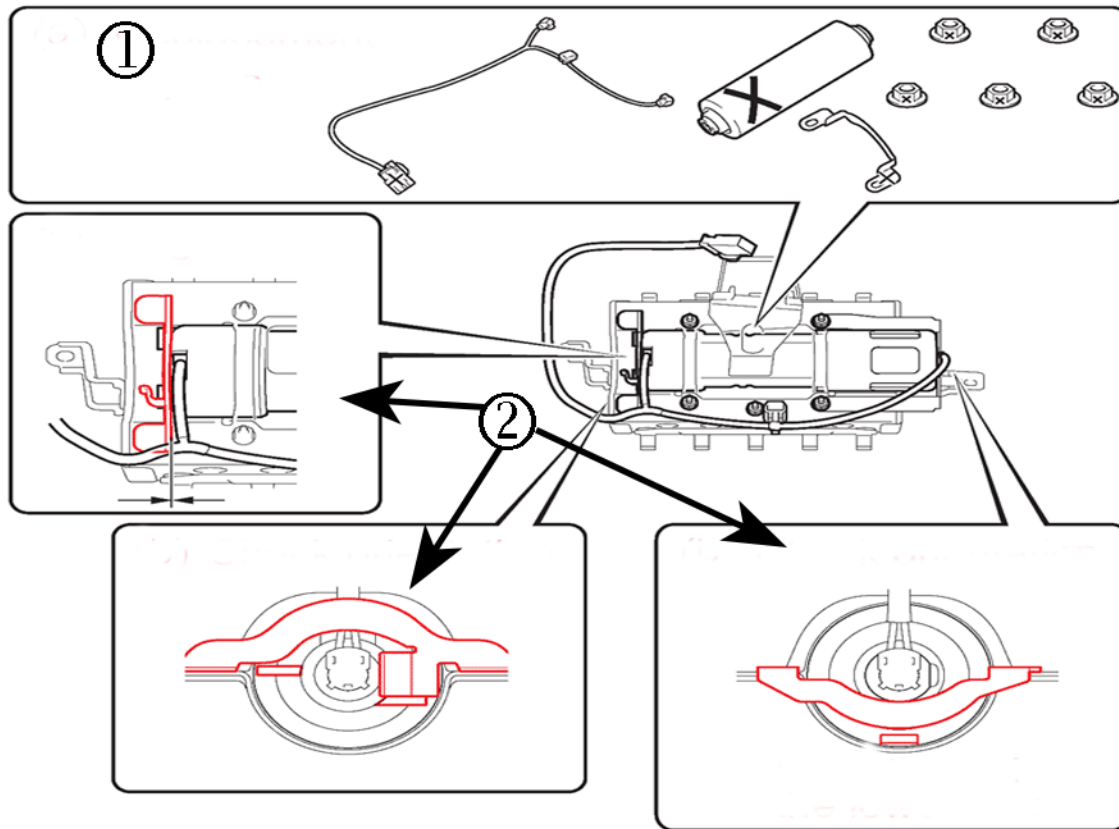
4751086

Note: If the airbag warning lamp remains on, it is likely to be caused by connection failure of the airbag connector.

12. Check that the inflator and 5 self-locking nuts, instrument panel wire, plate (1) are replaced.
13. Check that positions of the inflator and the position determining plate are correct (2).
(The flats should be aligned and there should be no gap.)
14. Install the instrument panel (IP) compartment. Refer to Instrument Panel Compartment Replacement in SI.
15. Check that the airbag warning lamp lights when the power switch is turned on.
 - Check that the airbag warning lamp goes off approximately 6 seconds after turning on of the power switch.
