# Product Safety Recall

## 17009 Front Passenger Air Bag Inflator

**Reference Number:** N162017009

**Revision:** 03

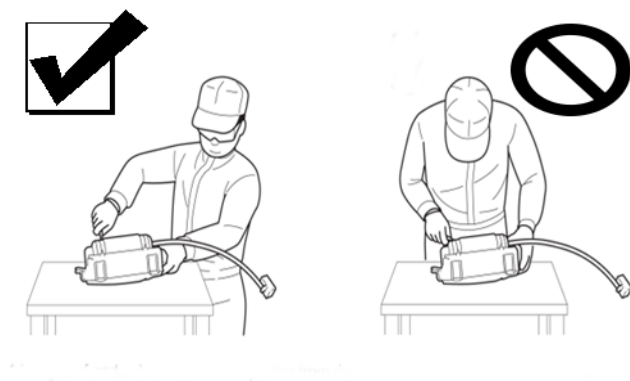
4751076

**Warning:** Confirm the stopper plate to inflator fitment is correct. **DO NOT** pinch the harness between the inflator and the stopper plate.

**Warning:** When working with the airbag module, avoid standing directly in front of the parts

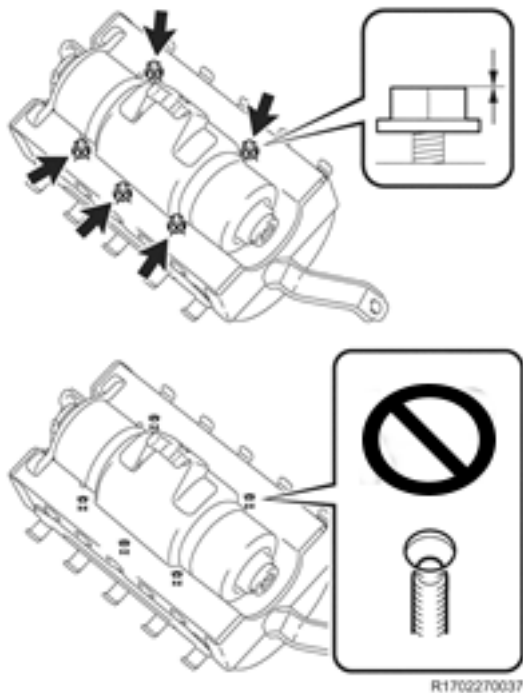
4751077

**Important:** DO NOT use an air driven tool. The stud bolt may fall inside if it is pushed down strongly while the 5 nuts are removed.

1. Loosen the 5 self-locking nuts until each face becomes flush with the edge of the stud bolt.

2. Remove the 2 self-locking nuts and plate. Store the removed self-locking nuts and plate in a parts box or the like.
3. Remove the inflator. Put an "X" on the inflator to prevent accidental reuse and store in a replacement box or the like.

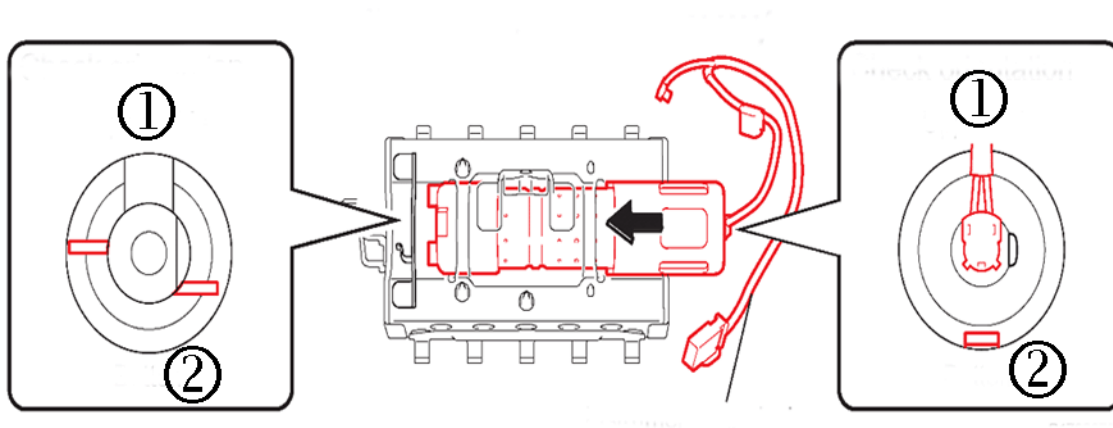
4751078

**Important:** DO NOT insert the inflator fully.

4. Insert a NEW inflator to the center of the airbag case with the correct orientation as shown (1) Upper side (2) Bottom.
  - If the passenger airbag inflator is upside down, it will not be able to be fully inserted.

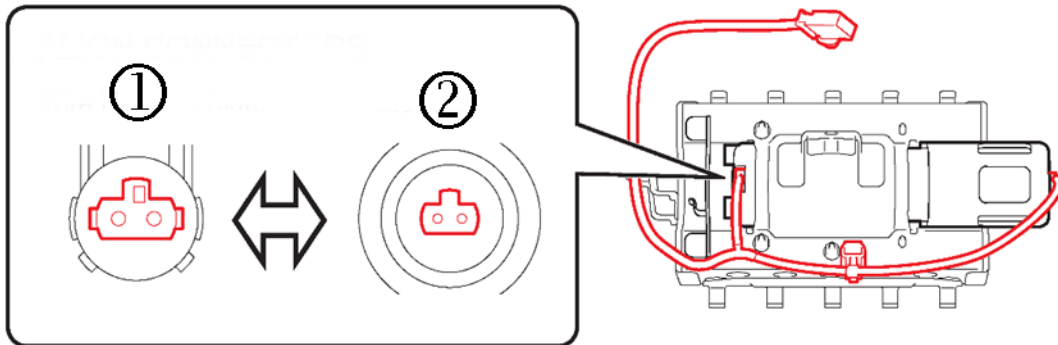
4751079

**Important:** Make sure that the inflator is oriented correctly as shown in the illustration, not upside down. If the passenger airbag inflator is upside down, it will not be able to be fully inserted.

5. Connect the connector and push in each airbag connector lock as shown (1). Wire harness side (2) Inflator side.

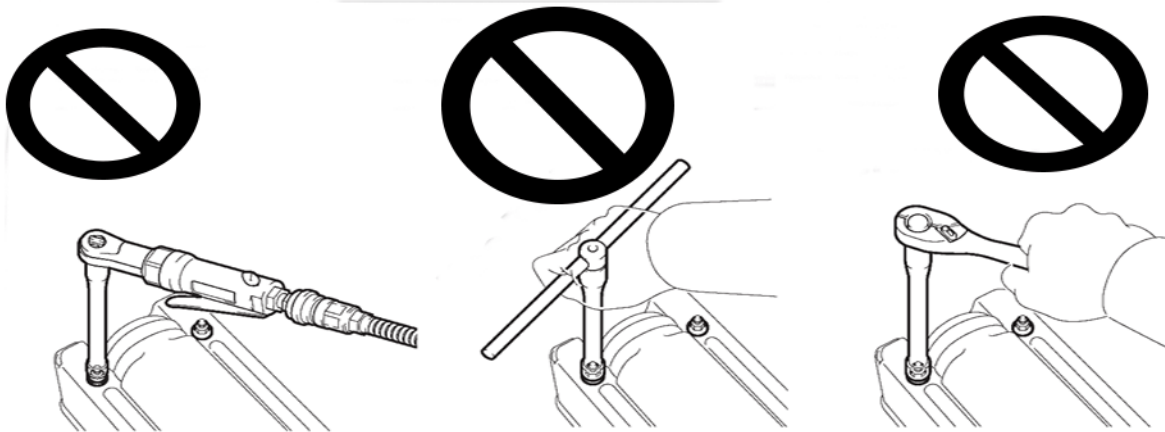
4751084

**Important:** The tightening torque is low (3.9 N·m). Use of an air ratchet wrench or tightening strongly with a T-handle wrench or a ratchet handle may cause deformation of the stud bolt.
