David J. Johnson
 Director
 Service Engineering Operations
 Ford Customer Service Division

March 14, 2018

SUBJECT: Safety Recall 17S01 - *Supplement #1*
 Certain 2005-2006 Ford GT, 2005-2009 and 2012 Mustang, 2006-2009 Milan,
 2006-2009 and 2012 Fusion, Zephyr/MKZ, 2007-2009 Edge and MKX, and
 2007-2009 Ranger Vehicles
 Passenger Airbag Inflator Replacement

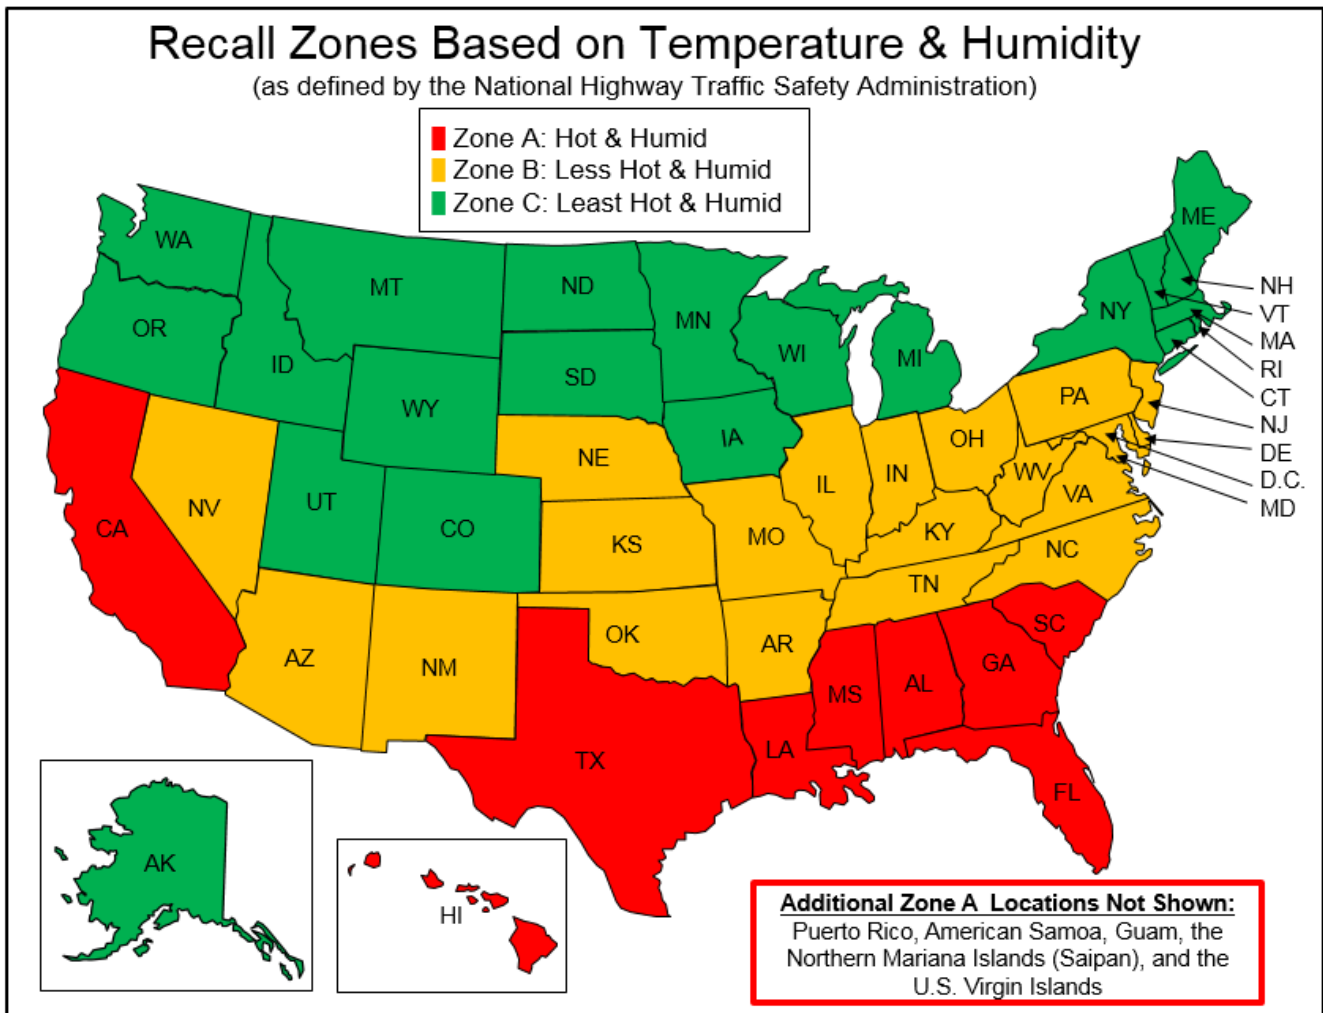
FIGURE 1

The Takata airbag recall zones have been defined by the NHTSA, based on temperature and humidity.
