David J. Johnson  
Director  
Service Engineering Operations  
Ford Customer Service Division

**SUBJECT:** **Safety Recall 17S01 – Supplement #10**

Certain 2005-2006 Ford GT, 2005-2009 and 2012 Mustang, 2006-2009 Milan, 2006-2009 and 2012 Fusion and MKZ/Zephyr, 2007-2009 Edge and MKX, and 2007-2009 Ranger Vehicles  
Passenger Airbag Inflator Replacement

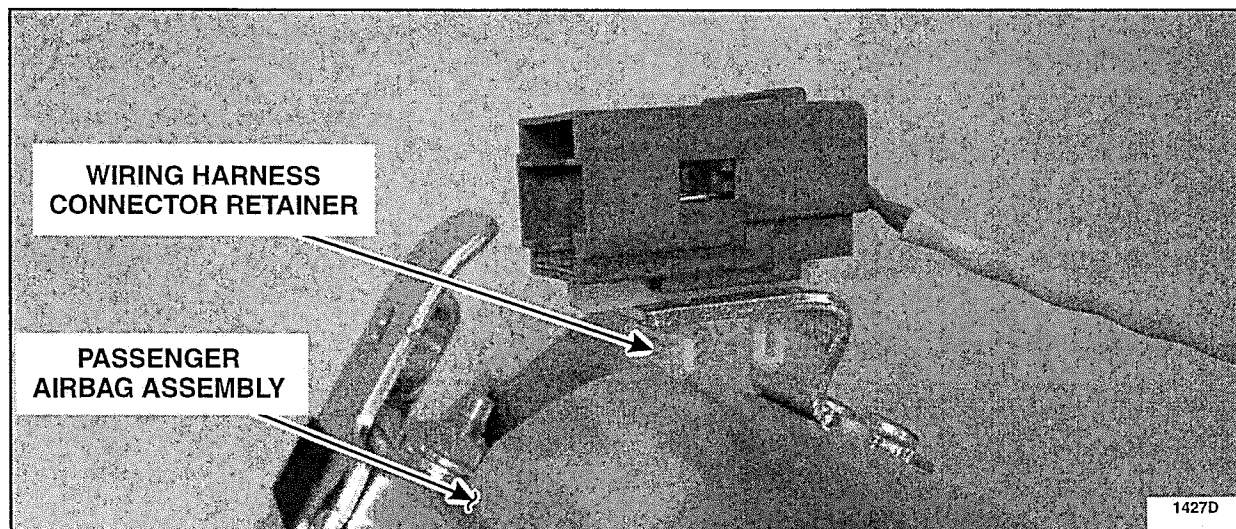
**FIGURE 1**

1. Remove the passenger airbag from the vehicle. Please follow the WSM procedures in Section 501-20B.
2. Set the airbag face down onto a surface that will not scratch or damage the airbag face.
3. Remove the wiring harness connector retainer from the passenger airbag assembly. See Figure 1.

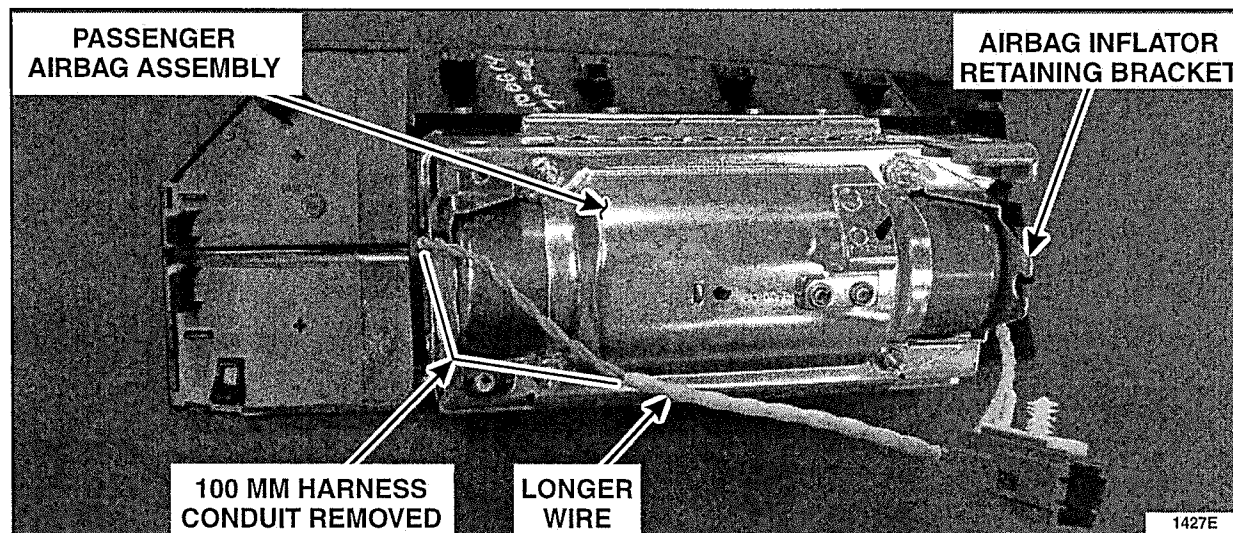
**FIGURE 2**

4. Remove approximately 100 mm (3.93 in) of the conduit from the passenger airbag assembly wire harness. See Figure 2.

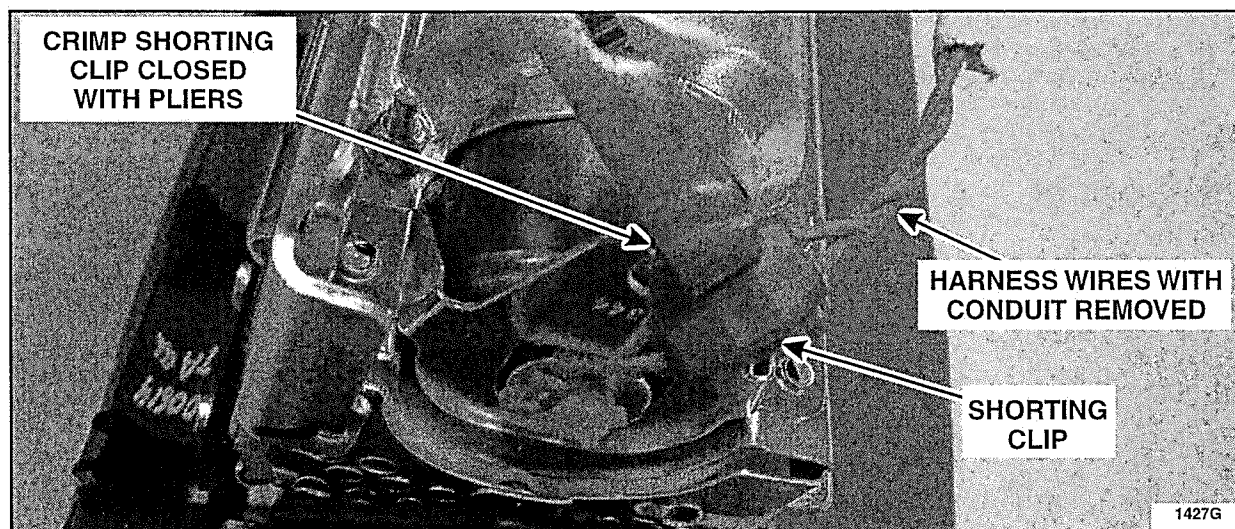
FIGURE 3

5. Position the shorting clip onto the harness wires, and crimp the shorting clip together one side at a time using pliers. See Figure 3.

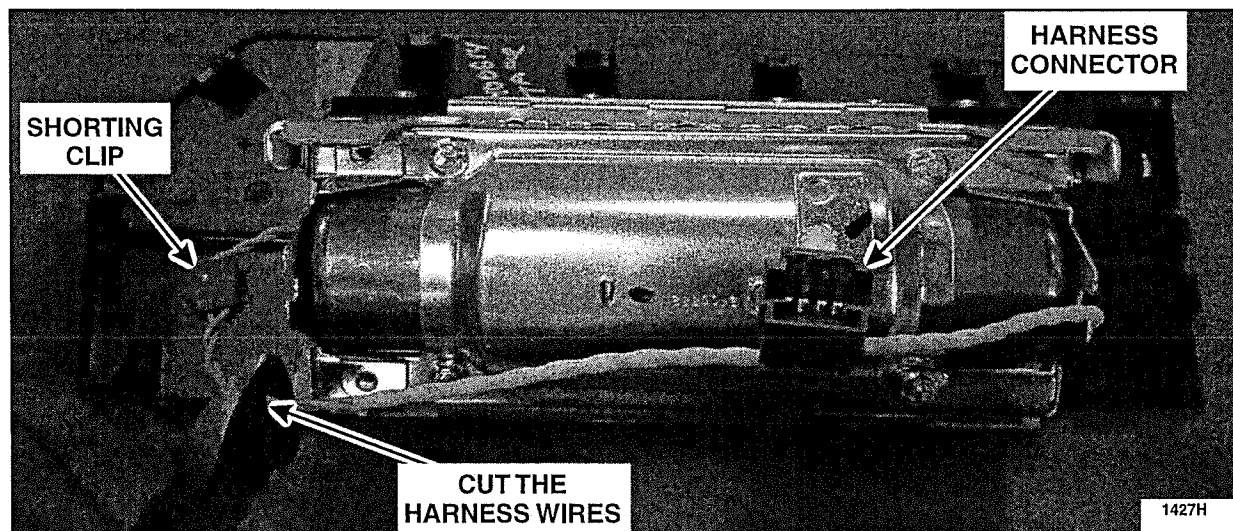
FIGURE 4

6. Cut the harness wires between the shorting clip and the harness connector. See Figure 4.

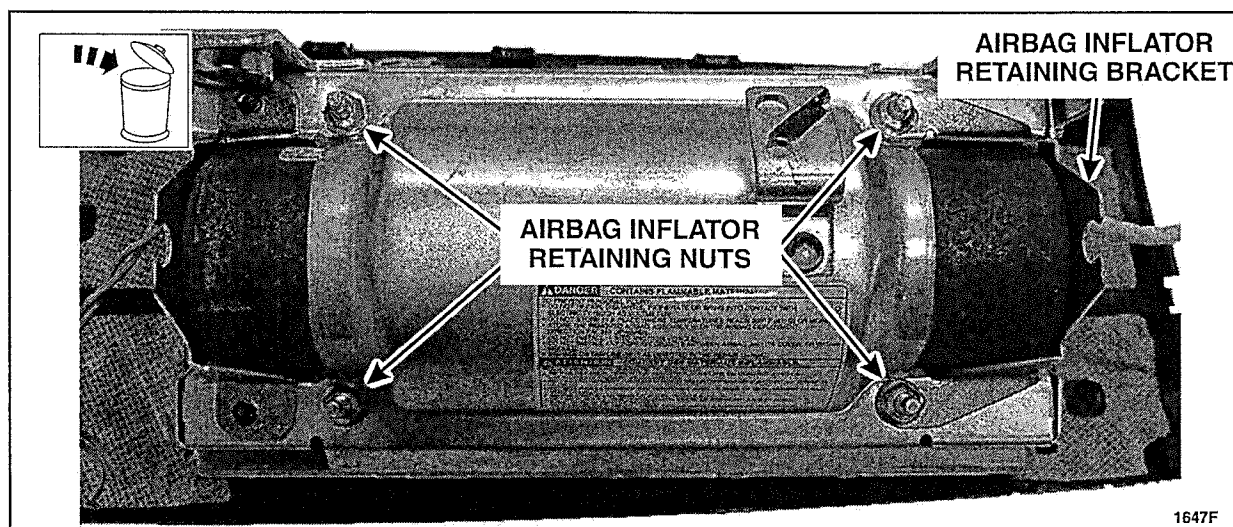
FIGURE 5

7. Remove and discard the four passenger airbag inflator retaining bracket nuts and the retaining bracket. See Figure 5.

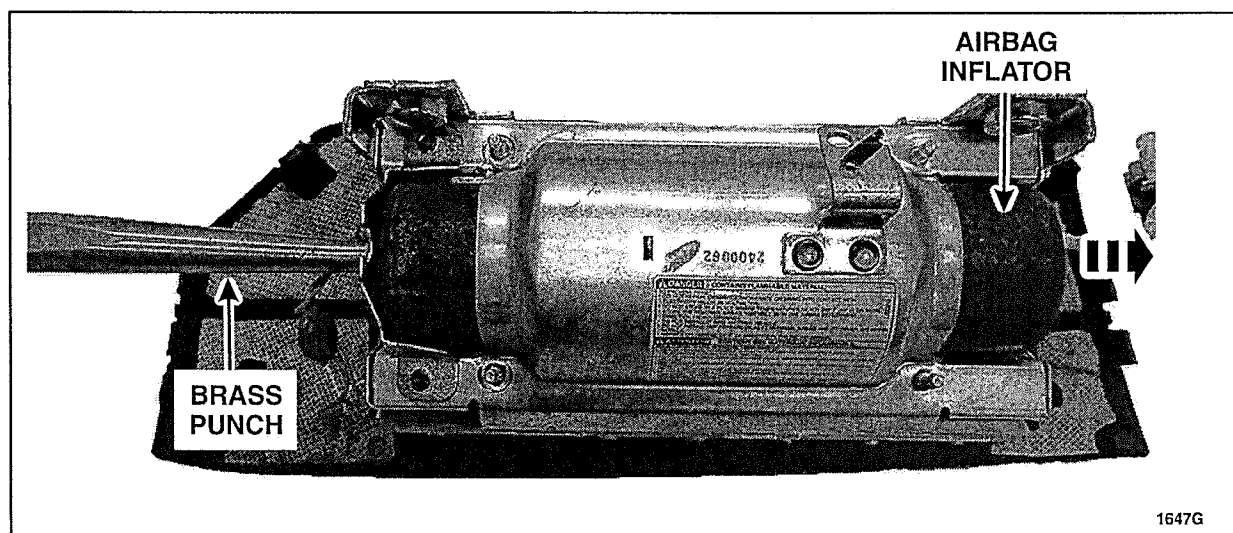
FIGURE 6

8. With an assistant holding the passenger airbag assembly, remove the inflator from the assembly by pushing outward on the inflator. Set the airbag inflator aside for return shipping. See Figure 6.

- If required, use of a brass punch is permitted (only at the location shown) to free the inflator from its mounted position.

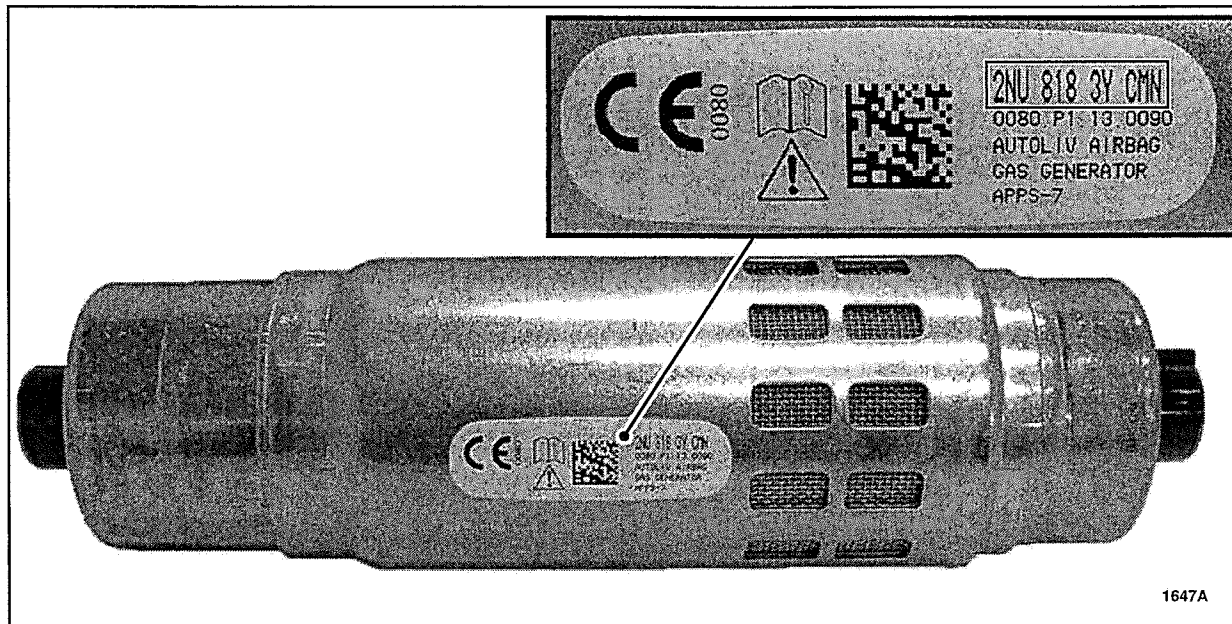
**FIGURE 7**

9. Record the 11 character serial number of the *new* airbag inflator on the repair order. See Figure 7.

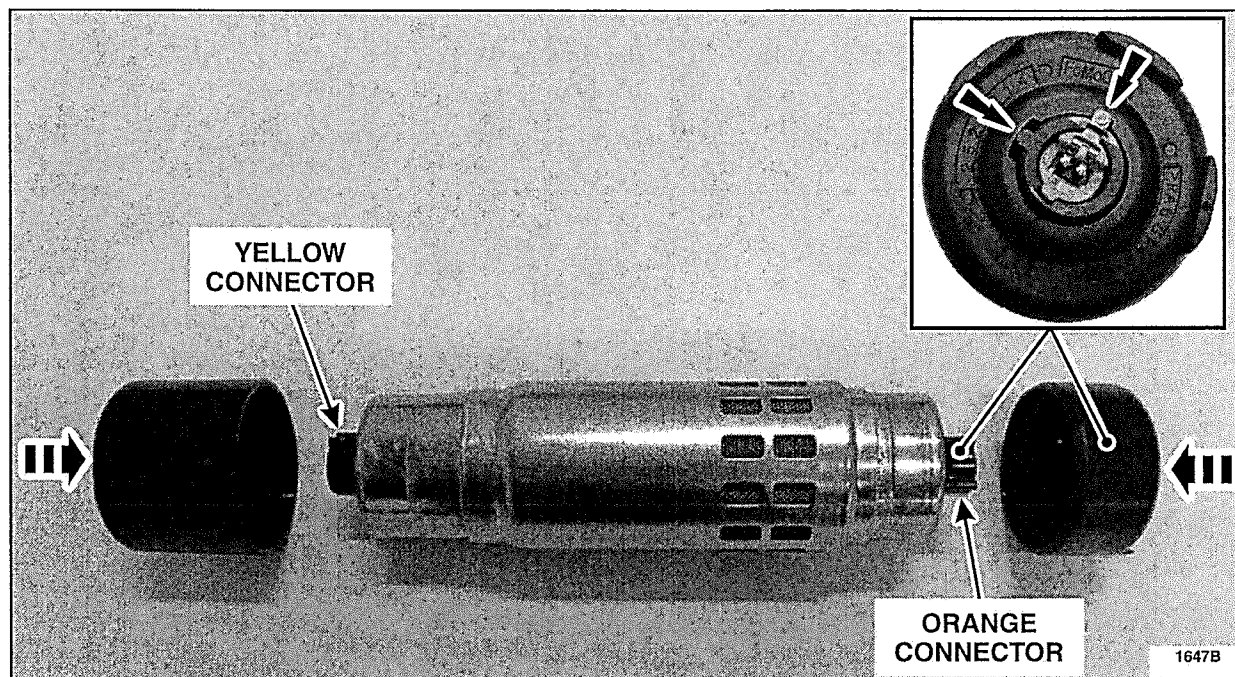
**FIGURE 8**

Install both *new* inflator end caps making sure the alignment feature on the cap nearest the inflator retaining bracket is properly oriented. See Figure 8.

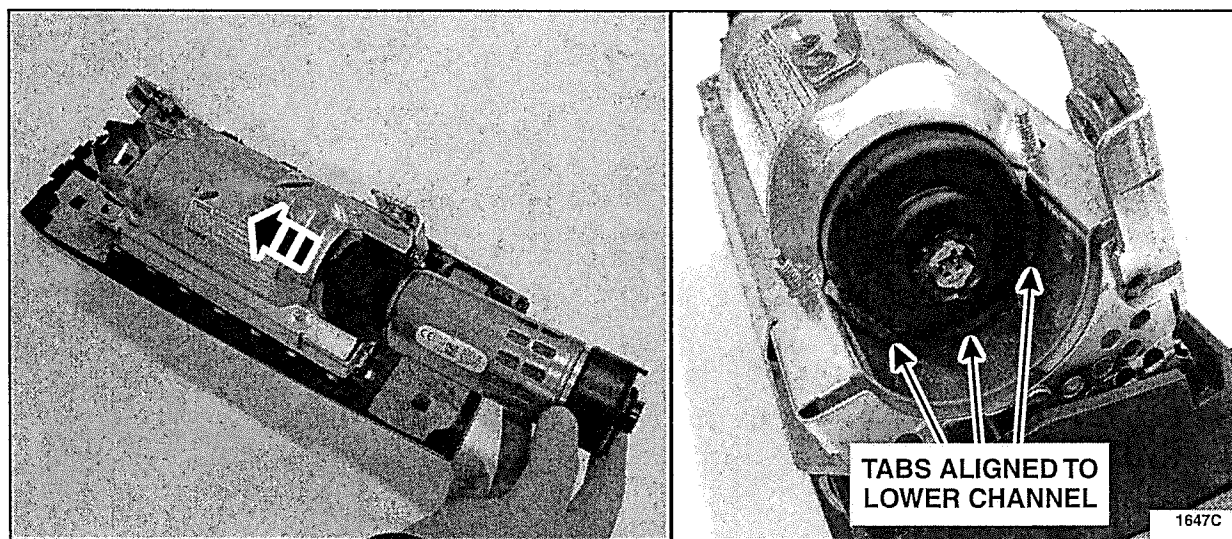
**FIGURE 9**

11. Install the inflator into the passenger airbag assembly with the orange connector end facing out. Align the three tabs on the cap nearest the inflator retaining bracket with the airbag module lower channel (facing down). See Figure 9.

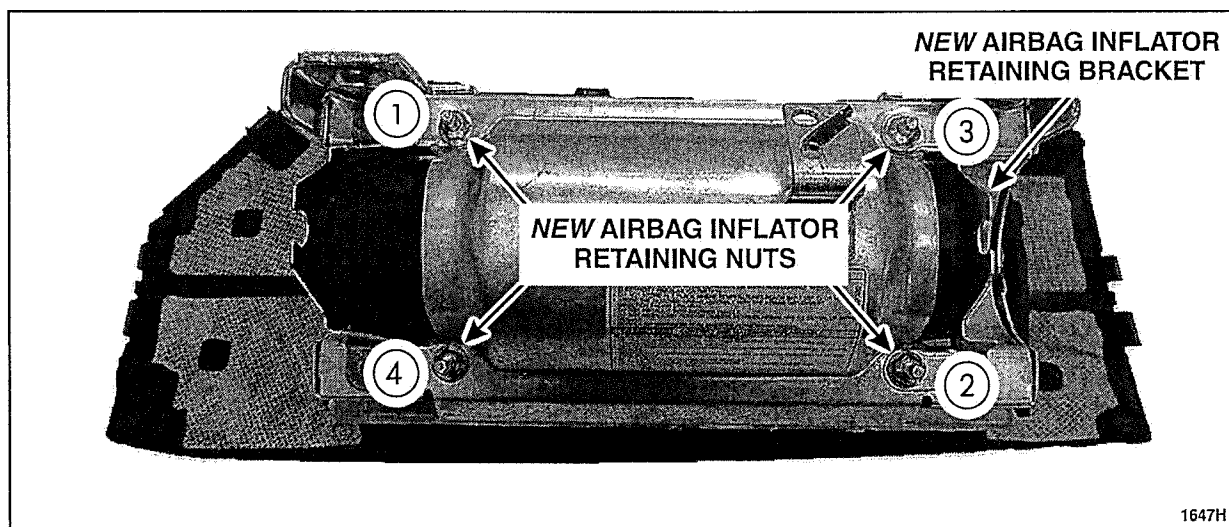
**FIGURE 10**

12. Install the *new* passenger airbag inflator retaining bracket and *new* nuts. See Figure 10.

- Torque the new retaining nuts in the sequence shown below to 4 Nm (35 lb.in).

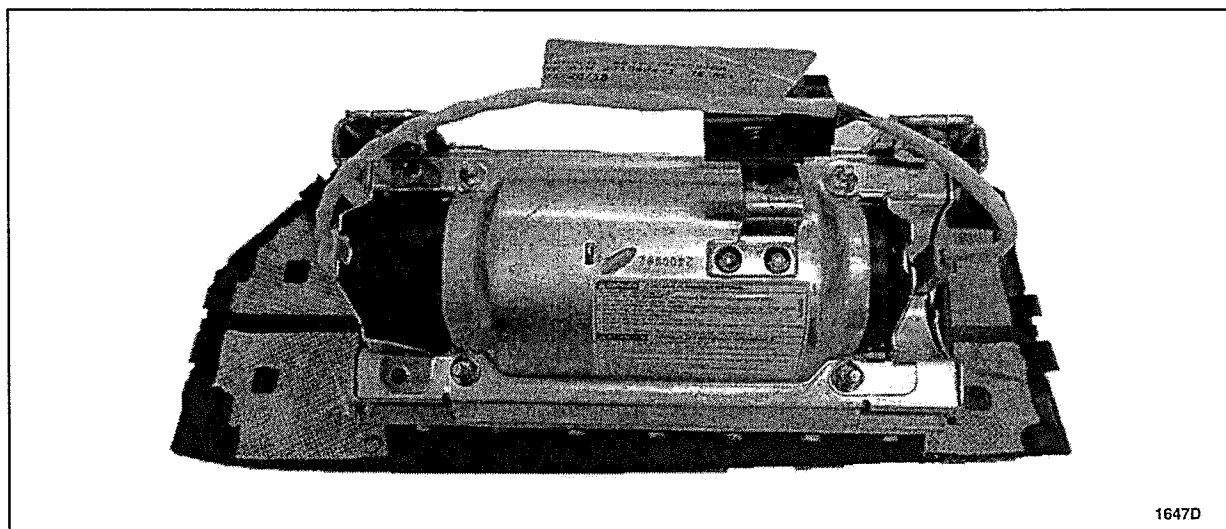
**FIGURE 11**

13. Align the T-shape index on both the wiring harness electrical connector and the airbag inflator. Install the new wiring harness onto the passenger airbag module and connect to both sides of the inflator. See Figure 11.

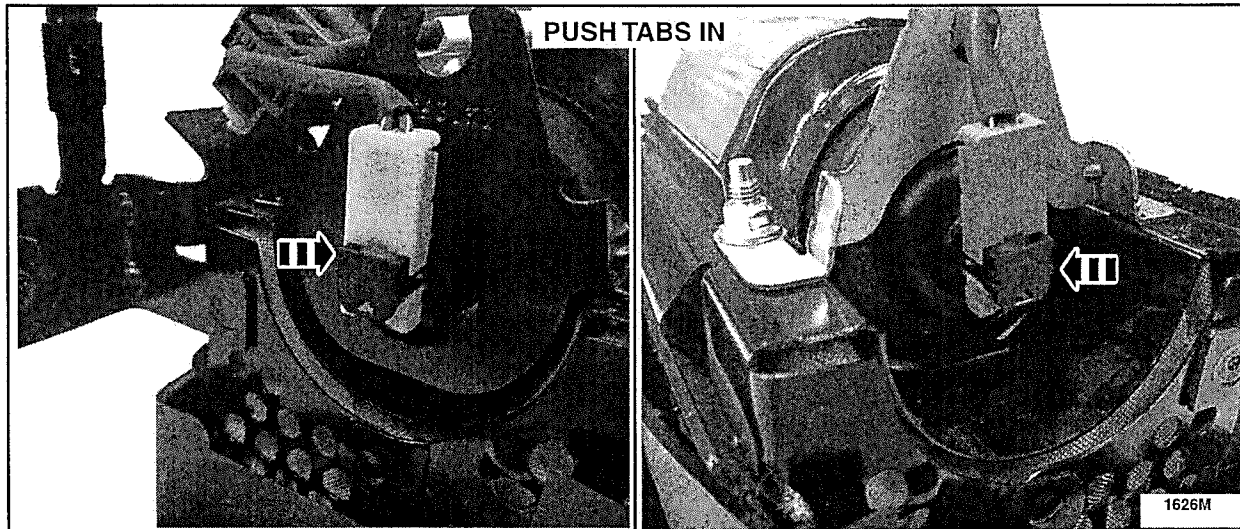
**FIGURE 12**

14. Insert black the inflator wiring harness connector tabs. See Figure 12.

NOTE: Pull gently on the wiring harness to ensure it is properly seated.
