SAFTEY RECALL

CAMPAIGN BULLETIN Takata Passenger Air Bag Inflator M Sedan Instrument Panel Repair Procedure Update

Reference: R1622/R1704, R1701, R1706 Date: October 4, 2017

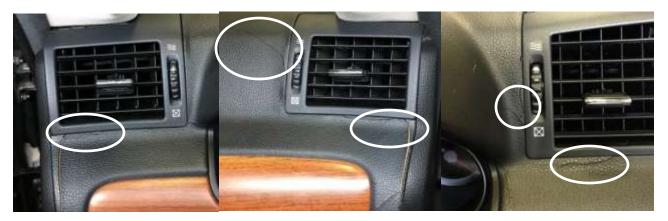
INFINITI has revised campaign bulletin ITB17-024 for 2006-07 M35/M45 sedans to help mitigate any incidental damage to original instrument panels during Takata repairs. The new version includes instructions for vent removal to minimize damage around vents as shown below:

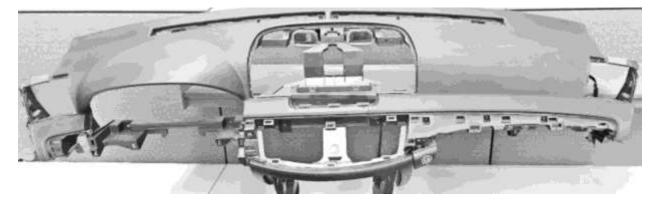
In addition to taking photographs before repair, service consultants may use the dash image below to identify pre-existing damage so the client can acknowledge it at the time the vehicle is dropped off.
