# SAFETY RECALL: SERVICE BULLETIN 546 - HEATED GRIP SPACER

### **SAFETY RECALL: Service Bulletin 546 – Heated Grip Spacer**

<b>SERVICE BULLETIN 546: HEATED GRIP SPACER</b>		
<b>Bulletin Number</b>	<b>Models Affected</b>	<b>VIN Range</b>
546	Bonneville T120	From 739727 to 776237
	Bonneville T120 Black	From 741136 to 776237

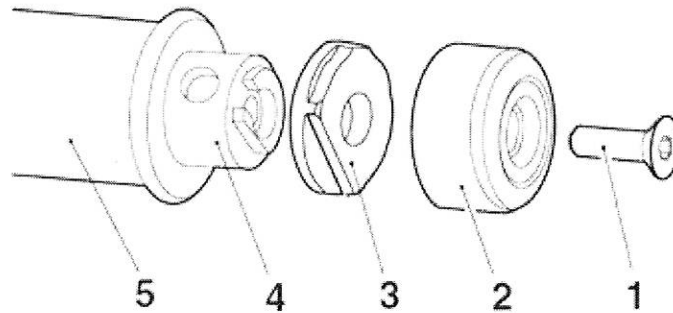
The addition of this new spacer (see Item 3 in diagram below) will ensure a sufficient expansion air-gap between the end of the throttle twist grip rubber and the end weight. The air-gap is required to accommodate the expansion of the rubber grip when the rider switches the heated grips to “on”. When turned “on” an insufficient air-gap may cause the (activated heated) throttle twist grip to bind on the end weight. Under these circumstances this may prevent the twist grip from returning to its positive stop without manual intervention by the rider. This symptom will not occur on a cold grip or models without heated grips.

1. Fixing
2. Handlebar end weight
3. Spacer
4. Handlebar
5. Heated twist grip

All affected motorcycles are to be repaired in accordance with SB546. Please see attached **SB546 - Heated Twist Grip** PDF or visit the Service Bulletin library on **Triumphonline.net (TOL)** to access SB546, then print off the new bulletin for your workshop files and ensure all appropriate staff are made aware of contents.
