SAFETY RECALL

Rear Door Sealing Screen/Vapor Barrier Voluntary Safety Recall Campaign

Reference: PC540
Date: January 19, 2017

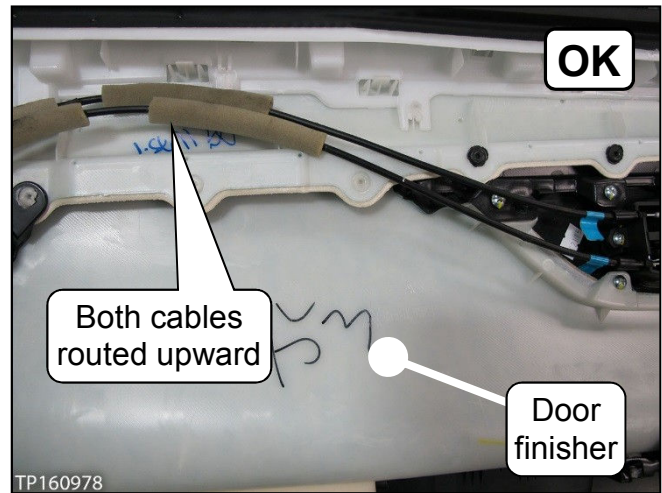
Figure 19 shows proper routing of the cables.

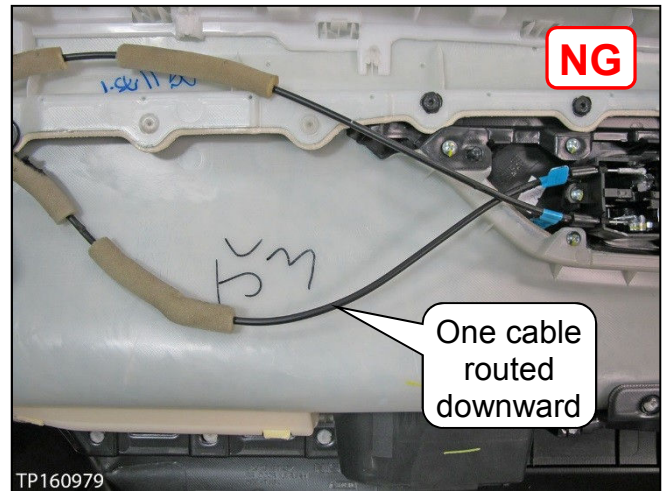
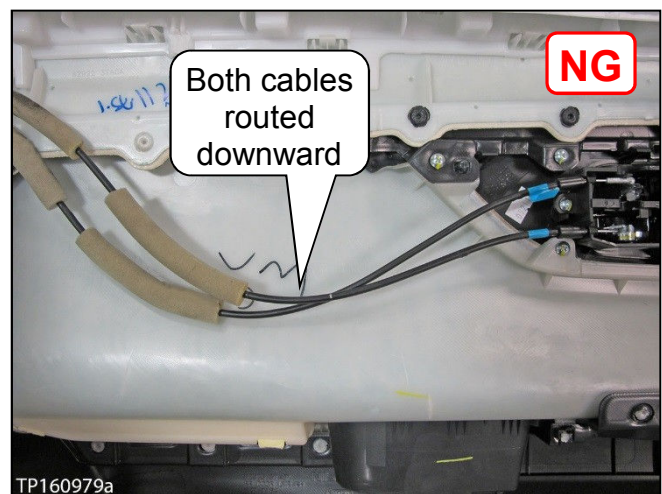
Figure 20 and 21 show incorrect routing of the cables.
