SAFETY RECALL

Rear Door Sealing Screen/Vapor Barrier Voluntary Safety Recall Campaign

Reference: PC540
Date: January 19, 2017

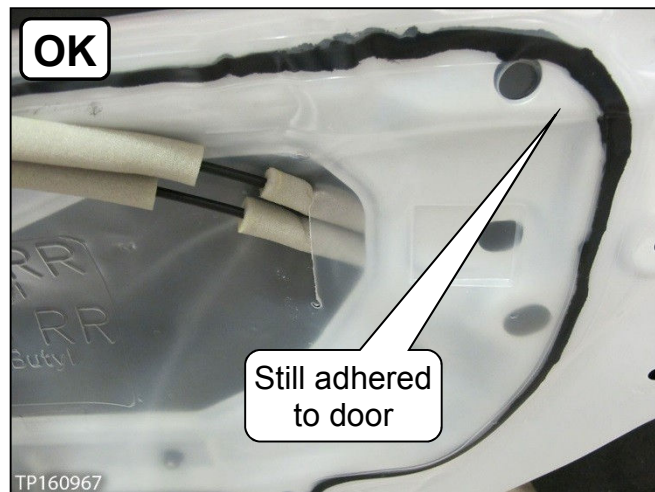
Figure 8

- 8. Inspect the upper right portion of the vapor barrier.
 - a. If the vapor barrier's condition is similar to the one in Figure 8, go to page 6, **Vapor Barrier - Adjustment**.

Vapor Barrier – Adjustment

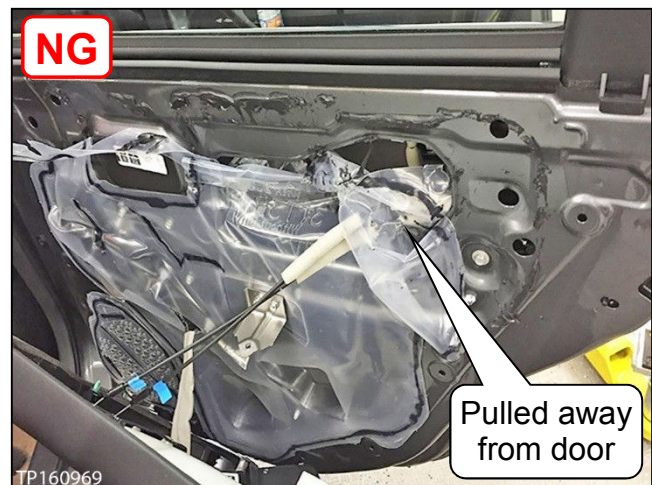
Figure 9

- b. If the vapor barrier's condition is similar to the one in Figure 9, go to page 8, **Inspect Rear Door Lock Assembly and Inside Handle, and Replace Vapor Barrier**.

7. Replace the damaged vapor barrier.

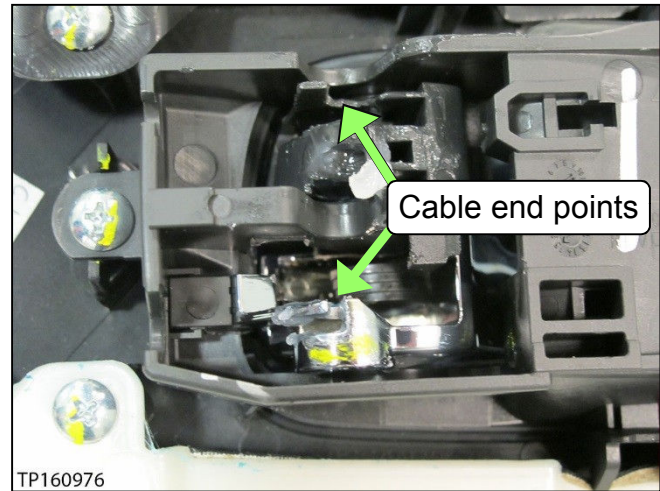
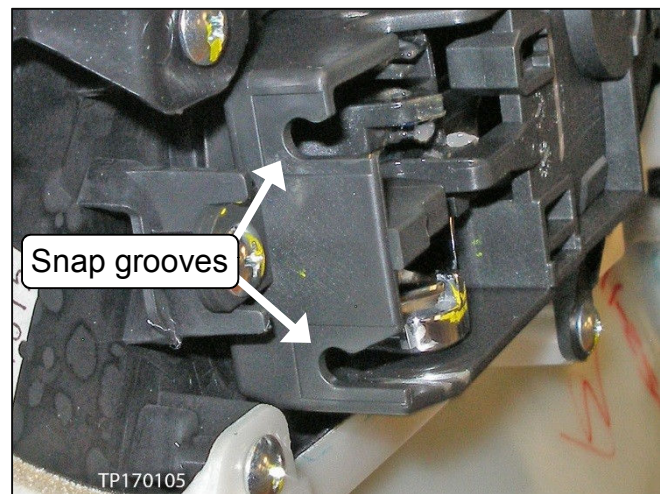
1. Inspect the inside door handle snap grooves and cable end points for damage (see Figure 15 and 16).
 - The inside door handle is fastened to the back side of the door finisher.
2. Damage found: Replace the inside door handle.
 - Refer to the ESM, section **INT-Interior**, for inside handle replacement.
3. No damage found: Do not replace the inside door handle.

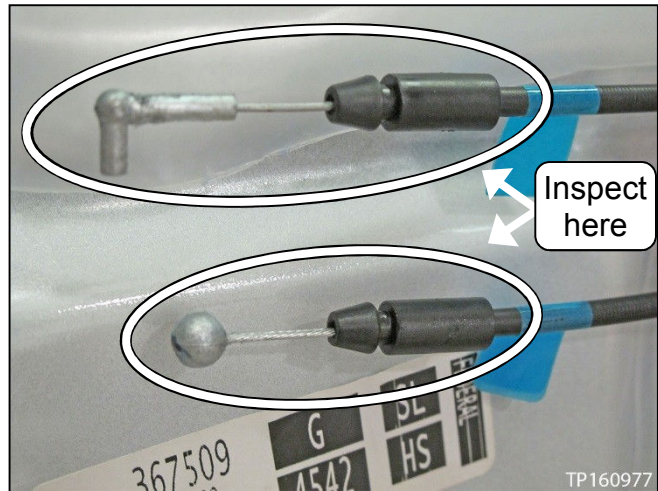
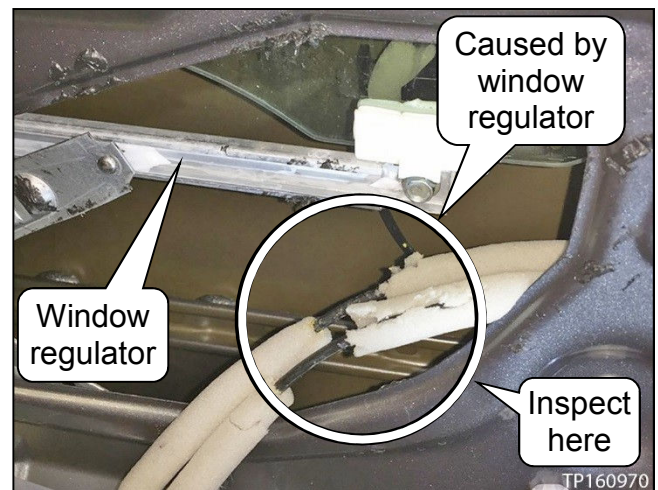
4. Inspect the cables (see Figure 17 and 18).

5. Damage found: Replace the door lock assembly with cables.

- Refer to the ESM, section **DLK-Door & Lock**, for cables and door lock assembly replacement.

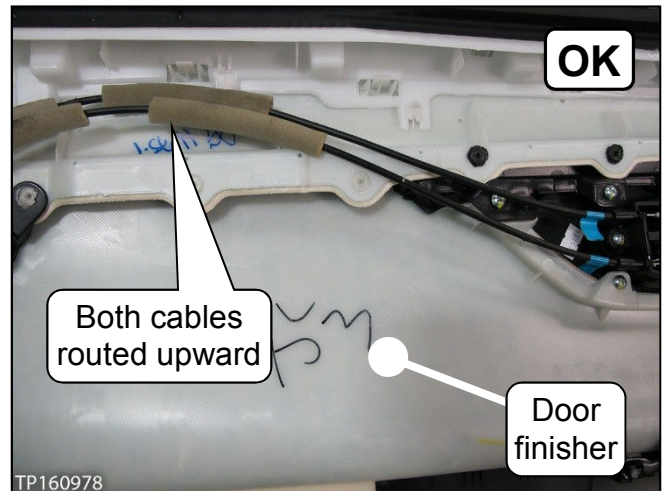
Figure 19 shows proper routing of the cables.

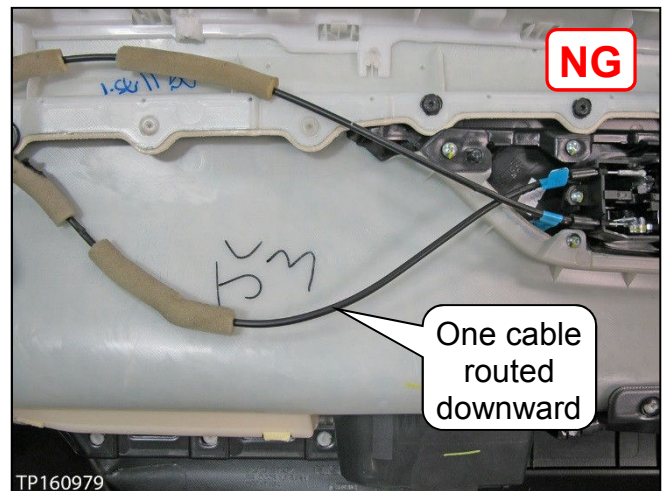
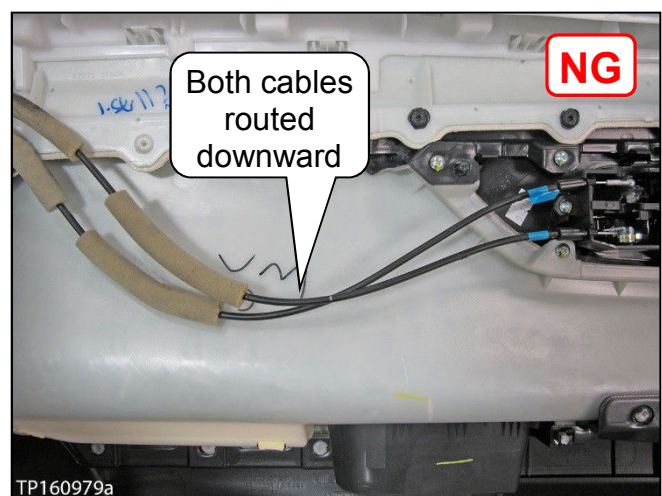
Figure 20 and 21 show incorrect routing of the cables.
