November 2017
FL731A-G
NHTSA #17V-043
Transport Canada #17-031
SECOND REVISED NOTICE

Subject: ICU3S Dual Cluster Displays

Models Affected: Specific Freightliner 108SD, 114SD, and Business Class M2 vehicles manufactured March 5, 2015, through August 15, 2016.

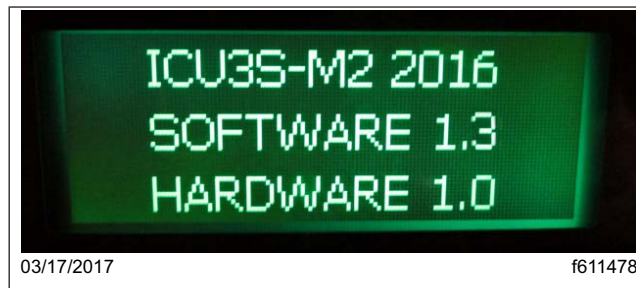
1. Check the base label (Form WAR259) for a completion sticker for FL731 (Form WAR260) indicating this work has been completed. The base label is usually located on the passenger-side door, about 12 inches (30 cm) below the door latch. If a completion sticker is present, no work is needed. If a completion sticker is not present, proceed to the next step.
2. Park the vehicle, shut down the engine, and apply the parking brakes. Chock tires.
3. On the driver side ICU, press the ICU3S mode button until the software/hardware versions display on screen. Verify the software level of the ICU3S. See [Fig. 1](#) .

If the software level of the ICU3S is 1.3, or higher, no further action is necessary. Continue with step 19.

If the software level is below 1.3, continue with the next step.

Fig. 1, ICU3S Screen Showing Software Version 1.3 (correct)
