RECALL 17V-047: DRIVER'S FRONT AIR BAG MODULE – PRIOR PARTS REPLACEMENT

This Service Information bulletin replaces SI B65 02 17 **dated April 2017**

**Model Year 2000-2003 BMW X5, 3 and 5 Series
Driver's Front Air Bag Module
Safety Recall 17V-047
Last updated: 1/26/2017**

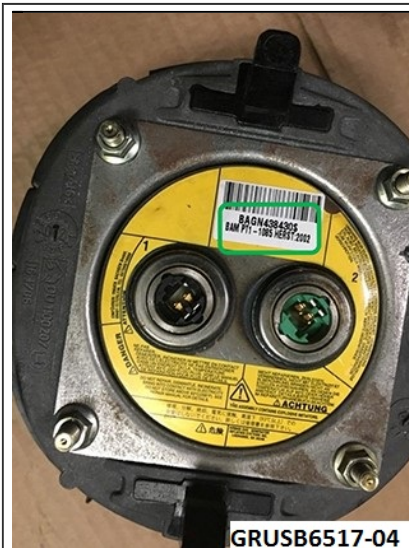
Is the label yellow with a white number sticker with printed serial number BAM XXX - 1085 (as shown below) printed below the bar code?

Air bags from other manufacturers (non-Takata), or Takata air bags with different chemical compositions (white label) are not affected by this recall and DO NOT need to be replaced.

YES- replace air bag following attached procedure.
