January 25, 2017

SUBJECT: NEW VEHICLE DEMONSTRATION / DELIVERY HOLD - Safety Recall 17S03
Certain 2016 Model Year Focus and C-Max Vehicles
Left-Hand Underbody Apron Weld Inspection and Repair

CERTAIN 2016 MODEL YEAR FOCUS AND C-MAX VEHICLES — LEFT-HAND UNDERBODY APRON WELD INSPECTION AND REPAIR

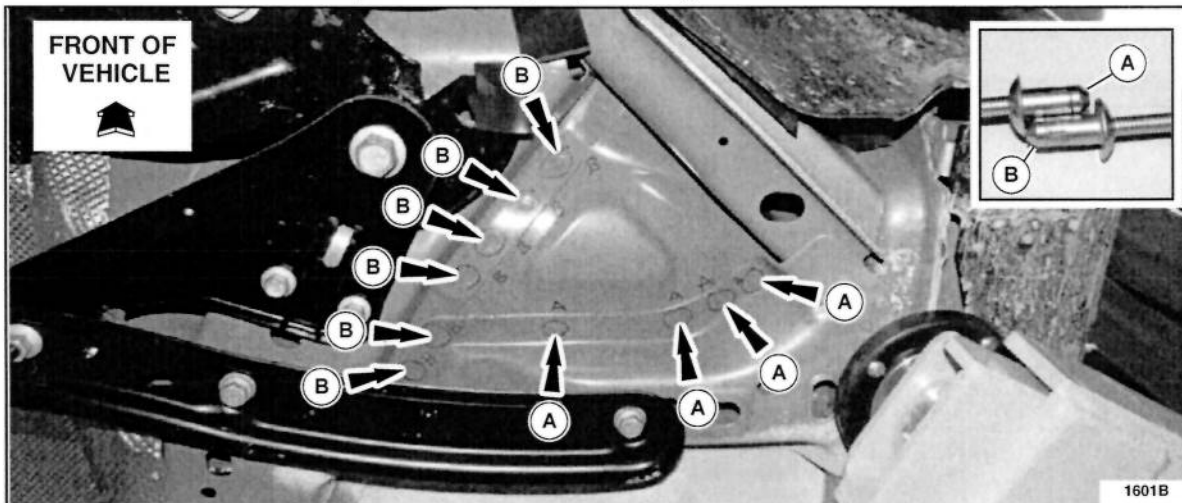
FIGURE 2

NOTE: Figure 2 shows a vehicle with ten (10) correctly applied factory spot welds. On the affected vehicles, these spot welds are inadequate or missing, and were replaced with rivets. Each spot weld location point must contain a rivet. See Figure 2.

2. Locate the rivets installed into the floor pan seam, under the vehicle behind the LH front tire. Inspect the rivets for proper installation. See Figures 2, 3a and 3b.
 - If the rivets are **installed and seated properly in each location**, no further action is required. See Figures 2, 3a and 3b.
 - If any of the rivets are **installed but seated improperly**, proceed to Repair Procedure on Page 3. See Figures 2, 3a, and 3b.
 - If a rivet is **not installed** in any of the ten (10) locations shown in Figure 2, install the correct rivet(s) as needed. Drill a hole in the appropriate location(s) using a suitable 17/64 in (6.75 mm) drill bit. Proceed to Repair Procedure, Step 6 on Page 5.

- If replacing rivets at "A" locations, install a short "A" rivet. See Figure 2.
- If replacing rivets at "B" locations, install a longer "B" rivet. See Figure 2.
