SAFETY RECALL

Takata Passenger Airbag Inflator Voluntary Safety Recall Campaign

Reference: R1703
Date: February 7, 2017

Affected Models/Years:	Affected Population:	Dealer Inventory:	SERVICE COMM Activation date:	Stop Sale In Effect
MY2002 Pathfinder (R50)	23	NA	February 7, 2017	YES

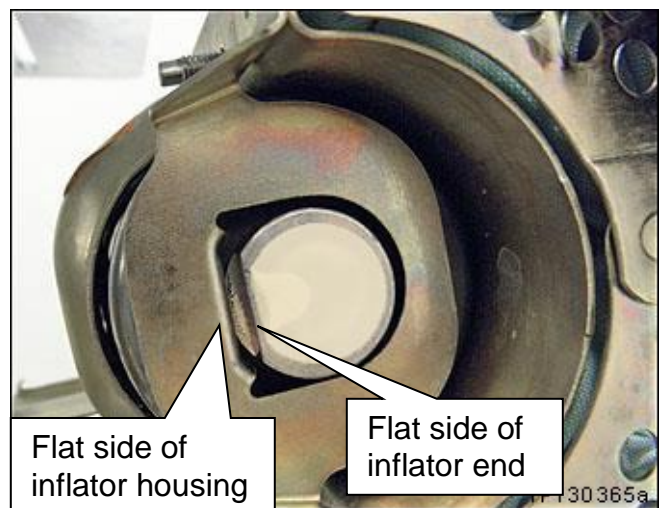
Figure P14

17. Make sure the inflator is positioned / oriented correctly, as shown.

- **The flat side of the inflator end (on the right side) must face the flat side of the inflator housing.**

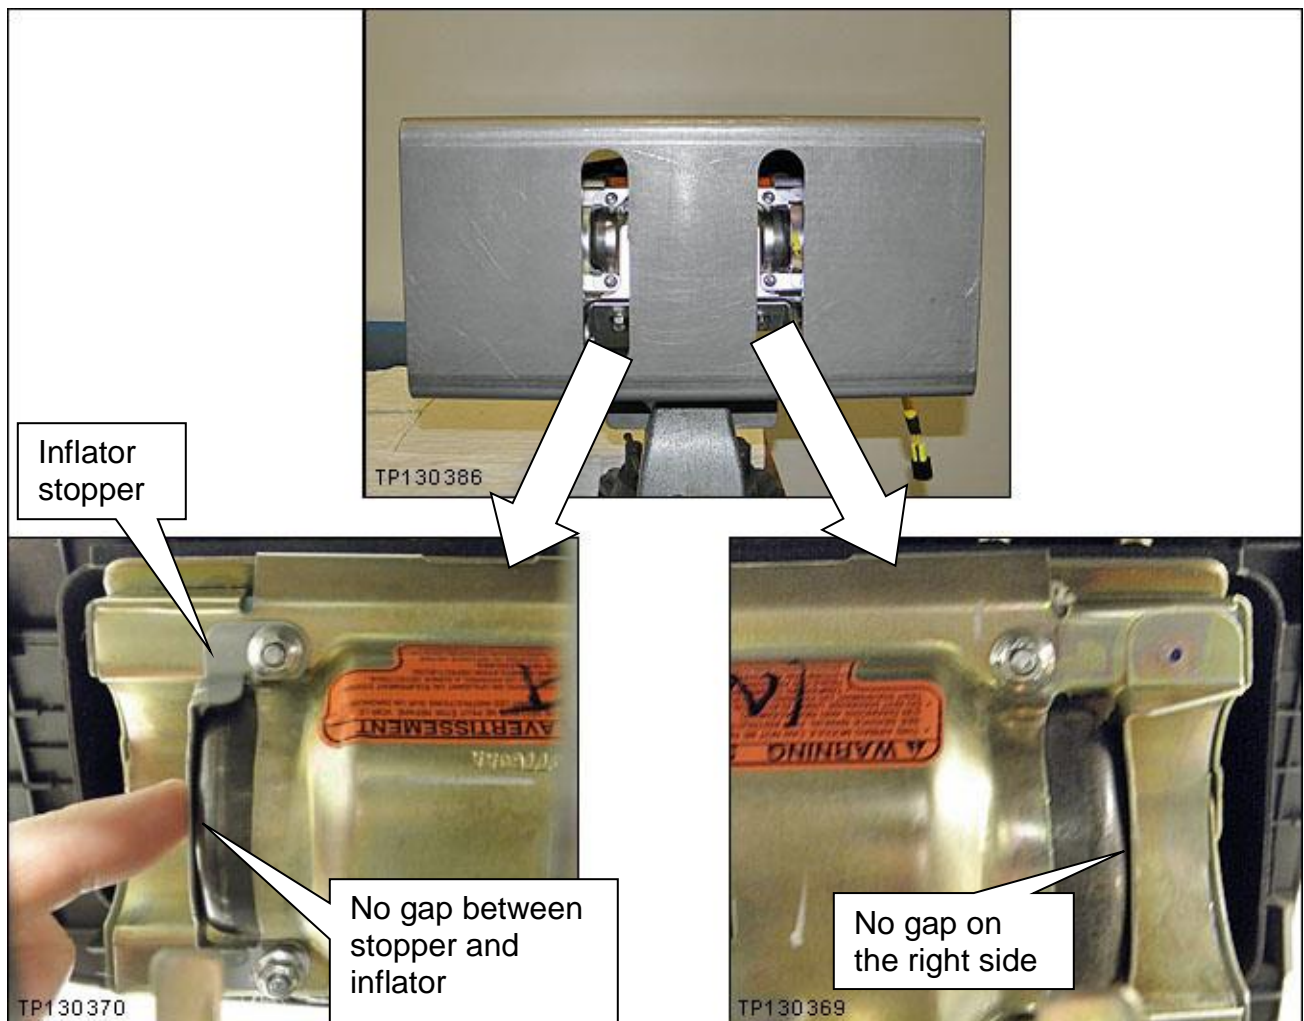
Figure P15

19. Make sure the inflator is pushed all the way into its housing – no gap on the right side (see Figure P15).

20. Make sure there is no gap between the inflator stopper and the inflator (see Figure P15).

18. Install the inflator stopper and 4 inflator securing nuts finger tight (see Figure P15).
