Campaign code.
L73X-R.01.17

Campaign description.
Evap system upgrade

Model.
Aventador Coupe and Roadster.

L73X-R.01.17	To: Official Lamborghini Service Network Subject: Update of fuel vapor circuit Date: February 24, 2017 Pages: 59	 
--------------	---	---

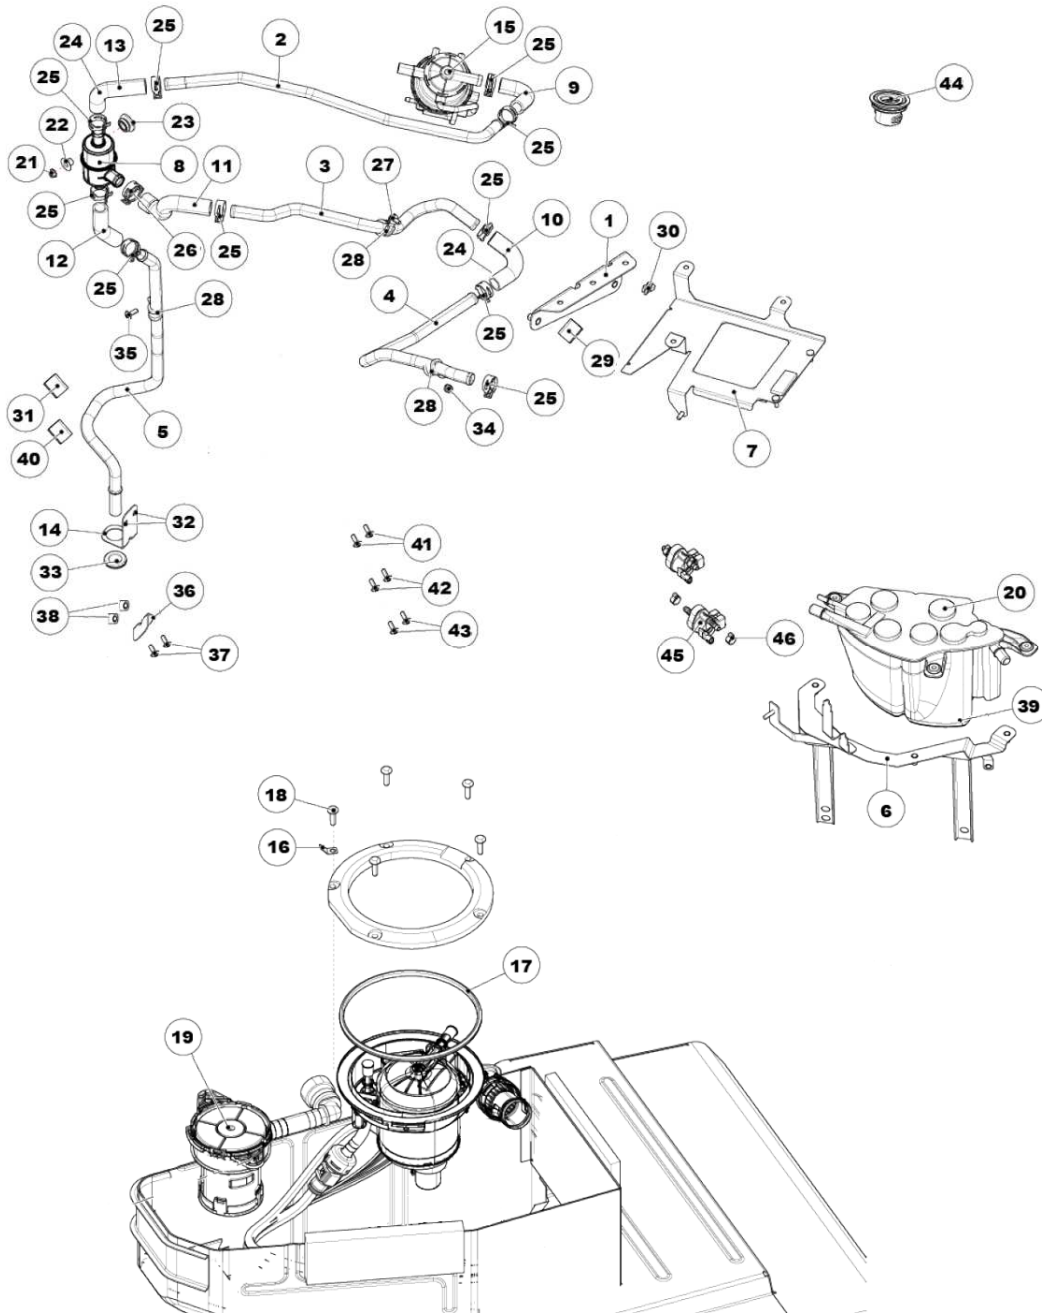
The Lamborghini Aventador fuel vapor collection circuit has been subjected to a few technical updates. A diagram of the updated components of the fuel system to be installed on the vehicle is provided below.

- A. Updating of the fuel vapor exhaust circuit, installation of the 3-way valve, replacement of the Activated Carbon Canister (ACC) filter and LDP diagnosis pump.
- B. FLVV valve update.
- C. Purge electro-valve update.
- D. Tank cap update.
