TO: Mercedes-Benz Dealer Principals, General Managers, Sales Managers, Service Managers, Parts Managers	FROM: Thomas Brunner, Department Manager, Vehicle Compliance and Analysis, Engineering Services
RE: Recall Campaign 2017020016 Launch MY 2017 Model 166 (GLE-Class), 292 (GLE-Coupe), and X166(GLS) Rework the Center Console	DATE: February 24, 2017

Campaign No. 2017020016, February 2017

SUBJECT: **Models 166, 292; Model Year 2017**
Remove Center Console Latch Bumper Stop

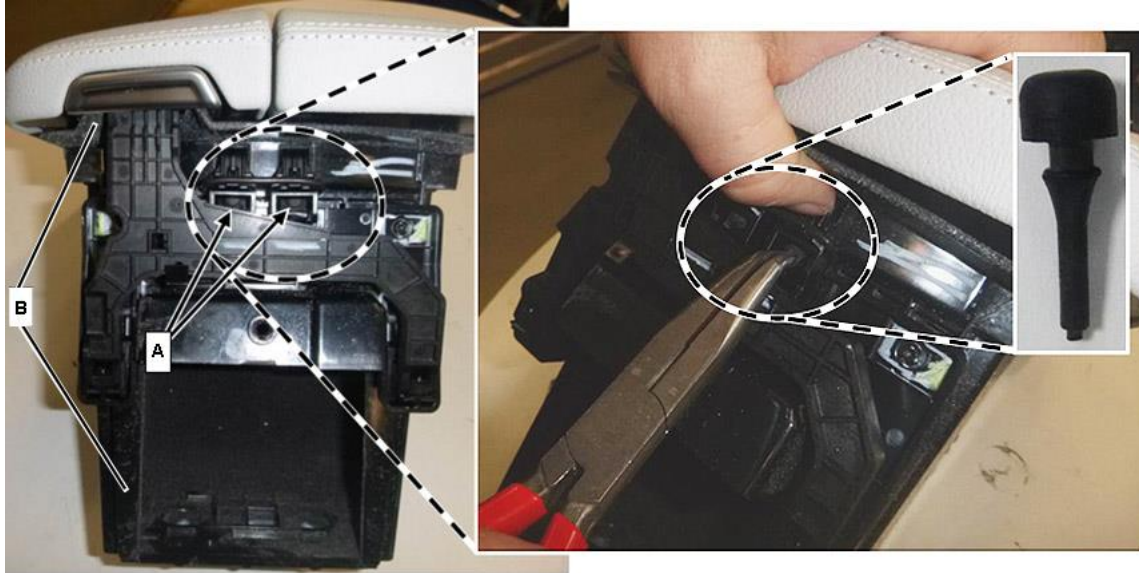
Figure 2 (front view shown with center console storage compartment [B] removed)

Daimler AG ('DAG'), the manufacturer of Mercedes-Benz vehicles, has decided that on certain GLE/ GLE Coupe vehicles (166/292 platform), the latch securing the center console doors might not meet current specifications. As a result the items secured in the center console might exit the compartment in the event of a crash increasing the risk of occupant injury. An authorized Mercedes-Benz dealers will remove the bumper stop for the center console armrest latch on affected vehicles.

Remove bumper stops (A, Figure 2) from **front** of center console storage compartment (B) after removing storage compartment (B) from center console.

- Remove the bumper stops (A) by pulling them out from the front of the storage compartment (B) using needle nose pliers (Figure 2). The bumper stops (A) are no longer required.
- **Do not** remove the top bumper stops (arrows, Figure 3) located directly below the storage compartment doors.
