TO: Mercedes-Benz Dealer Principals, General Managers, Sales Managers, Service Managers, Parts Managers	FROM: Thomas Brunner, Department Manager, Vehicle Compliance and Analysis, Engineering Services
RE: Recall Campaign 2017020017 LAUNCH MY 2016 Model 166 292 (GLE, GLS, GLE-Coupe) Check and Replace Upper Control Arm	DATE: March 21, 2017

Campaign No. 2017020017, March 2017

SUBJECT: **Models 166 and 292, Model Year 2016**
Check Torque of Upper Control Arm Nut to Steering Knuckle

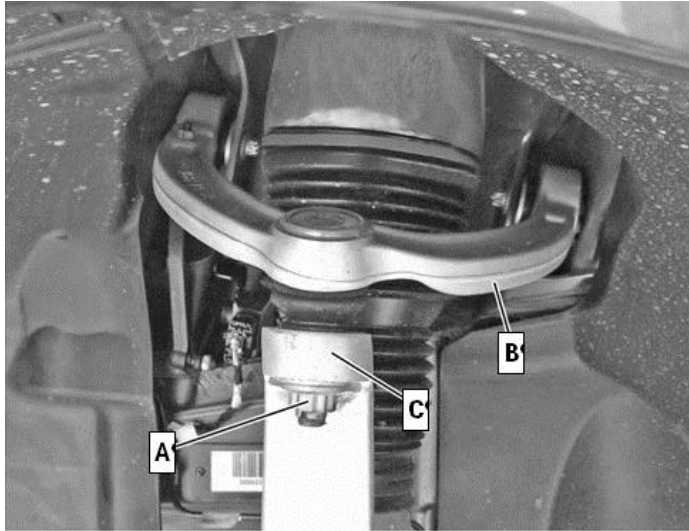
Figure 1

Daimler AG ('DAG'), the manufacturer of Mercedes-Benz vehicles, has determined that on certain GLE/GL (166 platform) and GLE Coupe (292 platform) vehicles, an error during assembly might have resulted in an improper bolt torque at the connection between the upper control arm and the axle stub. An improperly torqued bolt connection between the upper control arm and axle stub may cause improper wheel tracking and increase the risk of a crash.

1. Check nut (A, Figure 1) for upper control arm (B, Figure 1) to steering knuckle (C) at front left and front right. Nut torque should be 110 Nm:

i **Note:** The nut must not turn before reaching 110 Nm.

- If the nut does **not** turn prior to the test torque of 110 Nm **(OK)**: Procedure is complete.
- If the nut turns prior to reaching the test torque of 110 Nm **(NOT OK)**: Continue with Procedure.

2. Replace upper control arm: Refer to WIS: AR33.20-P-0500GQ.

i **Note:** If dents are evident on the conical flange of the steering knuckle, proceed to step 3.
