CONDITION OF CONCERN

SUBJECT VEHICLES

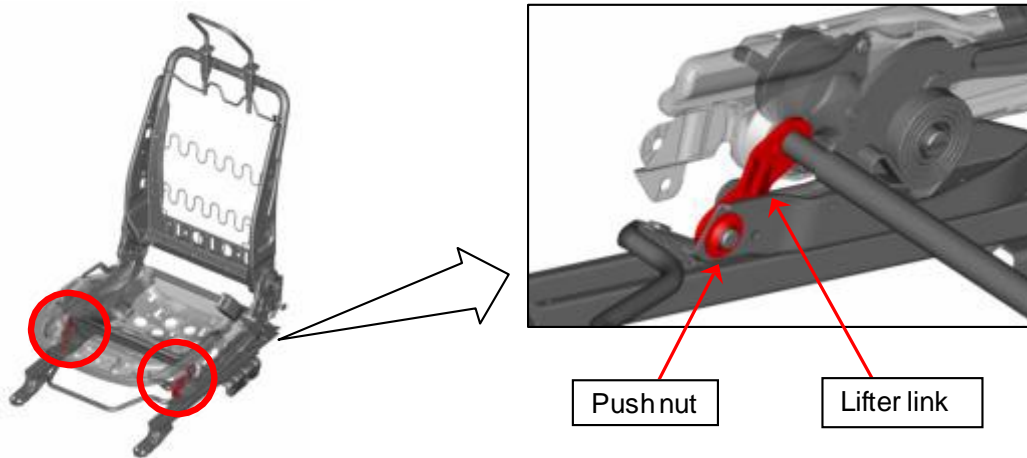
On the driver seat of certain 2010-2011 Mazda3 and 2011 Mazda2 vehicles, the seat height adjustment lifter link may be cracked due to insufficient strength of the lifter link or the lifter link push nuts may be separated. If the vehicle continues to be used in this condition, the seat may exhibit an abnormal noise or rattling. In the worst case, the lifter link may be broken or detached from the seat frame, causing the seat to be inclined and the driver may not be able to maintain an appropriate driving position, increasing the risk of a crash.1
