TO: Mercedes-Benz and Freightliner Dealer Principals, General Managers, Sales Managers, Service Managers, Parts Managers	FROM: Thomas Brunner, Department Manager, Vehicle Compliance and Analysis Michael Scott, Vans Regulations & Certifications
RE: <b>Recall Campaign Launch</b> <b>MY 2013- 2016 Model 906 (Sprinter 2500,3500)</b> <b>SRS ECU Plate</b>	DATE: May 19, 2017

<b>Campaign No. :</b>	<b>Campaign Desc.:</b>	<b>SRS ECU Plate</b>
<b>2017030016</b>	<b>906 SRS PLATE</b>	
<p>This is to notify you of a <b>Recall Campaign</b> to retrofit the reinforcement plate and protective bracket for the airbag control unit in <b>15,338</b> MY13-16 Sprinter (906) vehicles. Please review the recall information below. The recall campaign will be visible on the <a href="http://www.safercar.gov">www.safercar.gov</a> website and may generate questions from customers. All affected VINs will be flagged as "OPEN" in VMI on May 19, 2017.</p>		
<b>Background</b>		
<b>Issue</b>	<p>Daimler AG ("DAG"), the manufacturer of Mercedes-Benz and Freightliner Sprinter Vans, has determined that in certain SPRINTER vehicles for the North American market the reinforcement plate/protective bracket are not installed to t

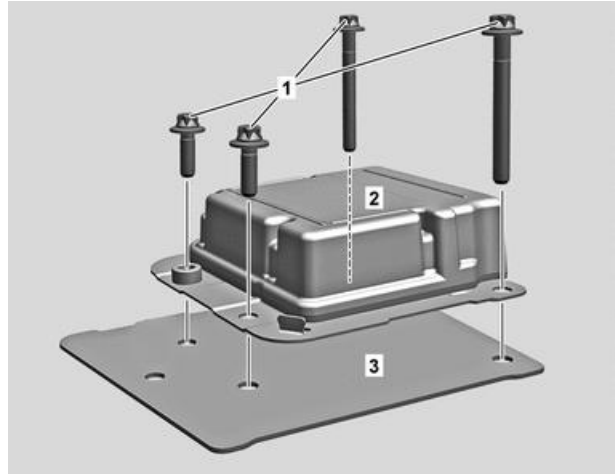
Figure 1

Daimler AG ("DAG"), the manufacturer of Mercedes-Benz and Freightliner Sprinter Vans, has determined that in certain Sprinter vehicles, the reinforcement plate/protective bracket was not installed to the airbag control module. This component is designed to protect the airbag control module in the event of a frontal crash and to ensure it remains operative after that crash. Without the reinforcement plate/protective bracket the airbag control module could be damaged and may not remain functional after a crash. An authorized Mercedes-Benz or Freightliner Sprinter dealer will install the reinforcement plate/protective bracket on affected vehicles.

Retrofit SRS control module reinforcement plate/protective bracket (3, Figure 1): Align reinforcement plate/protective bracket (3) with threaded mounting bores of SRS control module (2) at control module's installed position.

Reinstall SRS control module (2, Figure 1) on top of reinforcement plate/protective bracket (3):

Torque mounting bolts (1) to: 10 Nm.

**Note:**  
 Check for correct seating of reinforcement plate/protective bracket (3) when installing SRS control module (2).
-
