TO: Mercedes-Benz and Freightliner Dealer Principals, General Managers, Sales Managers, Service Managers, Parts Managers	FROM: Thomas Brunner, Department Manager, Vehicle Compliance and Analysis Michael Scott, Vans Regulations & Certifications
RE: Recall Campaign 2017030018 MY 2015 Model 906 (Sprinter 2500,3500) Drive Shaft Catch Strap	DATE: May 26, 2017

Campaign No. 2017030018, April 2017

SUBJECT: **Model 906, Model Year 2015**
Retrofit Drive Shaft Strap/Loop

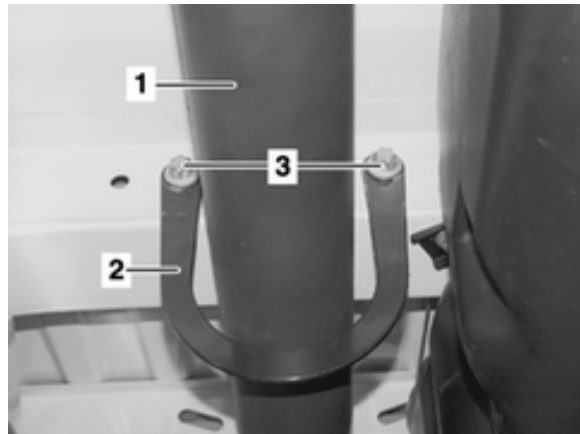
Daimler AG (DAG), the manufacturer of Mercedes-Benz Sprinter Vans, has determined that certain Sprinter 4x4 vehicles were not equipped with a drive shaft loss protection catch strap. As a result, in the event of a crash, the missing catch strap may lead to the drive shaft damaging the fuel tank, increasing the risk of fuel loss and a fire. In addition, the vehicle will not fulfill the requirements of Federal Motor Vehicle Safety Standard FMVSS 301 (Fuel System Integrity). An authorized Mercedes-Benz Sprinter dealer will retrofit the additional drive shaft catch strap to the affected vehicles.

Figure 1 (1 Drive shaft, 2 Drive shaft strap/loop, 3 Bolts)

Retrofit drive shaft strap/loop (2, Figure 1) to cross member with mounting bolts (3).

Torque mounting bolts (3) to: 70 Nm.
