BULLETIN NUMBER:
CB17-K-001

IMPORTANT SAFETY RECALL

AUTOMATIC TRANSMISSION MOUNTING BRACKET

17V-105 (Transport Canada – 2017-088)

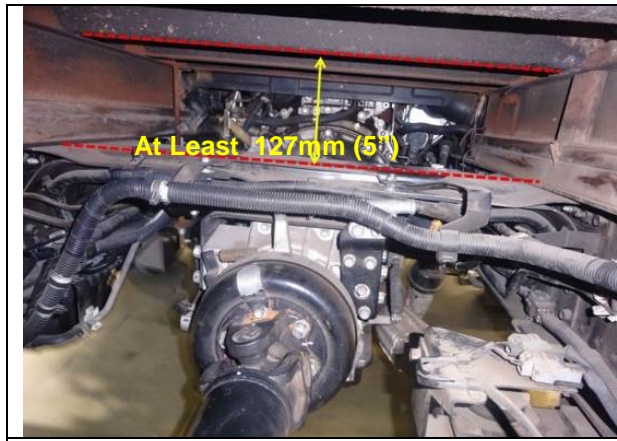
Figure 1

1. Ensure there is enough space between the lowest portion of the body floor and the transmission cross-member (Figure 1). At least 127mm (5”) is required to accurately perform the inspection. Make sure the area under the vehicle is well lit.

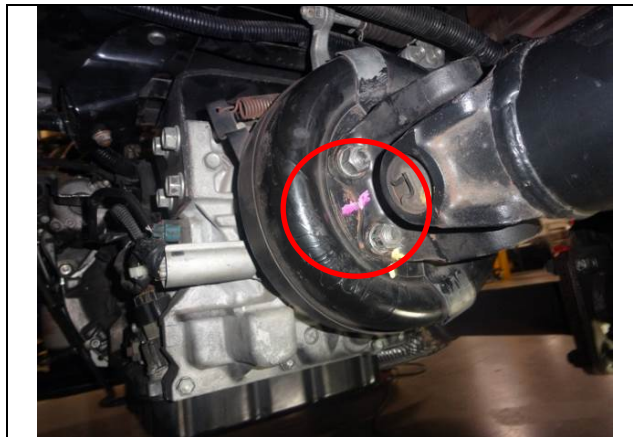
Figure 2

2. Block the wheels. Ensure the vehicle will not move while performing the procedure.
3. Place a match mark on the propeller shaft and parking brake drum using a marker or paint pen (Figure 2).

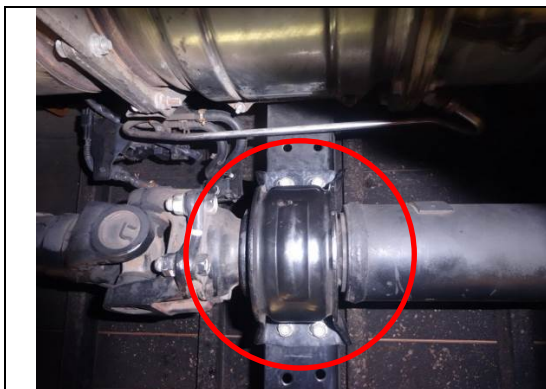
Figure 3

4. Remove the four (4) nuts and washers that attach the propeller shaft to the transmission output flange.
5. Remove the four (4) bolts that attach the center bearing bracket (if equipped) to the cross-member (Figure 3) and disconnect the propeller shaft from the transmission output flange. Lay the propeller shaft assembly aside underneath the SCR assembly (Figure 4).

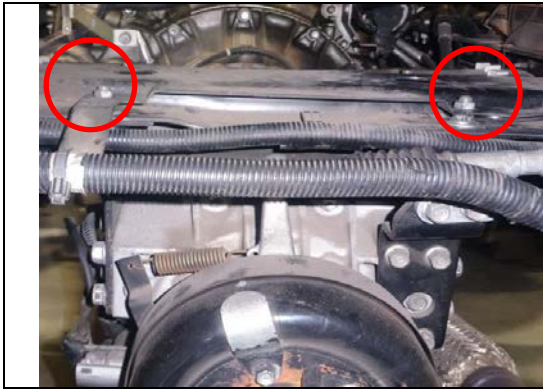
Figure 5

- Remove the two (2) 14mm nuts that hold on the DEF line bracket (Figure 5). Move the DEF line bracket assembly back out of the way (Figure 6).

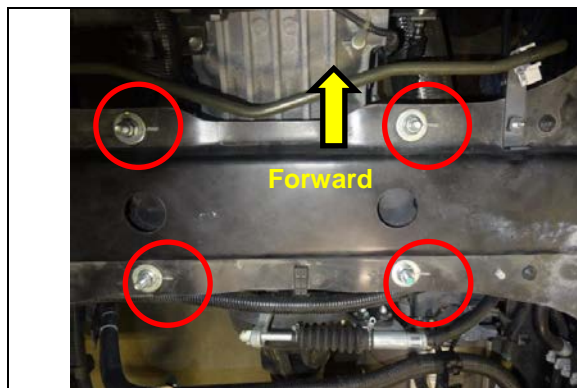
Figure 7

- Thoroughly clean the area surrounding the four (4) transmission mounting locations (Figure 7).
- Determine which procedure will be used to complete the inspection.
 - If you have the Brownline digital angle gauge or an equivalent, you may proceed to Step 12.
 - If you do not have a digital angle gauge, continue to Step 9.
- Put a paint mark on each nut and the transmission cross-member to mark the original position of each nut (Figures 7 and 8). Use an inspection mirror to assist in marking the front nuts.

24. Install the four (4) new washers and nuts provided in the kit to the mounting brackets at the transmission cross-member (Figure 7) and torque to 51.2 Nm (37.8 ft/lbs).

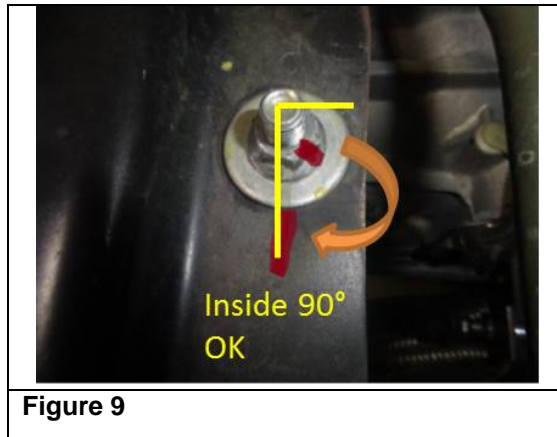
- a. If the paint mark on all four nuts stays within the 90° arc (as shown in Figure 9), the vehicle **passes** inspection. Proceed to Step 16.

16. Torque all four (4) 14mm nuts to 51.2 Nm (37.8 ft/lbs).
 - a. If all four of the nuts achieve torque to 51.2 Nm (37.8 ft/lbs), proceed to Step 33.
 - b. If any one or more of the nuts do not achieve torque to 51.2 Nm (37.8 ft/lbs), shims must be installed and both transmission mount brackets must be replaced. Proceed to Step 17.

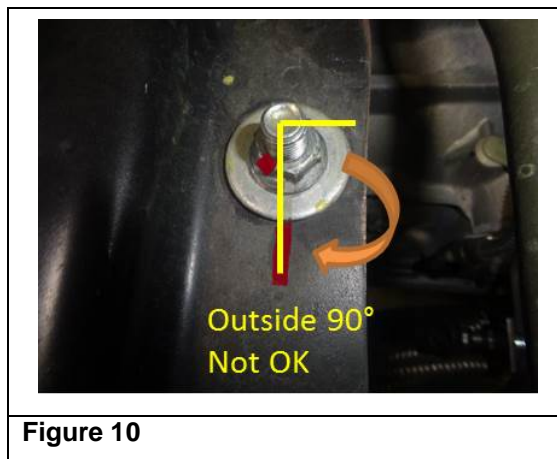
- b. If the paint mark on any of the nuts is not within the 90° arc (as shown in Figure 10), the vehicle does **not pass** inspection. Proceed to Step 17.

17. Using a floor jack or transmission jack, support the transmission. When using a floor jack, utilize a block of wood or rubber pad between the lifting point and the transmission pan to keep from damaging the transmission pan (Figure 13).

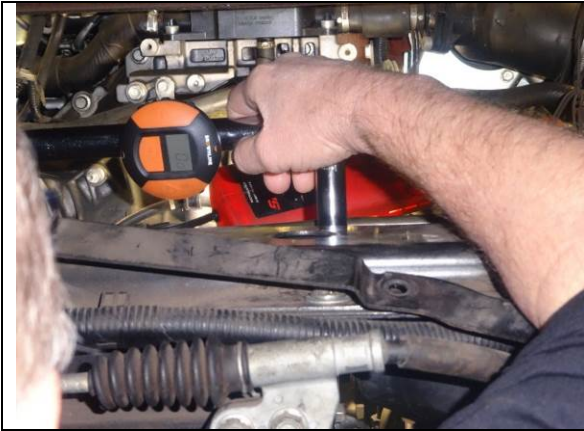
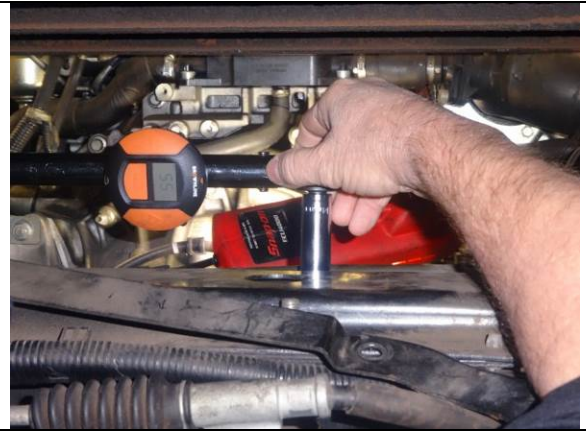
nut. Press the “select” button on the angle gauge and slowly tighten the nut until the torque wrench clicks at 30.0 Nm (22.1 ft/lbs) (Figures 11 and 12).

14. If 30.0 Nm (22.1 ft/lbs) of torque is achieved without the angle gauge reaching 90°, the nut **passes** inspection. If the 30.0 Nm (22.1 ft/lbs) of torque is only achieved after the angle gauge reaches or exceeds 90°, the nut does **not pass** inspection.

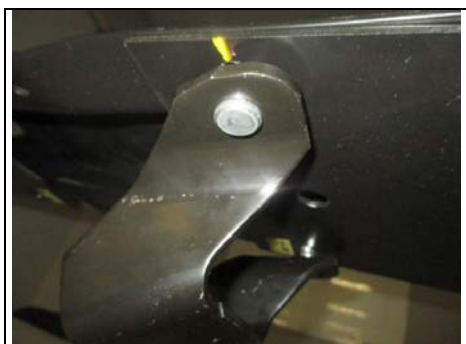
Figure 14

21. Using a paint pen or marker, mark the center of the slot hole on the cross-member (Figure 14). Repeat this procedure for each of the remaining three (3) holes.

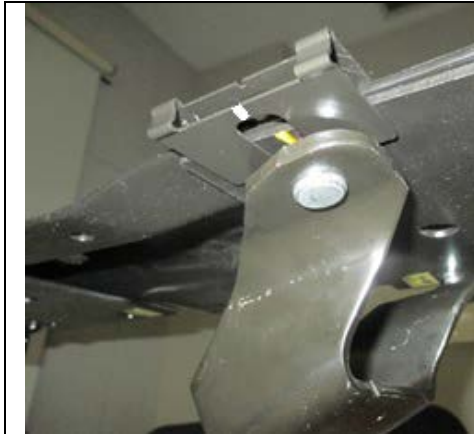
Figure 15

22. Slide a shim over the cross-member at each hole (Figure 15). Center the white paint mark on each shim with the center hole marks made in Step 21. Make sure the shim is inserted until it stops and is not covering the hole (Figure 16).
 - a. If the transmission mount brackets need replacement as indicated in Step 16b, proceed to Step 26.

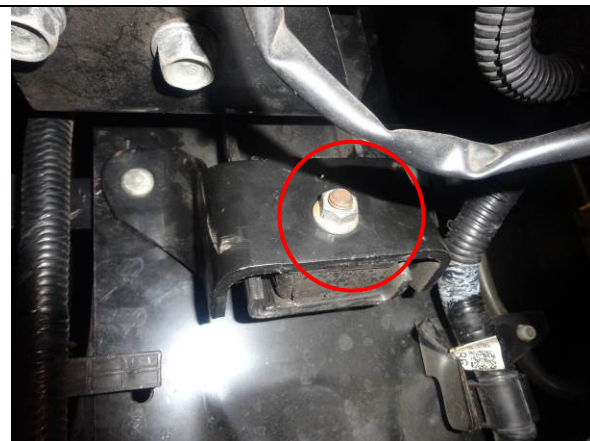
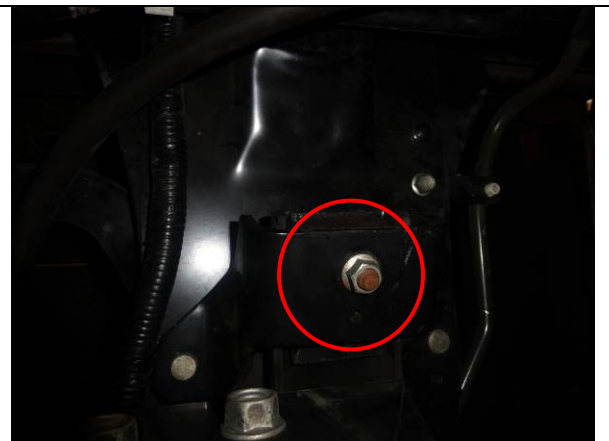
26. Remove the left and right rubber mount nuts (Figures 17 and 18).

29. Install the left and right rubber mount nuts removed in Step 26 (Figures 17 and 18) and torque to 47.1 Nm (34.7 ft/lbs). Ensure that all four (4) shims installed in Step 22 are still correctly in place (Figure 16).
