TO: Mercedes-Benz Dealer Principals, General Managers, Sales Managers, Service Managers, Parts Managers	FROM: Thomas Brunner, Department Manager, Vehicle Compliance and Analysis, Engineering Services
RE: Recall Campaign 2017020021 with RETAIL HOLD ORDER MY15-17 CLA-Class (117 platform), GLA-Class (156 platform), C-Class (205 platform), E-Class (213 platform) and GLC (253 platform) Starting Current Limiter	DATE: February 22, 2016

Campaign No. :		<h2>Starting Current Limiter</h2>
2017020021		
This is to notify you of a new Recall Campaign with RETAIL HOLD ORDER for certain CLA-Class (117 platform), GLA-Class (156 platform), C-Class (205 platform), E-Class (213 platform) and GLC (253 platform) vehicles.		
Background		
Issue	This Recall Campaign has been initiated because Daimler AG (DAG), the manufacturer of Mercedes-Benz vehicles, has determined that on certain CLA-Class (117 platform), GLA-Class (156 platform), C-Class (205 platform), E-Class (213 platform) and GLC (253 platform) vehicles, the starting current limiter could be overloaded under certain conditions during the starting procedure. In the event the starter is -blocked due to engine/transmission damage (e.g. a hydro-locke

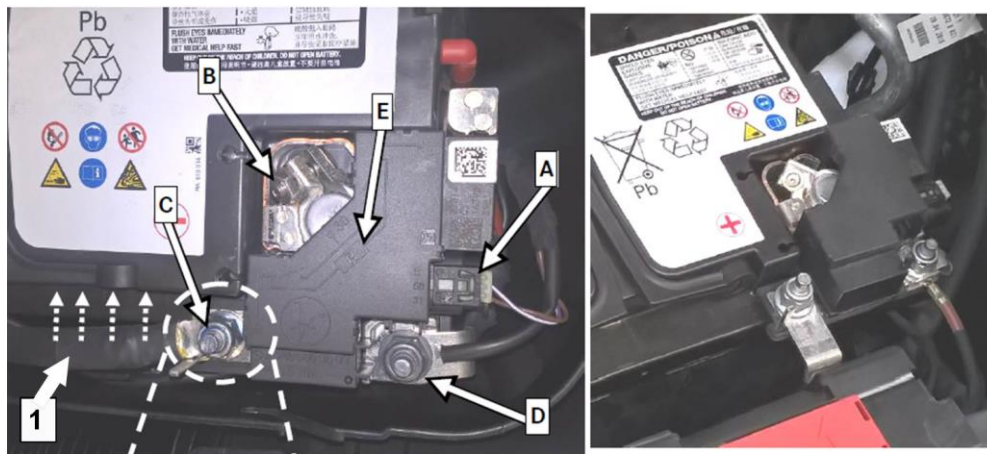
Figure 1

Daimler AG (DAG), the manufacturer of Mercedes-Benz vehicles, has decided that on certain C-Class (205 platform), E-Class (213 platform) and GLC (253 platform) vehicles, the starting current limiter could be overloaded under certain conditions during the starting procedure. In the event the starter is blocked due to engine/transmission damage (e.g. a hydro-locked engine), a very high electric current would flow through the starting current limiter during the subsequent start attempt. Should the driver attempt to start the engine repeatedly despite the engine not cranking, the very high electric current draw could lead to overheating of the starting current limiter. In the worst case, surrounding components could melt, and potentially ignite and lead to a fire. As a precautionary measure an authorized Mercedes-Benz dealer will replace the starting current limiter on affected vehicles.

1. Disconnect negative battery cable for models:
 - 117/156 refer to WIS: AR54.10-P-0003NKB.
 - 205/213/253 refer to WIS: AR54.10-P-0003LW.
2. Disconnect harness connector (A, Figure 1).
3. Loosen nut (B), battery clamp for removing starting current limiter (E) from positive battery post.

Nm Torque nut (B) for battery clamp to positive battery pole: 5.5 Nm.

4. Remove nut (C) then remove cable (1) from current limiter post.

5. Remove nut (D) along with pre-fuse box cable.

- **Nm** Torque nuts (C and D), positive cable for starter and positive cable for pre-fuse box to: 16 Nm.
- Tightening torque **must** be observed.

6. Replace starting current limiter (E, Figure 1).

Install new starting current limiter (E) in a tension-free manner with equal clearance on the battery.
