# **IMPORTANT SAFETY RECALL**

# Airstream Travel Trailer NHTSA Recall Number 17V-155 Transport Canada Recall Number 2017-151

#### Problem

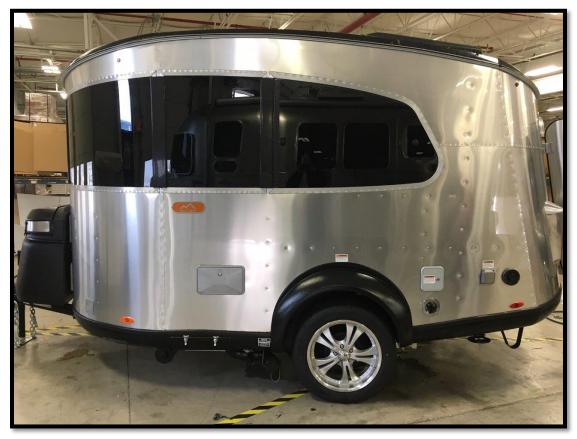
<u>Note:</u> This is how the axle will be situated in the wheel well upon completion. It is a 10° axle. As the load increases and the axle settles, the clearance front-to-back will become more even. It is designed to only shift forward when loaded or when going over bumpy road conditions.

<u>Step 15:</u> Mount the wheels with the new 235/55R18 tires back on the coach. Lower the coach and using a torque wrench, torque wheels to 110 ft. lbs. Perform LP drop pressure test and check for leaks.
