TO: Mercedes-Benz Dealer Principals, General Managers, Sales Managers, Service Managers, Parts Managers	FROM: Thomas Brunner, Department Manager, Vehicle Compliance and Analysis, Engineering Services
RE: <b>New Recall Campaign 2017030019</b> <b>Replace Bowden Cable</b> <b>MY16 Model 463 (G-Class)</b>	DATE: April 21, 2017

Campaign No. 2017030019, April 2017

SUBJECT: **Model 463, Model Year 2016**  
**Replace Inner Door Handle Cable**

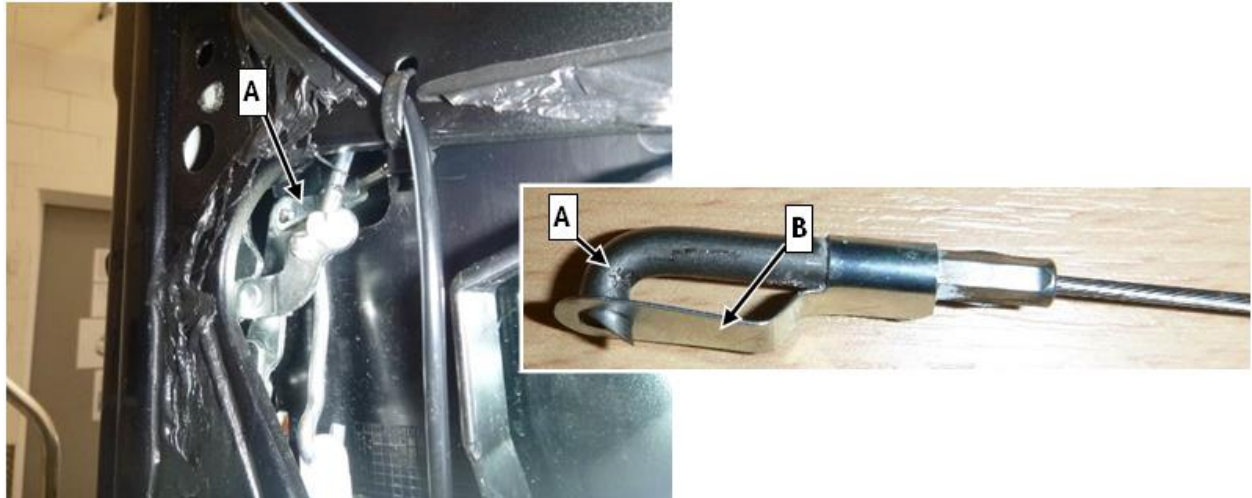
**Figure 1** (cable in installed position)

Daimler AG ('DAG'), the manufacturer of Mercedes-Benz passenger vehicles, has determined that on certain G-Class vehicles (463 platform) the Bowden cable between the inner door handle and the door lock might have experienced manufacturing variations during the stamping process that could cause the end hook to yield under very high loads. In the event of a crash, the necessary force to unlock the door lock may be increased. As a result, occupants may not be able to open the door from inside the vehicle, increasing the risk of injury. An authorized Mercedes-Benz dealer will replace the Bowden cables between the inner door handle and the door lock on all four doors.

1. Replace cable (A, Figure 1) at **right and left** for the door opening handle of **front** doors:
  - Remove front door panel, refer to WIS AR72.10-P-1000GN.
  - Install cable (A) with locking clip (B) as shown (Figure 1).

Cable (A, Figure 1) will engage lever and locking clip (B) automatically moves to its designated position (Figure 1).
