Michael A. Berardi
Director
Service Engineering Operations
Ford Customer Service Division

April 26, 2017

SUBJECT: NEW VEHICLE DEMONSTRATION / DELIVERY HOLD - Compliance Recall 17C06
Certain 2017 Model Year F-250 Vehicles with 6.2L Engine and 6R100 Transmission
Transmission Park Rod Actuating Plate

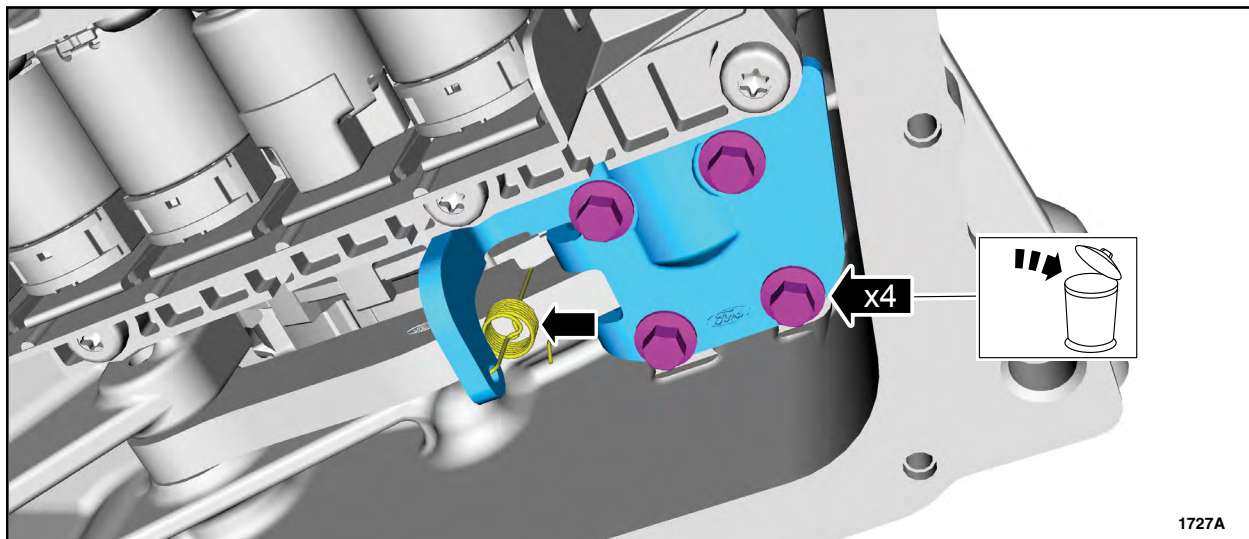
FIGURE 1

Some of the affected vehicles may not conform to the requirements specified by Federal Motor Vehicle Safety Standard (FMVSS) No. 102 Transmission Shift Position Sequence, Starter Interlock and Transmission Braking Effect, and FMVSS No. 114 Theft Protection and Rollaway Prevention. Vehicles built with a damaged park rod actuating plate may not achieve mechanical Park within the automatic transmission after the driver moves the shift lever to Park. If the parking brake is not applied, this could result in unintended vehicle movement without warning, increasing the risk of injury or crash. Dealers are to replace the transmission park rod actuating plate.

2. Remove the park pawl return spring and save for reuse. See Figure 1.

3. Remove and discard the four bolts and the park rod actuating plate. See Figure 1.
