TO: Mercedes-Benz Dealer Principals, General Managers, Sales Managers, Service Managers, Parts Managers	FROM: Thomas Brunner, Department Manager, Vehicle Compliance and Analysis, Engineering Services
RE: New Recall Campaign with Retail Hold 2017050013 MY16-17 Model 166 (GLE, GL, GLS) 292 (GLE Coupe-Class), 207 (E-Coupe) Electric Power Steering Connector	DATE: May 26, 2017

Campaign No. 2017050013, May 2017

SUBJECT: **Models 207, 292 and 166; Model Years 2016 and 2017**
Replace Electric Power Steering Rack Connector Housing and Check Contacts

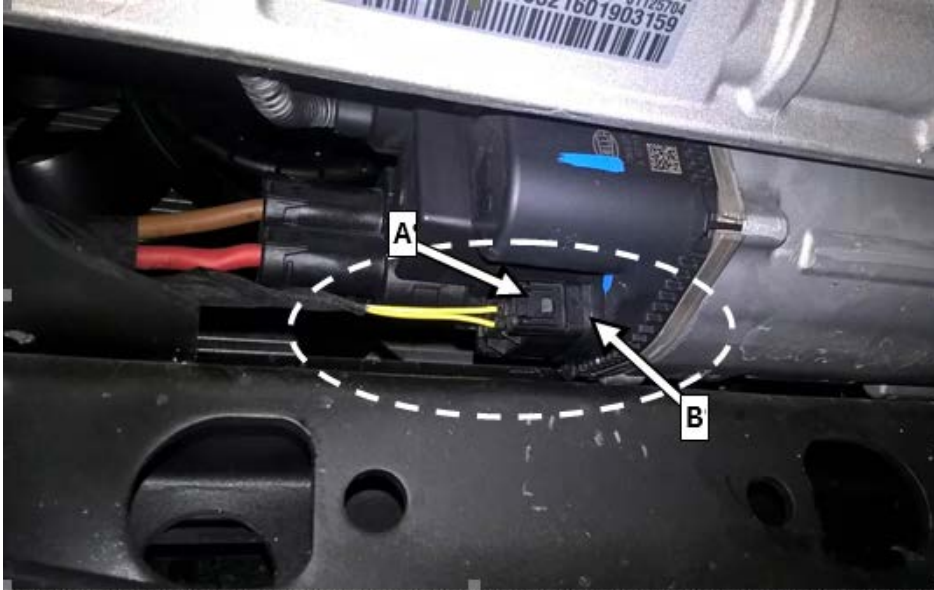
Figure 1

3. Check contact sockets in harness connector housing (A Figure 1) and mating connector (B) contact plugs on electric power steering rack for signs of corrosion:
 - If there are no signs of corrosion or corrosion/damage only on the **harness side** connector (A) proceed to step 5.
 - If there are **major** signs of corrosion in harness connector housing (A) and mating connector (B) on electric power steering rack proceed to step 4:
 4. Create PTSS case:
 - Submit pictures along with VIN.
- i** Note:
- Pictures submitted must be of good quality and high resolution.
 - No SDS print out is required.
 - Wait until guidance is provided by Engineering Services

1. Remove lower engine compartment panel under electric power steering rack.
2. Disconnect electric power steering rack connector (A, Figure 1).

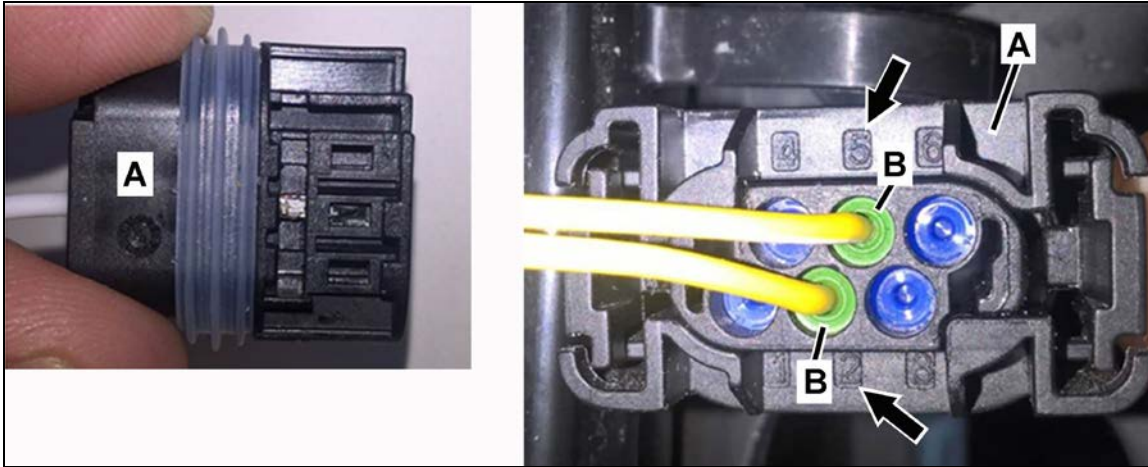
Figure 5

- **Observe contact socket assignment in housing**
- For general repair methods for wiring harness refer to WIS: AR00.19-P-0100A.
- If contact sockets unpinned from plug housing (A) are **NOT** damaged/corroded proceed to step 8.
- If contact sockets unpinned from plug housing (A) are damaged/corroded replace contacts and connector seals (B) then proceed to step 8 (do not install contact sockets back into old connector housing).

7. Unpin contact sockets from slot 5 and 2 (arrows, Figure 5) and pull wire carefully out of plug housing (A) and inspect contacts:
