TO: Mercedes-Benz Dealer Principals, General Managers, Sales Managers, Service Managers, Parts Managers	FROM: Thomas Brunner, Department Manager, Vehicle Compliance and Analysis, Engineering Services
RE: <b>Recall Campaign with Retail Hold 2017050014 MY17 213 (E-Class) Rework Roof Spoiler</b>	DATE: May 26, 2017

Campaign No. 2017050014, May 2017

SUBJECT: **Model 213, Model Year 2017**  
**Check Roof Spoiler for Proper Fastening, Replace as Necessary**

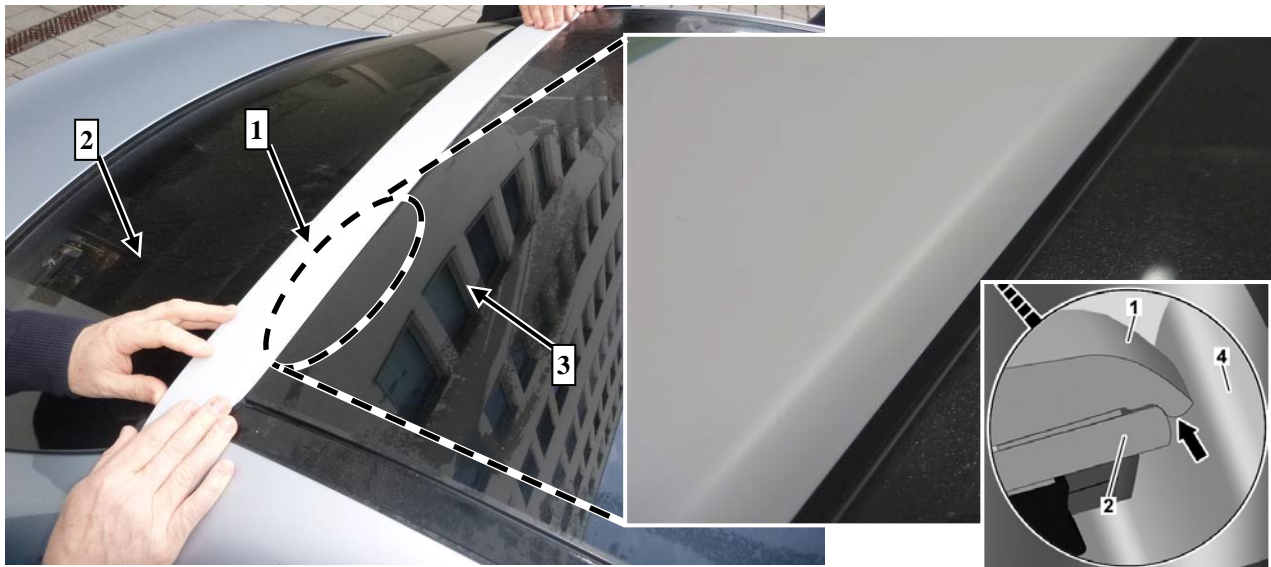
Picture 1 **OK**

1. Check proper fastening of roof spoiler (1) to the rear window (2) (picture 1).

**i** The edge (enlarged detail, arrow, picture 1) attached to the roof spoiler (1) **must** be in contact with the rear window. The glass edge of the rear window (2) **must not** be visible from above.

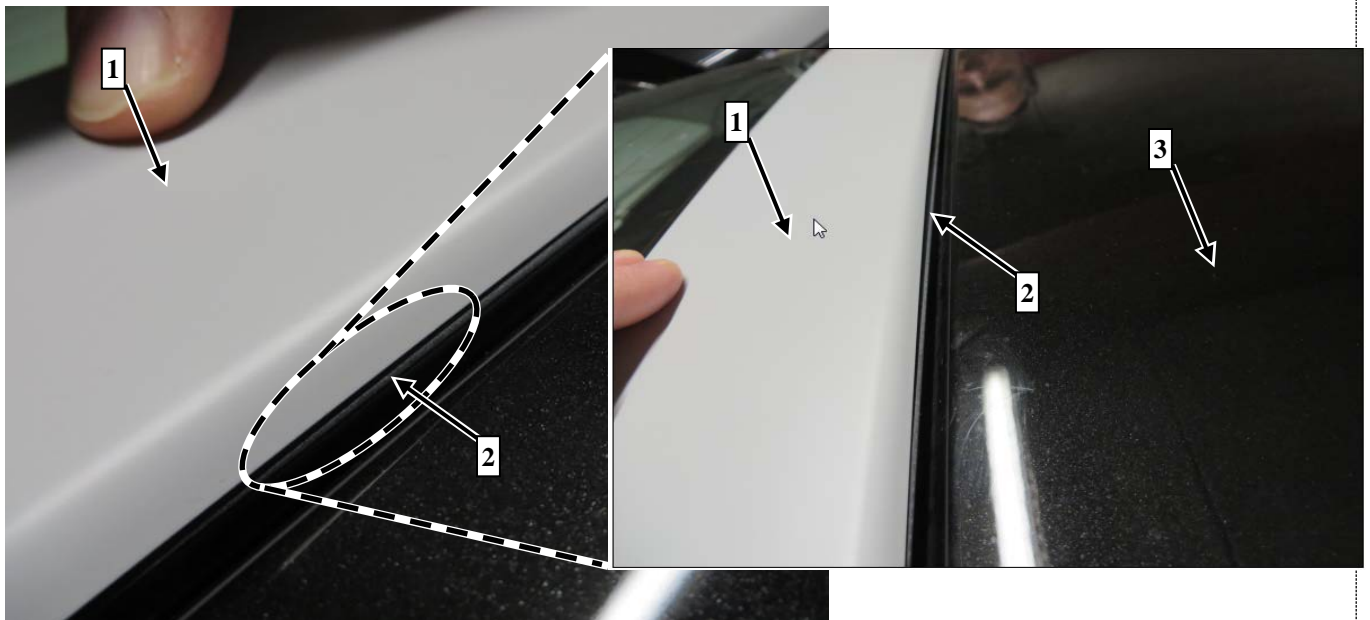
Picture 2 **Not OK**

Picture 2 shows a **not OK** state. The roof spoiler (1) **must** be in full contact with rear window and bonded completely. To check the roof spoiler, lightly lift it toward the vehicle roof (3) by hand.

- If roof spoiler is **not** fastened correctly (**not OK**): Proceed to Subject B.
- If roof spoiler **is** fastened correctly (**OK**): Procedure is complete.

1. Replace roof spoiler: Refer to WIS: AZ88.30-P-0015LWE.

**i** **Note**:-To disassemble the roof spoiler, use plastic wedge. Completely remove adhesive residues.
