TO: Mercedes-Benz Dealer Principals, General Managers, Sales Managers, Service Managers, Parts Managers	FROM: Thomas Brunner, Department Manager, Vehicle Compliance and Analysis, Engineering Services
RE: Recall Campaign Launch 2017060004 MY13-16 463 (G-Class) Replace Steering Coupling	DATE: June 23, 2017

Campaign No. 2017060004, June 2017

SUBJECT: **Model 463, Model Years 2013 - 2016**
Replace Bottom Steering Shaft Universal Joint on Steering Gear

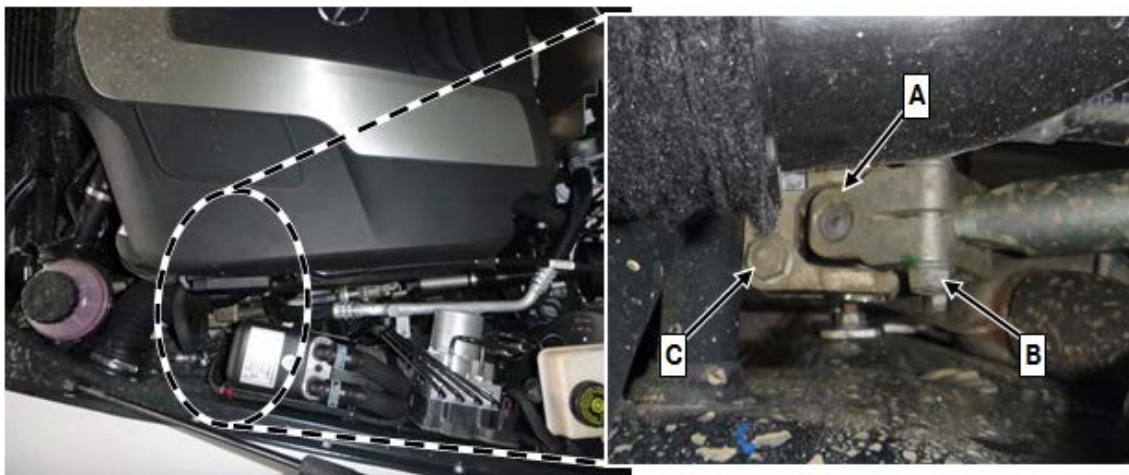
Figure 2

Daimler AG ('DAG'), the manufacturer of Mercedes-Benz vehicles, has determined that on certain G-Class vehicles (463 platform), insufficient tightening torque at the steering coupling could lead to excessive wear of the steering coupling interlock under conditions of increased force application. Excessive wear at the splined steering coupling could cause the connection between the coupling and shaft to be compromised, resulting in the possible loss of steering. An authorized Mercedes-Benz dealer will replace the universal joint on the affected vehicles.

3. Replace bottom universal joint (A, Figure 2) on steering gear.

- After the universal joint (A) is removed, the steering wheel and front wheels must not be moved.
- The universal joint (A) must be mounted to the steering gear shaft horizontally.
- In the straight-ahead position, the clamping groove faces outwards (not towards the engine).
- Check the steering wheel center position before tightening the universal joint (A) with the new bolts. If necessary, correct the steering wheel center position by reconnecting the universal joint (A).

- The bolts on the universal joint (A) **must** be easy to assemble.
- The bolts on the universal joint (A) may only be used once due to micro-encapsulation.
- The shafts must be flush to the interior of the universal joint.

- Torque nut (B, Figure 2) from bottom universal joint to steering shaft to: 22 Nm
- Torque nut (C) from bottom universal joint to steering gear to: 32 Nm.
