RE: **Recall Campaign 2017050024
Launch Notification**
MY17 205, 222, 253 (C-Class, GLC-Class, S-Class)
Mix Ratio Front Seatbelt Pre-tensioner (Driver)

Campaign No. 2017050024, July 2017
Revision B

SUBJECT: **Model 205, 253, and 222, Model Year 2017**
Replace Left Front Seat Belt

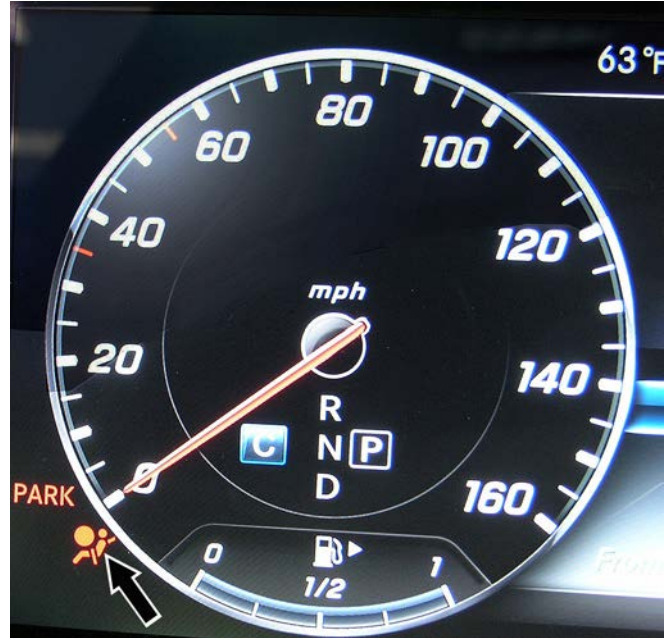
Figure 1 (shown on model 213)

1. Start engine and check whether Supplemental Restraint System (SRS) indicator lamp (arrow, Figure 1) goes out after a few seconds.

After installation of new seat belt be sure to start engine and check whether SRS indicator lamp goes out after a few seconds (arrow, Figure 1).
