TO: Mercedes-Benz Dealer Principals, General Managers, Sales Managers, Service Managers, Parts Managers	FROM: Thomas Brunner, Department Manager, Vehicle Compliance and Analysis, Engineering Services
RE: Recall Campaign Launch MY13-15 204 (C-Class) Check Steering Coupling Bolt Torque	DATE: May 12, 2017

Campaign No. 2017040006, May 2017

SUBJECT: **Model 204, Model Years 2013 - 2015**
Check Tightening Torque of Steering Coupling Bolt Connection

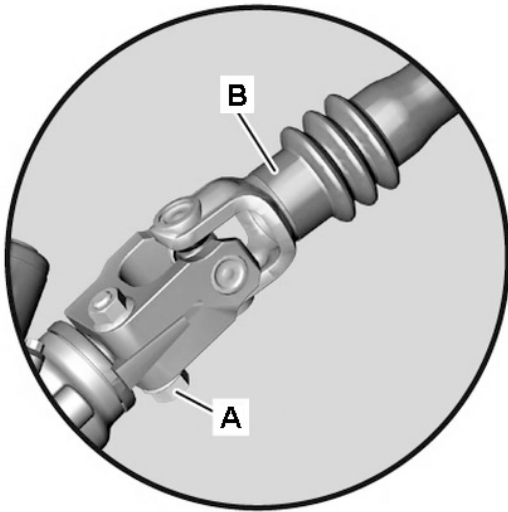
Figure 1

Check tightening torque of steering coupling bolt connection (A, Figure 1) at **bottom** universal joint on rack-and-pinion steering:
 -

Self-locking bolt, steering coupling to rack-and-pinion steering: **24 Nm**.

**Note:** The steering coupling bolt connection (A) **must not** turn before reaching **24 Nm**.
 - If the steering coupling bolt connection (A) **does not** turn prior to the test torque of 24 Nm **(OK)**: Procedure is complete.

- If the steering coupling bolt connection (A) **turns** prior to reaching the test torque of 24 Nm **(NOT OK)**: Continue with Procedure:
-

- 3. **Replace** nut and bolt (Figure 1) then torque steering coupling bolt connection (A) to **24 Nm**.
-
