CONDITION OF CONCERN

SUBJECT VEHICLES

Model	VIN range	Build Date Range
2004 RX-8	JM1 FE**** 40 100053 – 138902	From April 10, 2003 through May 7, 2004

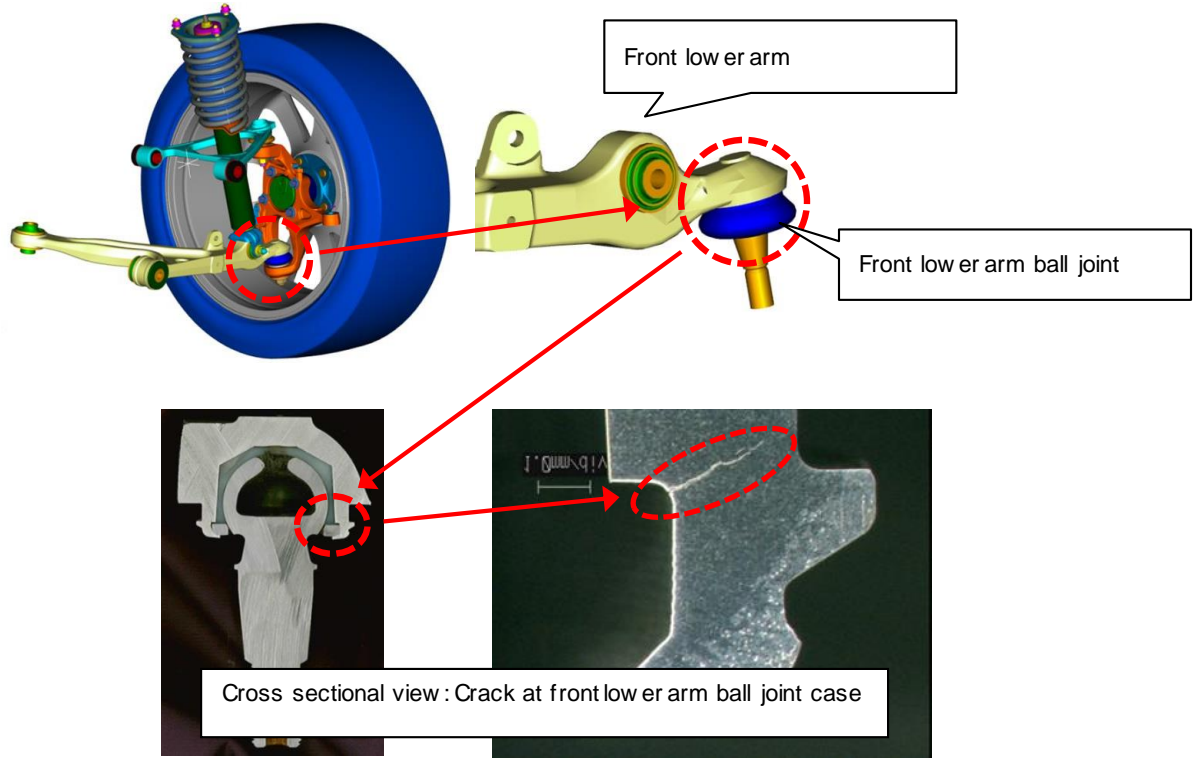
On certain RX-8 vehicles, the front lower arm ball joint case may have a crack due to inappropriate process at production stage. In the worst case, the ball joint case may break and detach from the ball joint if a large load is applied during driving, causing a loss of steering control and increasing the risk of a crash.

Dealers are instructed to replace the front lower arms (both left and right) with modified ones.
