SAFETY RECALL ACTION

Reference number:	RA-07-0022	Issued: 6 July, 2017
Subject:	Transmission Software Update for the V8 Vantage with 7-Speed Sportshift II Transmission	
Model(s):	V8 Vantage, V8 Vantage S and V8 Vantage S Dragon 88.	
VIN range:	Refer to the separately published list of VINs	
Applicable to:	All Dealers (Not USA)	
Distribute to:	After Sales Manager Executive Manager Service Manager Sales Manager	Warranty Staff Technician(s) Parts Staff

Reason for this Recall Action

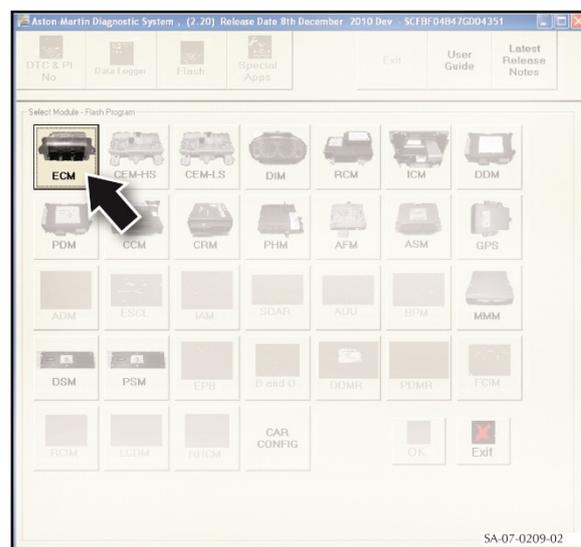
Figure 4

Note: It is possible that the ECM software will not need to be updated. If this happens, the AMDS will display a message.

- Update the software for the Engine Control Module (ECM) with the latest version (refer to Figure 4).
