SAFETY RECALL ACTION

Reference number:	RA-07-0024	Issued: 6 July, 2017
Subject:	Connector failure on V8 Vantage 7-Speed SportShift II Transmission	
Model(s):	V8 Vantage and V8 Vantage S with 7-Speed SportShift II Transmission	
VIN range:	Refer to the separately published list of VINs	
Applicable to:	All Dealers (Not USA)	
Distribute to:	After Sales Manager Executive Manager Service Manager Sales Manager	Warranty Staff Technician(s) Parts Staff

Safety Recall Action RA-07-0024 – Connector failure on V8 Vantage 7-Speed SportShift II Transmission

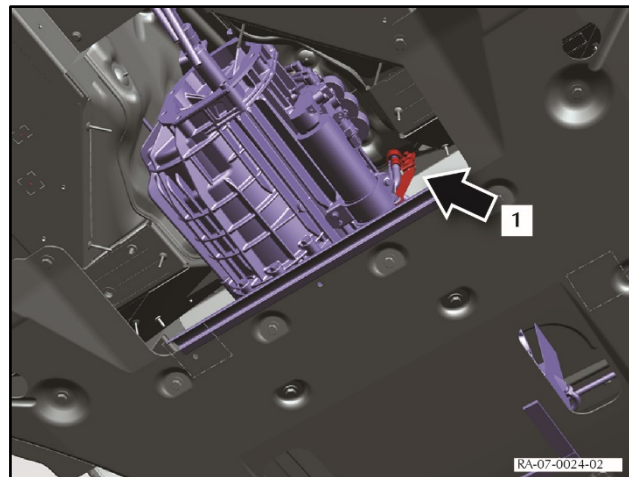
2. Examine the connector on the clutch supply line. If the bracket (1) shown in Figure 3 is installed, you do not need to do more work. Do Step 4.

If the bracket is not installed, continue from Part B.

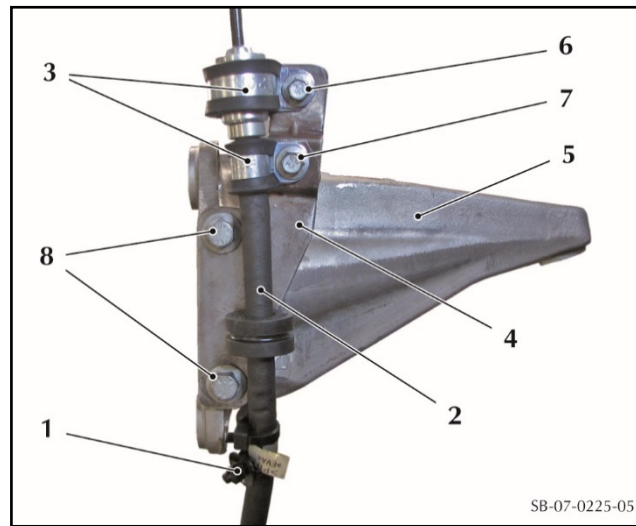
Figure 9

In October 2010, a connector in the hydraulic system for the 7-speed Auto-Shift Manual (ASM) transmission that is installed on V8 Vantage, was found not to have sufficient support. The connector is between the pipe for the clutch fluid and the ASM system. It is possible that this connector can fail and cause loss of the clutch fluid.

16. Cut and remove the fir-tree fixing (1) that attaches the ASM hose assembly (2) to the transmission (refer to Figure 9).
17. Install the two P-clips (3) onto the ASM hose assembly (2).
18. Put the new ASM hose bracket (4) in position on the transmission mounting bracket (5).
19. Loosely install the screw (6) that attaches the top P-clip to the ASM hose bracket (4).
20. Align the top P-clip (3), the ASM hose bracket (4) and the ASM hose (2).
21. Align the ASM hose bracket (4) with the holes in the transmission mounting bracket (5). Install and tighten the two attachment screws (8).

22. Put the bottom P-clip (3) into the correct position and loosely install the attachment screw (7).
23. Make sure that the P-clips (3) and the ASM hose assembly (2) are correctly aligned and tighten the two P-clip attachment screws (6 and 7).
