RE: **Recall Campaign 2017090002**
Launch Notification
MY17 453 (smart) Steering Knuckle

Campaign No. 2017090002, September 2017

SUBJECT: **Model 453 Model Years 2017**
Check left front axle steering knuckle and replace, if necessary

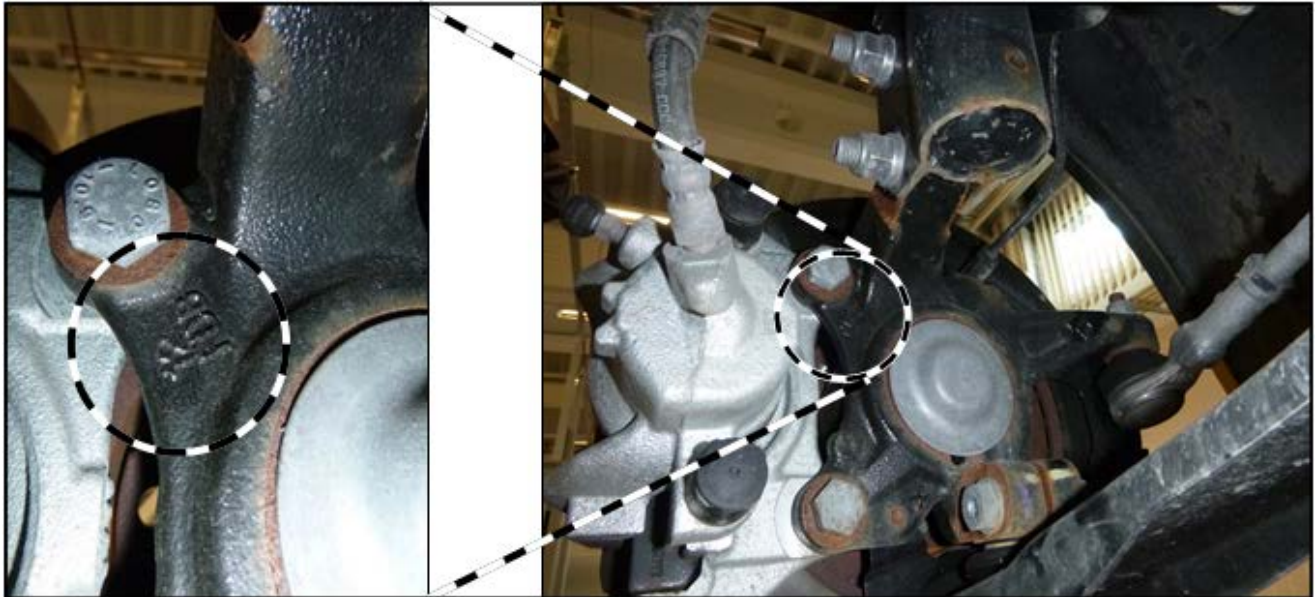
**Figure 1**

1. Lift vehicle with vehicle lift.
2. Check outer steering knuckle stamping (**figure 1**)

- a) If "FDB 14" is stamped on the steering knuckle: Perform check B
- b) If another stamping is present: End measure

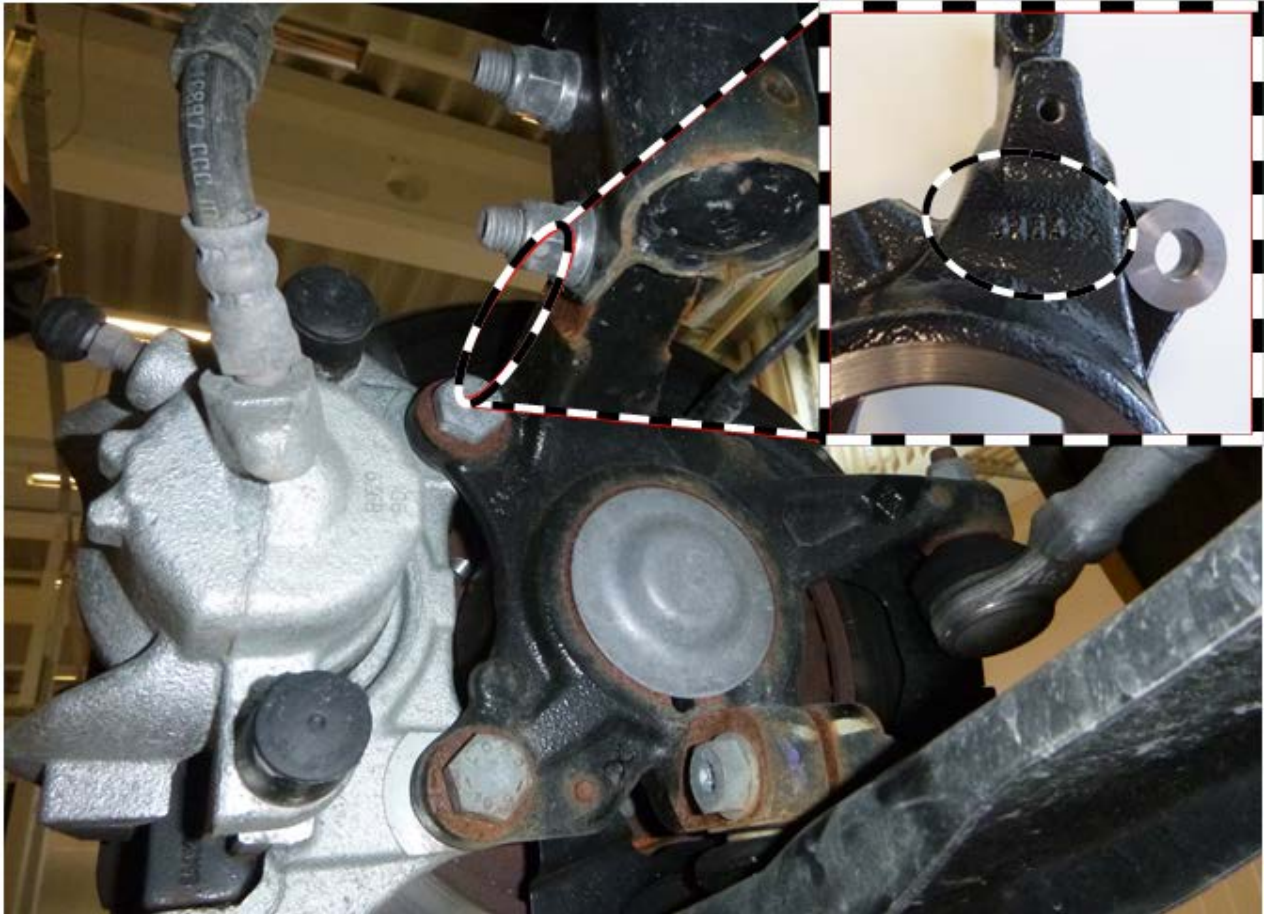
1. Remove left front brake splash shield (AR42.10-P-0233SR).
i Clean the removed parts if necessary.
2. Check inner steering knuckle stamping (figure 2)

- a) Check whether "17 061" or "17 067" is stamped on the suspension strut support
If yes: **Perform work procedure**
- b) If another stamping is present: **End measure**

1. Replace steering knuckle and wheel bearing (AR33.25-P-0400SR / AR33.20-P-0302SR).
 - i** Replace all screws/bolts required for installing the steering knuckle
2. Perform wheel alignment check and wheel alignment.
