TO: Mercedes-Benz Dealer Principals, General Managers, Sales Managers, Service Managers, Parts Managers	FROM: Thomas Brunner, Department Manager, Vehicle Compliance and Analysis, Engineering Services
RE: <b>Recall Campaign 2017080009 Launch MY16 453 (smart) Parking Brake</b>	DATE: September 15, 2017

Campaign No. 2017080009, September 2017

SUBJECT: **Model 453 Model Year 2016**  
**Check adjusting nut of parking brake, replace if necessary**

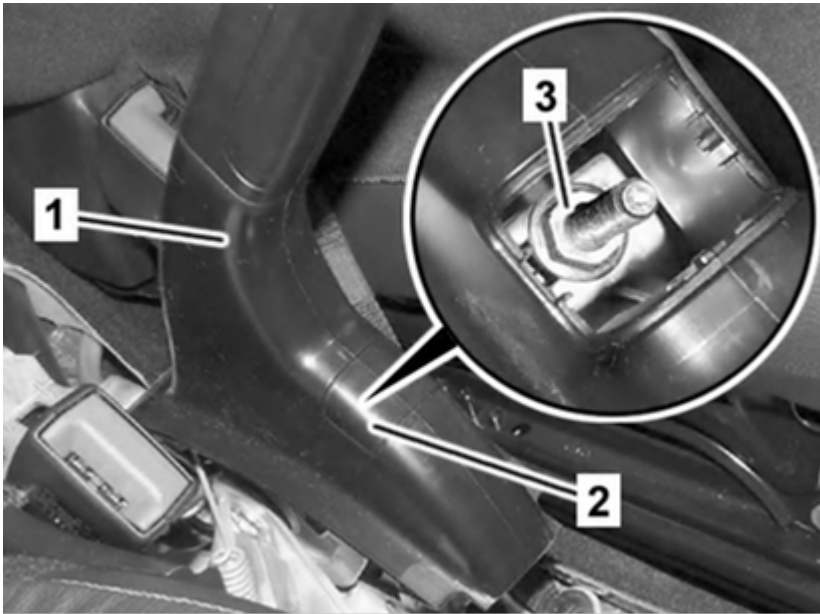
Figure 1

Daimler AG ('DAG'), the manufacturer of Smart vehicles, has determined that on certain Smart For-two vehicles (453 platform) the lock nut that secures the Bowden cable to the parking brake lever might loosen over time which may result in increased parking brake lever travel. Should the parking brake lever travel increase, the holding force of the parking brake may decrease to a point where the vehicle is no longer safely secured in all parking situations. Should the safe parking recommendations in the Operator's Manual not be followed (gear engaged or transmission in "P" and parking brake applied), the vehicle may unexpectedly move when parked on a slope, increasing the risk of an accident. An authorized Mercedes-Benz smart dealer will replace the lock nut on the affected vehicles.

1. Check whether the adjusting nut (3) on the hand brake lever is a polystop nut or a micro-encapsulated nut (Figure 1).

- a) If micro-encapsulated nut is installed: **Perform work procedure.**
- b) If polystop nut is installed: **End measure.**

1. Replace micro-encapsulated nut on the hand brake lever with polystop nut.
