SUBJECT: NEW VEHICLE DEMONSTRATION / DELIVERY HOLD -

Compliance Recall 17C13

Certain 2017 Model Year Focus Vehicles Rear 60% Seat Back Frame Pivot Nut Weld

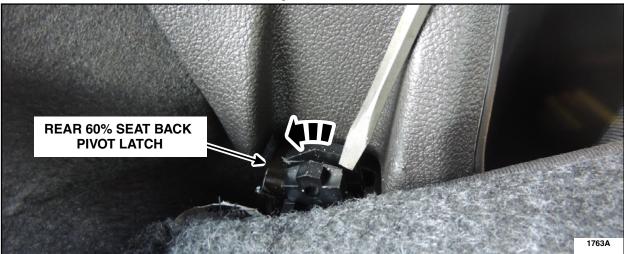
FIGURE 1

2. Unlatch the rear 60% seat back pivot. See Figure 1.

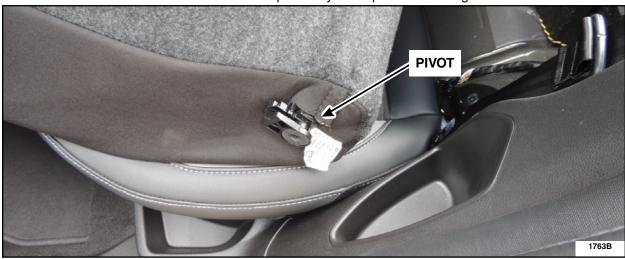
FIGURE 2

3. Position the rear 60% seat back so that the pivot may be inspected. See Figure 2.

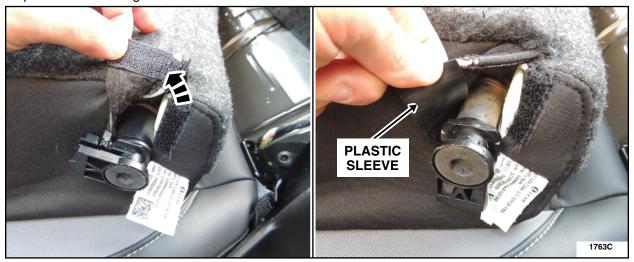
FIGURE 3

4. Release the hook and loop strip adjacent to the pivot and remove the black plastic sleeve around the pivot shaft. See Figure 3.

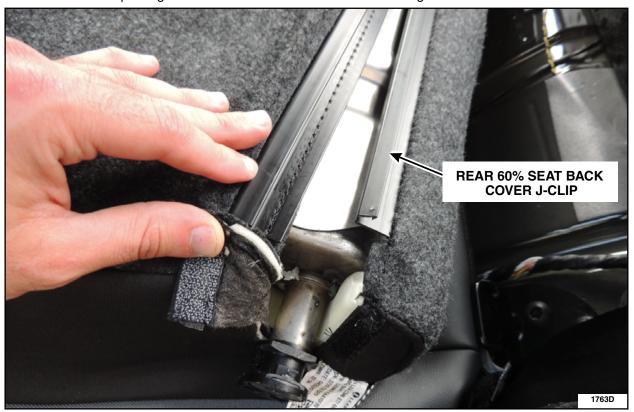
FIGURE 4

5. Release the J-clip along bottom of the rear 60% seat cover. See Figure 4.

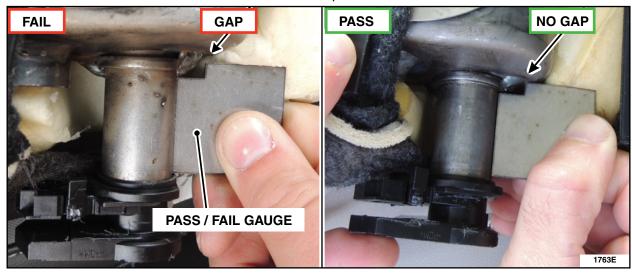
FIGURE 5

- 6. Place the Pass/Fail Gauge over the weld area. Ensure the Gauge is flush against the bracket and pivot shaft, zero gap is allowed on the bracket or pivot shaft. Utilize the Pass/Fail Gauge to measure the entire circumference of the weld area, the pivot weld must be contained within the notched measurement area of the Pass/Fail gauge. See Figure 5.

- If the Pass/Fail Gauge makes contact with both the pivot shaft and base of the seat back frame, the seat back frame passes inspection. The vehicle can be reassembled by reversing the removal procedure.

- If the Pass/Fail Gauge does not make contact to the base of the seat back frame due to an incorrect weld, the seat back must be replaced. Replace the rear 60% seat back frame following the Workshop Manual (WSM) procedure in Section 501-10B. When replacing the 60% seat back frame, it is not necessary to remove the hog rings or to separate the cushion cover from the cushion for seat back frame replacement.
