**SUBJECT: NEW VEHICLE DEMONSTRATION / DELIVERY HOLD - Safety Recall 17S23**  
Certain 2017 Explorer, Taurus, Police Interceptor Utility and Sedan Vehicles  
Electronic Power Assist Steering Heat Shield Fastener Inspection

## CERTAIN 2017 EXPLORER, TAURUS, POLICE INTERCEPTOR UTILITY AND SEDAN VEHICLES — ELECTRONIC POWER ASSIST STEERING HEAT SHIELD FASTENER INSPECTION

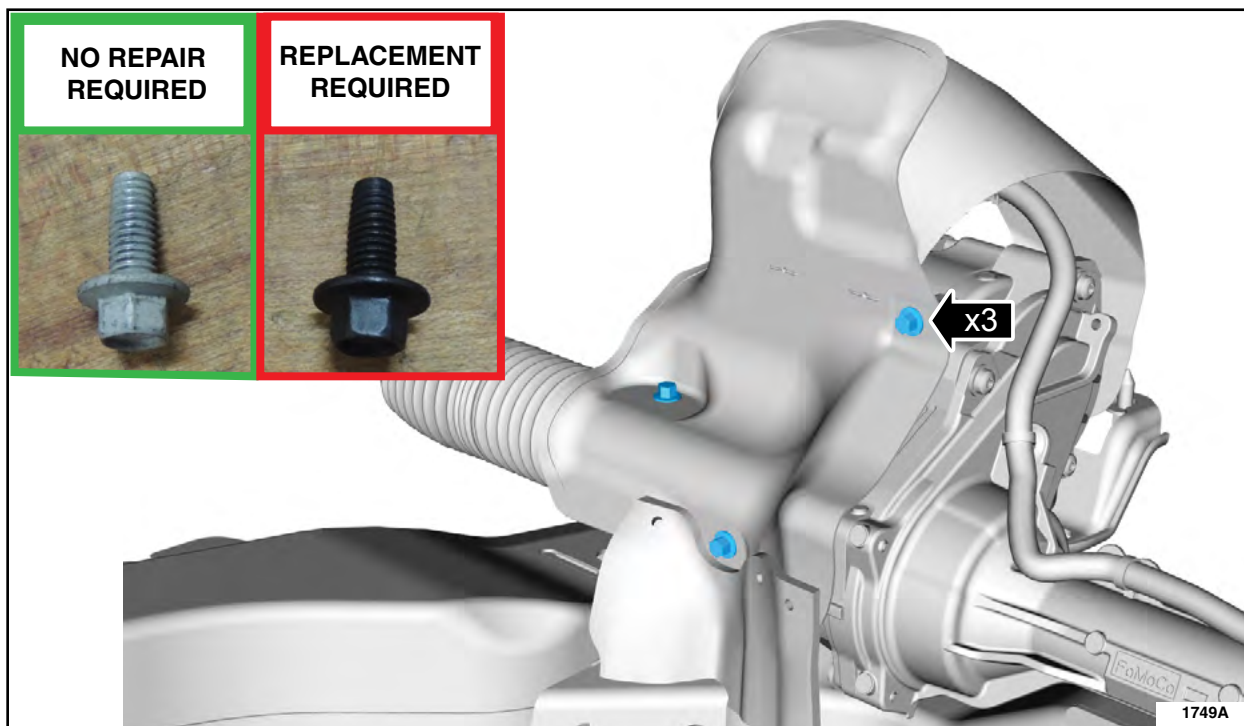
**FIGURE 1**

In some of the affected vehicles, the fasteners used to secure the Electronic Power Assist Steering (EPAS) heat shield may not have sufficient corrosion protection. If the fasteners do not have sufficient corrosion protection, they may not retain the heat shield over time, exposing the steering gear to higher than expected temperatures. If the steering gear connectors melt, the driver may experience loss of assist accompanied by the fault message “SERVICE POWER STEERING NOW” in the instrument cluster. Loss of power steering assist while driving would result in higher steering efforts, especially at lower speeds. Dealers are to inspect and replace, if necessary, the EPAS heat shield fasteners following the Service Procedure below.

2. Inspect all three steering gear heat shield fasteners. Are all three fasteners gray in color?  
See Figure 1.

3. If equipped, remove the under body shield retainers and the under body shield.
4. Replace each of the three highlighted fasteners that are not gray in color. See Figure 1.

- Tighten the *new* steering gear heat shield fasteners to 9 Nm (80 lb-in).
