Federal Recall Information

817-D

Safety Recall – The Front Axle Sway Bar Links May Be Assembled Incorrectly

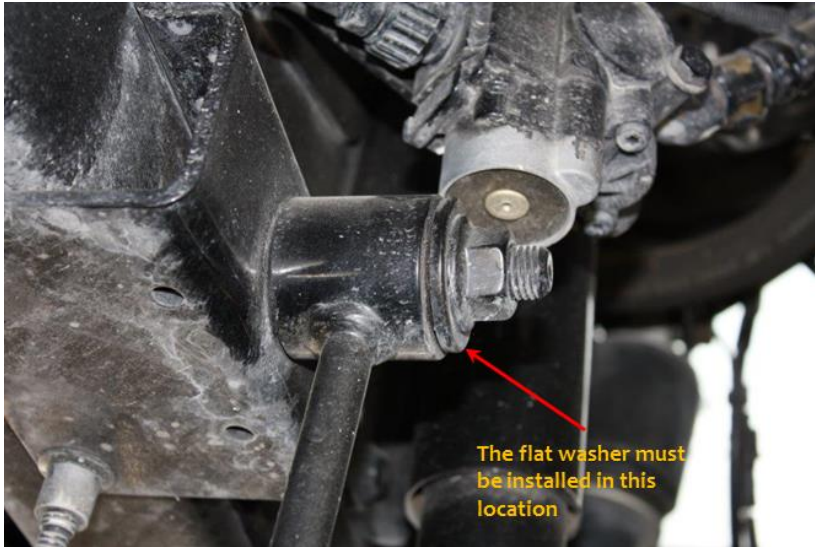
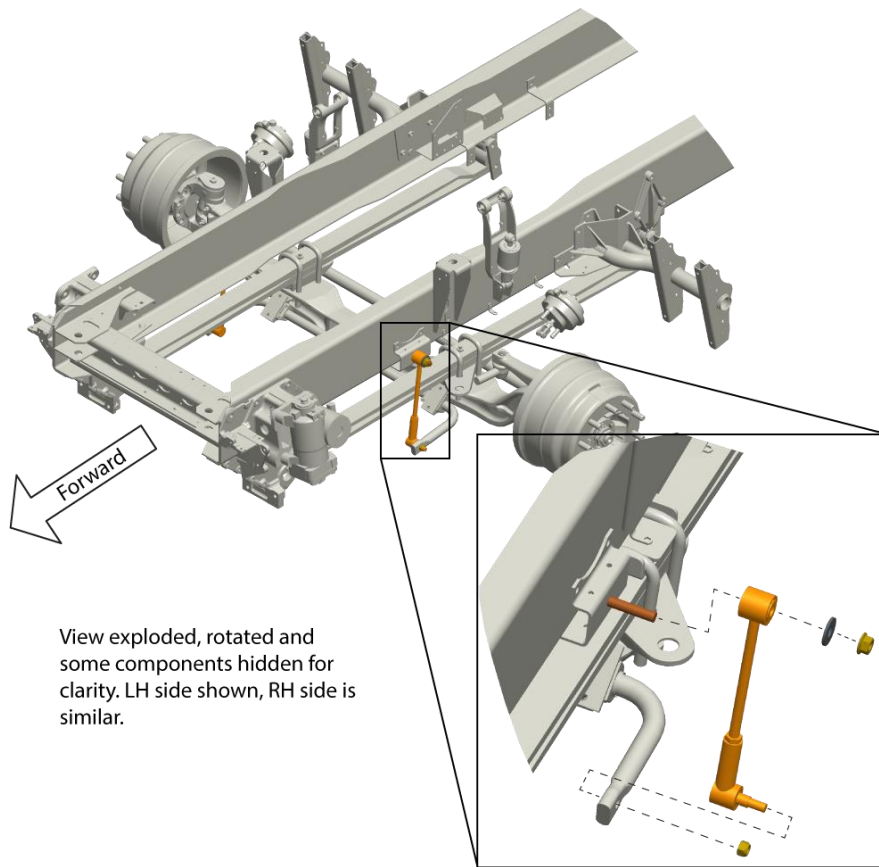
1. Inspect the sway bar link attachment **on each side of the vehicle** for the location of the retention washer as shown in the images below.
2. Reinstall the hardened flat washer in correct location if assembled incorrectly.
3. If the hardened flat washer is missing, install the hardened flat washer in the correct location.
