# IMPORTANT T59 SAFETY RECALL UPDATE

## BRAKE BOOSTER WATER SHIELD ON 11-14 GRAND CHEROKEE/DURANGO

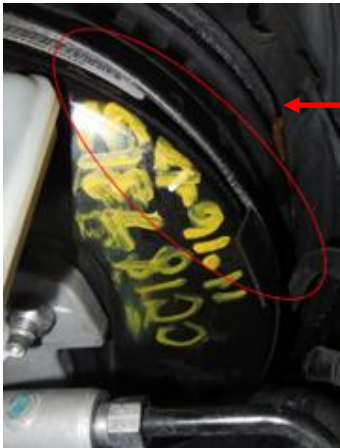
Improper repair, water shield pushed up and VIN/date written on the face of the brake booster.

It is imperative that these instructions be followed to ensure the Brake Booster Water Shield is installed correctly with the tab edges flush with the edge of the brake booster and located at the three o'clock and nine o'clock positions.

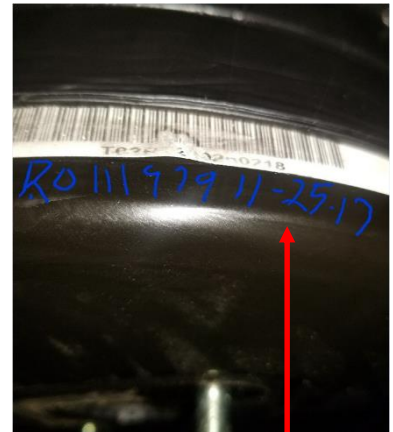
Picture has been modified afterwards to add the VIN and date. This is considered warranty fraud and will not be accepted.

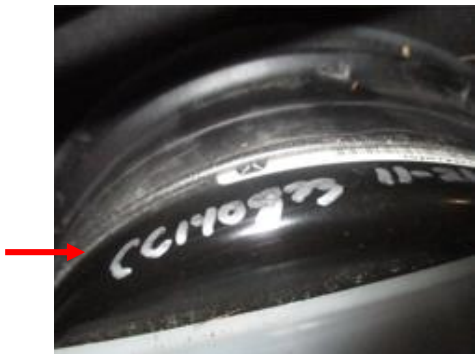
Picture does not show any tab locations and therefore unable to verify proper repair.

- Proper positioning of the water shield on the brake booster (both water shield tabs are visible). This is critical to ensure proper placement. **Claims with pictures that do not show the proper tab alignment will be returned.**
- The recorded VIN and date written on the outer circumference of the booster
