September 26, 2017

SUBJECT: NEW VEHICLE DEMONSTRATION / DELIVERY HOLD - Safety Recall 17S29
Certain 2018 Model Year F-150 Raptor SuperCab Vehicles
Roof Center Bow K-Brace Rivet Installation

CERTAIN 2018 MODEL YEAR F-150 RAPTOR SUPERCAB VEHICLES — ROOF CENTER BOW K-BRACE RIVET INSTALLATION

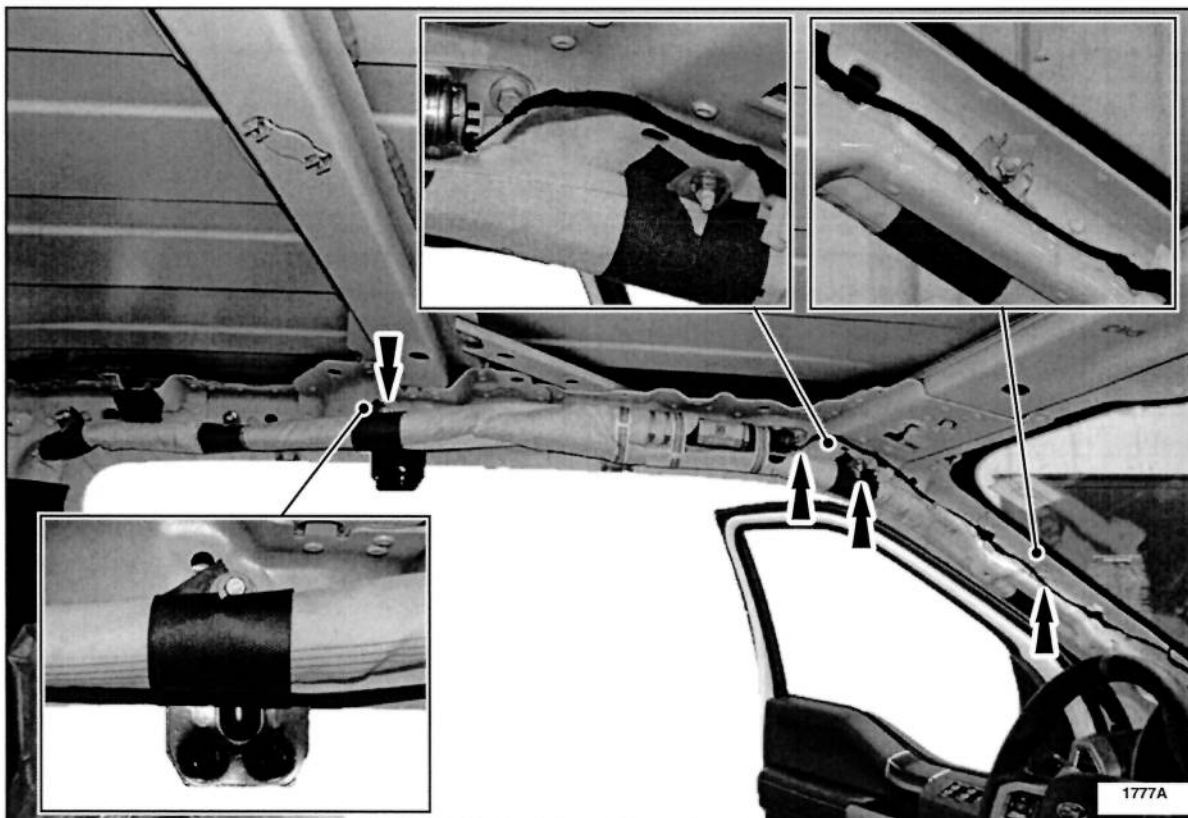
FIGURE 1

NOTE: LH side curtain airbag shown, RH similar.

1. Remove the headliner. Please follow the Workshop Manual (WSM) procedures in Section 501-05.
2. Lower, but do not fully remove the right hand (RH) and left hand (LH) side curtain airbags.
See Figure 1.

- a. Disconnect both side curtain airbag electrical connectors.
- b. Remove the four fasteners on each side, as shown in Figure 1.
- c. Lower the RH and LH side curtain airbags.
- d. Using a drop cloth or equivalent, cover the airbags to avoid metal shaving contamination.

- a. Remove the protective cover from both side curtain airbags.
- b. Place the RH and LH side curtain airbag in its original position.
- c. Install the four RH and LH side curtain airbag fasteners shown in Figure 1.
 - Tighten fasteners to 93 lb.in (10.5 Nm).
- d. Connect both side curtain airbag electrical connectors.

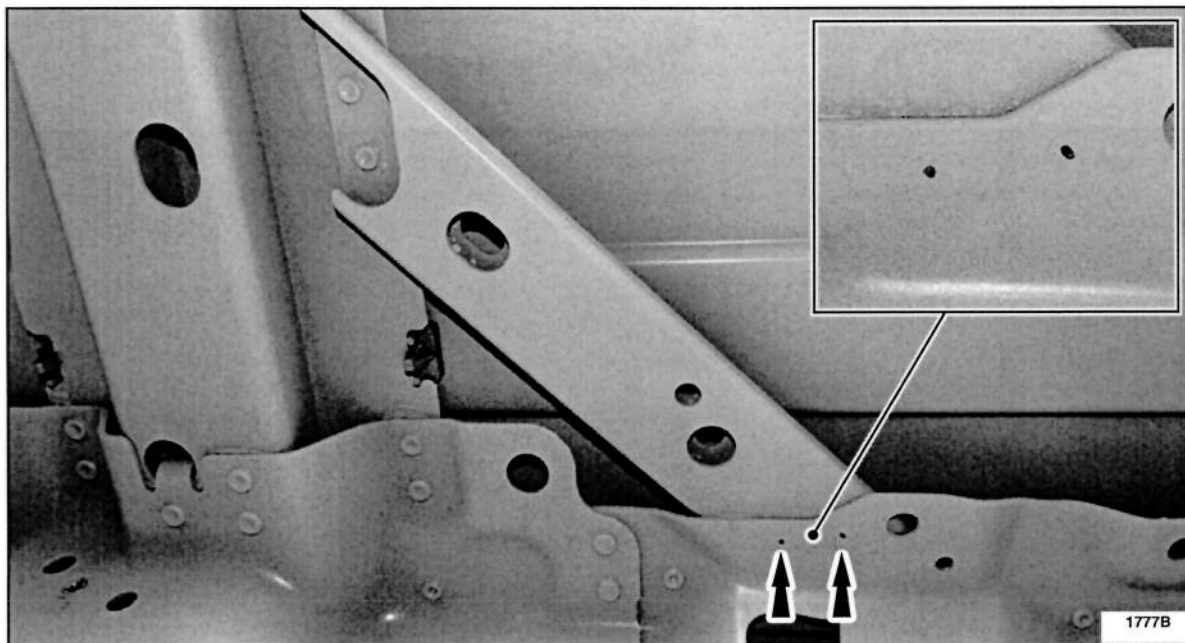
FIGURE 2

NOTE: LH roof brace shown, RH similar.

3. On both sides, mark the drilling locations on the roof rail at the center bow K-brace. See Figure 2.

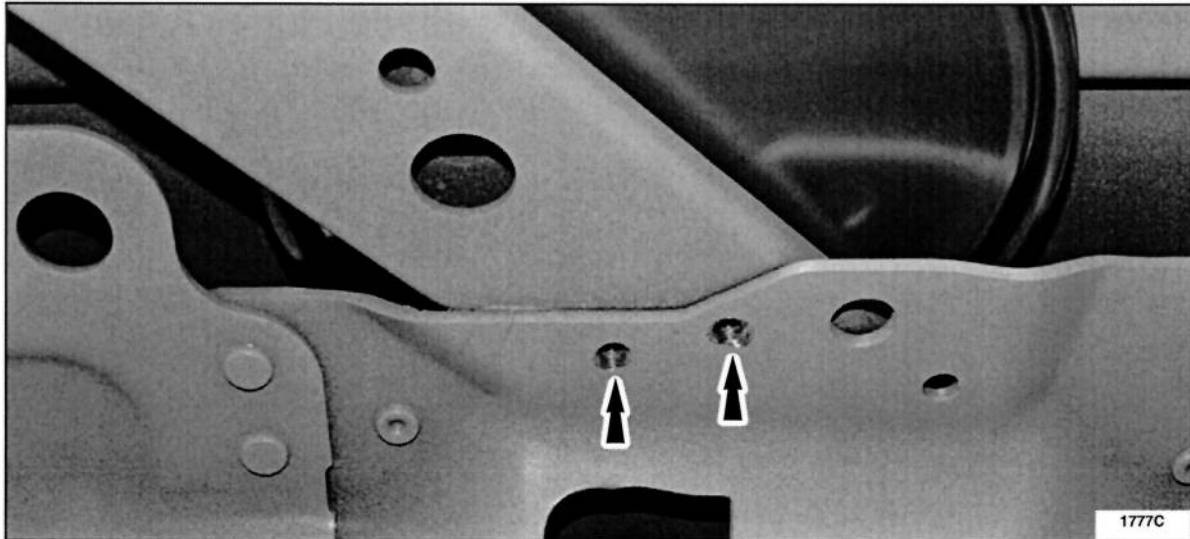
FIGURE 4

NOTE: Figure 4 shows a clean paint can lid being used above the roof K-brace to protect the roof sheet metal.

NOTE: LH roof brace shown, RH similar.

5. Temporarily position a suitable flat piece of metal above the RH and LH roof K-brace to prevent damage to the roof sheet metal. See Figure 4.

6. Drill the previously marked roof K-brace holes on the RH and LH side. See Figure 4.

- Using an assistant, hold a vacuum near the drilling location to capture the metal shavings.
- Remove the temporary flat piece of metal used to prevent damage to the roof sheet metal once drilling is complete.

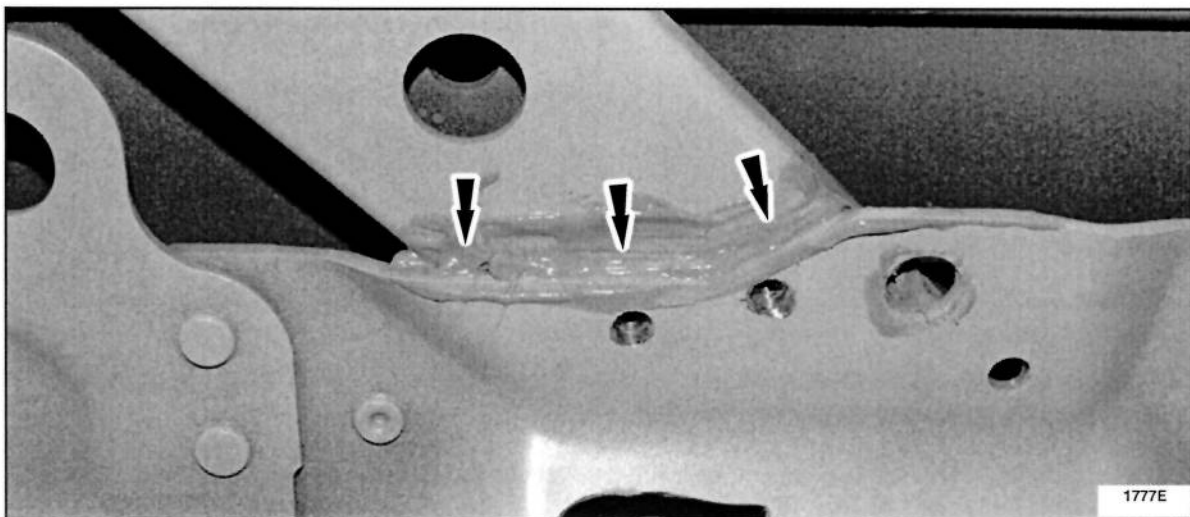
FIGURE 5

NOTE: LH roof brace shown, RH similar.

7. Apply metal panel bonding adhesive where the RH and LH roof K-brace meets the roof rail. See Figure 5.

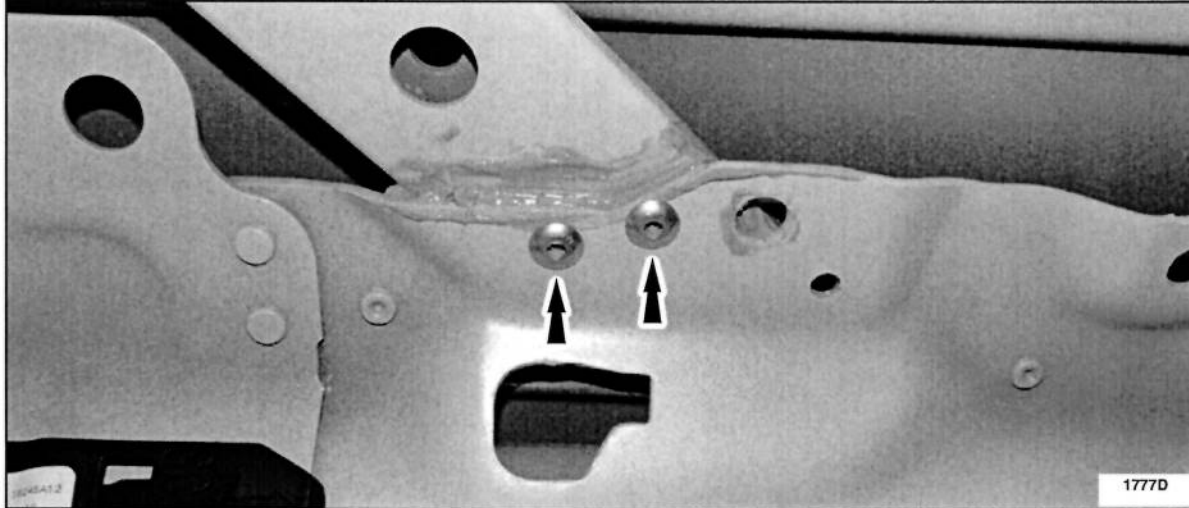
FIGURE 6

NOTE: LH roof brace shown, RH similar.

8. Using a pneumatic rivet gun, install two rivets into the RH and LH roof K-brace. See Figure 6.
