TO: Mercedes-Benz Dealer Principals, General Managers, Sales Managers, Service Managers, Parts Managers	FROM: Gregory Gunther, Department Manager, Vehicle Compliance and Analysis, Engineering Services
RE: <b>Recall Campaign Phase 2 Launch Notification 2017110013 (Electric Steering Column) SCM Ground MY15-18 C-Class, GLC-Class (205, 253)</b>	DATE: January 19, 2018

<b>Campaign No. :</b>	<b>Campaign Desc. :</b>	<b>Install Steering Control Module Ground</b> (Electric Column Adjustment)
<b>2017110013 (Elec)</b>	<b>1709P46C63 (Elec)</b>	
<p>This is to notify you of a Recall Campaign update for certain Model Year 2015–2018, Model 205, 253 platform vehicles (C-Class, GLC-Class). Please review the recall information below. The Recall Campaign is visible on the <a href="http://www.safercar.gov">www.safercar.gov</a> website and may generate questions from the media or customers. <b>Please note that this recall launch notification only applies to vehicles with electric steering columns affected by the recall in the first phase of launch. These vehicles were flagged in VMI as “OPEN” on January 19, 2018. All other vehicles affected by the recall will continue to remain flagged in VMI as “PENDIN

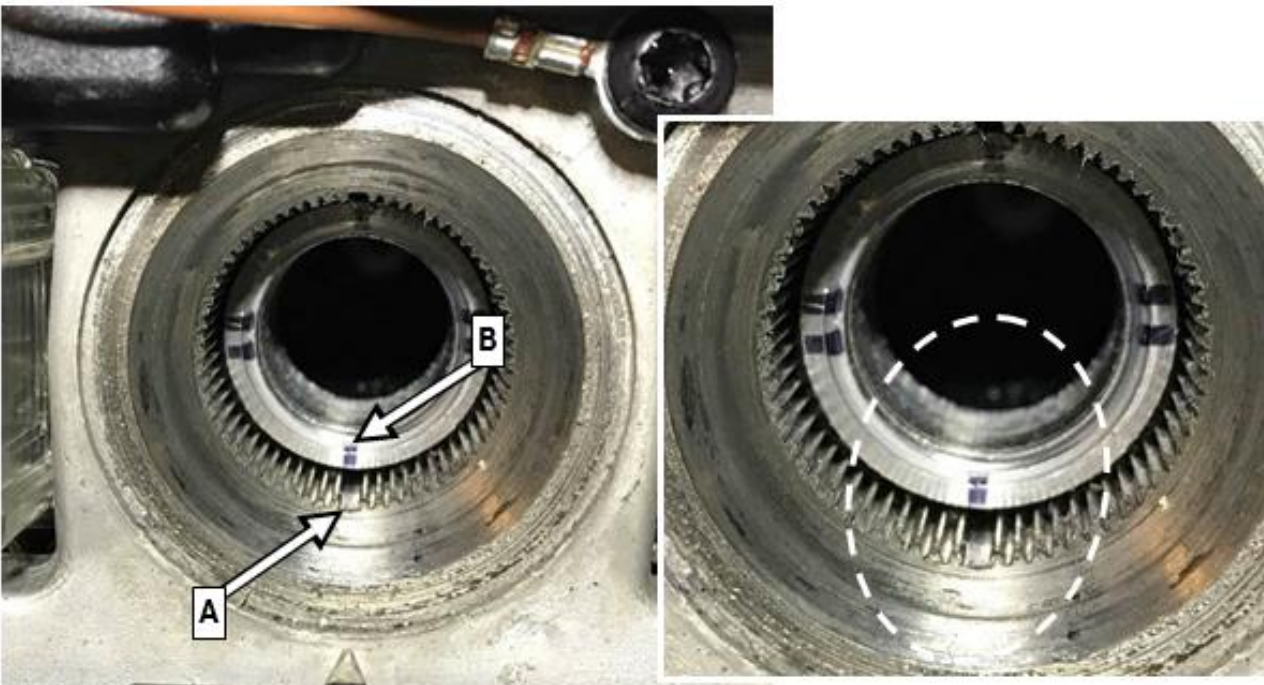
Figure 1

**i** The serrations (**A, Figure 1**) on the steering wheel must be aligned with the marking (**B, Figure 1**) on the steering shaft .

**i** **Check the position carefully before removal and position identically during installation!**

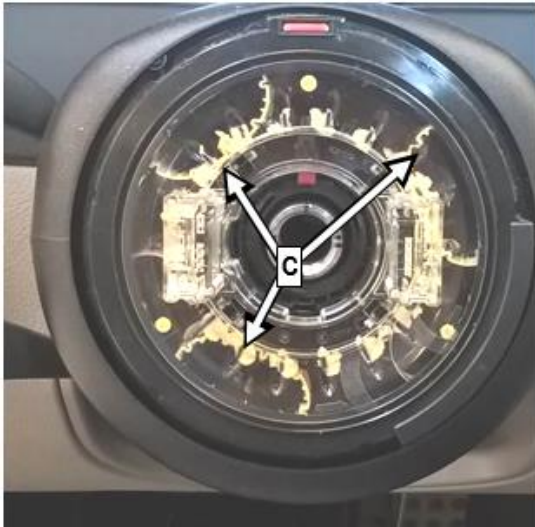
Figure 2, Valeo without modification

Some dealers have reported differences in the steering column modules portrayed in the campaign bulletin versus the actual steering column module installed in the vehicle. Specifically, there have been instances where vehicles only featured 2 support bands, versus steering column modules with 3 support bands. It should be noted that vehicles with steering column modules with 2 support bands are to be included in the recall campaign for repair.

**i** Valeo steering column switch modules *without* modification can be recognized by the three **or two** support bands (**C, Figure 2**) and missing protective ring.

- a. Steering column switch module from Valeo installed: **Perform work procedure.**
- b. Steering column switch module from Kostal installed: **End measure.**

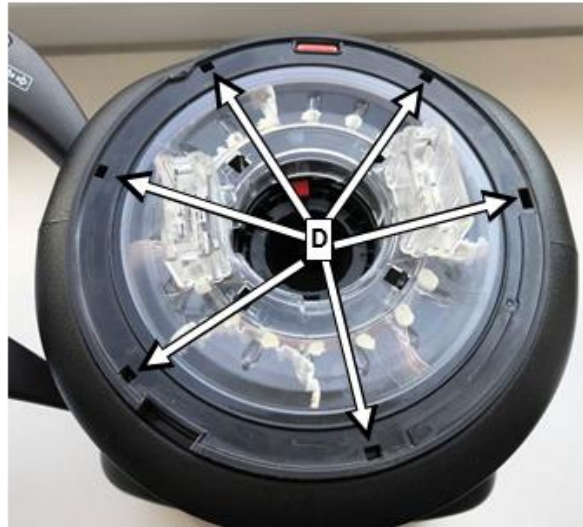
Figure 3, Valeo with modification

**i** Valeo steering column switch modules **with** modification can be recognized by the three white support bands and **already cast-on protective ring**.

**i** A cast-on protective ring can be recognized by the six square openings (**D, Figure 3**).

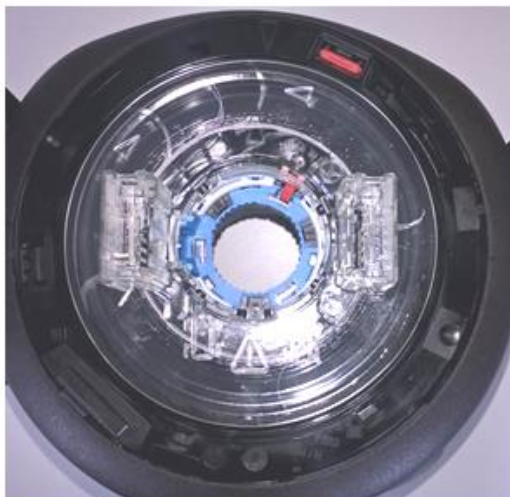
Figure 4, Kostal

Kostal steering column switch modules do not have three white support bands.
