RE: **Recall Campaign Phase 6 Launch Notification**  
**2017110011 (Manual Steering Column)**  
**SCM Ground**  
**MY14-18 CLA-Class, GLA-Class, B-Class Electric**  
**(117, 156, 242)**

Campaign No. 2017110011, May 2018  
**Revision D**

SUBJECT: **Models 242, 117, and 156 Model Years 2014 - 2018**  
**Steering Column Module (SCM) Ground – Manual Steering Column Adjustment**

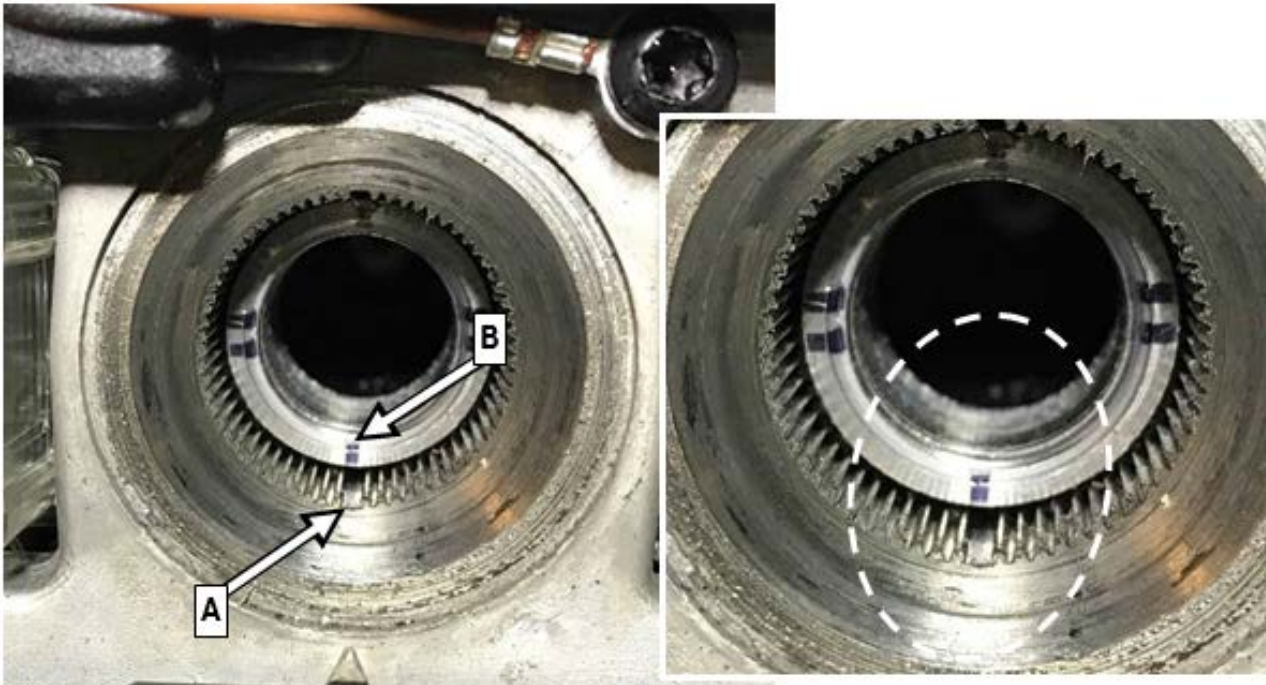
Figure 1

**i** The serrations **(A, Figure 1)** on the steering wheel must be aligned with the marking **(B, Figure 1)** on the steering shaft.

**i** Check the position carefully before removal and position identically during installation!

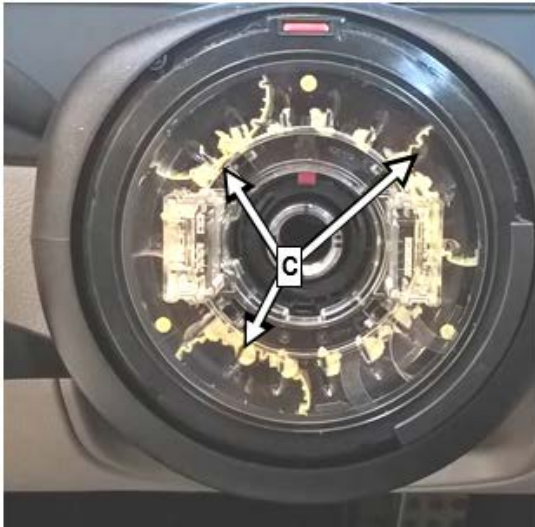
Figure 2, Valeo without modification

**i** Valeo steering column switch modules *without* modification can be recognized by the three **or two** white support bands (**C, Figure 2**) and missing protective ring.

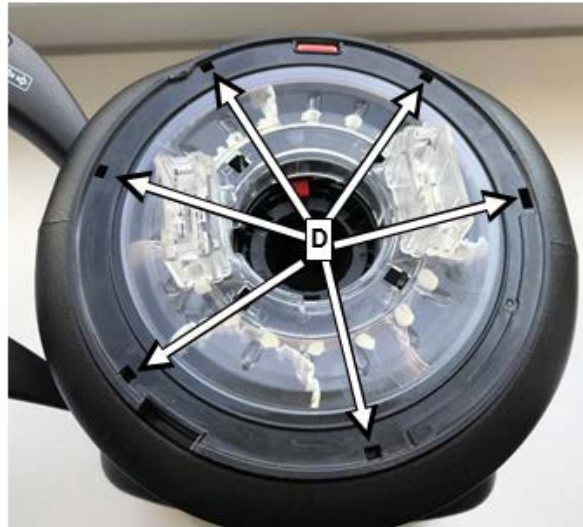
Figure 3, Valeo with modification

**i** Valeo steering column switch modules **with** modification can be recognized by the three **or two** white support bands and **already cast-on protective ring**.

**i** A cast-on protective ring can be recognized by the six square openings (**D, Figure 3**).

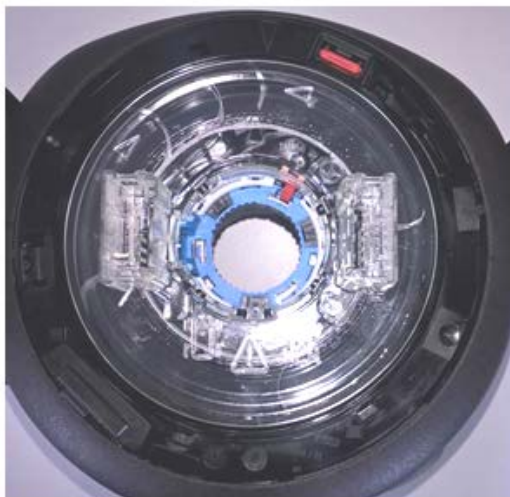
Figure 4, Kostal

Kostal steering column switch modules do not have three white support bands.

- a. Steering column switch module from Valeo installed: **Perform work procedure.**
- b. Steering column switch module from Kostal installed: **End measure.**

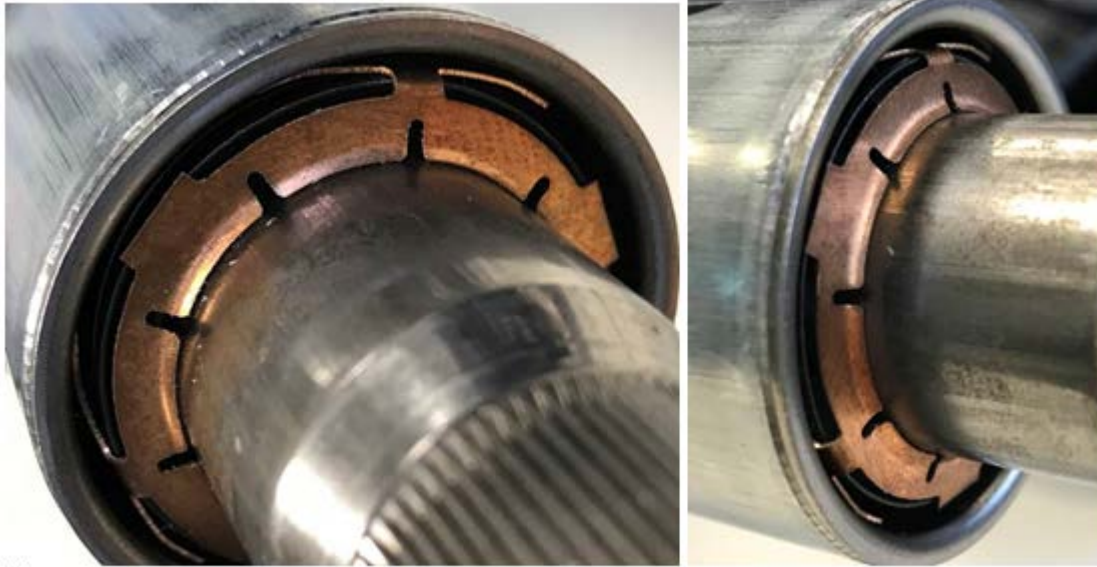
**Figure 8**

**i** **Figure 8:** Sample depictions of a contact bridge in final stop position on the steering column.

**i** The contact tabs disappear completely into the bearing outer race of the steering column!
