# newschannel update

| RE: <b>Recall Campaign Phase 4 Launch Notification</b><br><b>2018030002 (Manual Steering Column)</b><br><b>SCM Ground</b><br><b>MY14-16 CLA-Class, GLA-Class, B-Class Electric</b><br><b>(117, 156, 242)</b> | DATE: March 9, 2018 |

Campaign No. 2018030002, March 2018

SUBJECT: **Models 242,177,and 156 Model Years 2014 - 2016**  
**Steering Column Module (SCM) Ground – electric steering column adjustment**

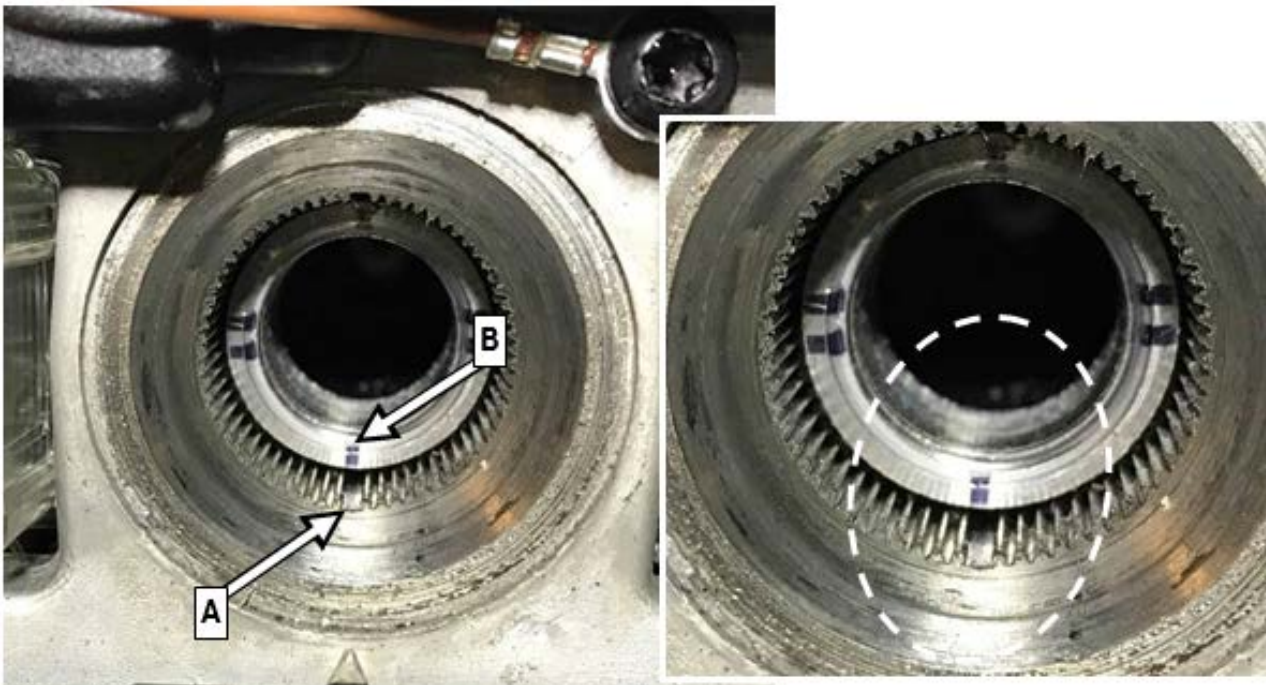
Figure 1

**i** The serrations (**A, Figure 1**) on the steering wheel must be aligned with the marking (**B, Figure 1**) on the steering shaft .

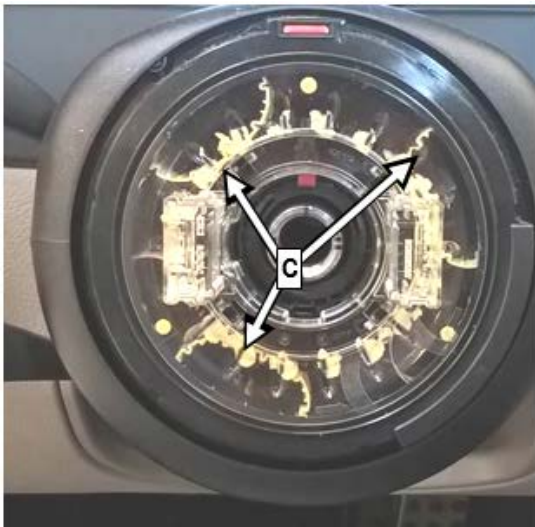
Figure 2, Valeo without modification

Valeo steering column switch modules *without* modification can be recognized by the three or two

white support bands (**C, Figure 2**) and missing protective ring.

- a. Steering column switch module from Valeo installed: **Perform work procedure.**
- b. Steering column switch module from Kostal installed: **End measure.**

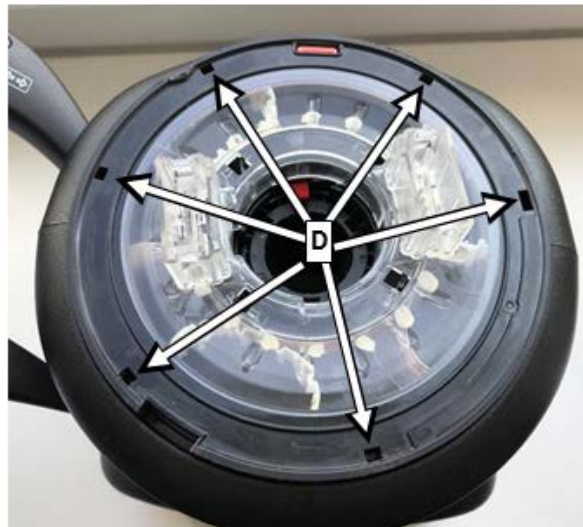
Figure 3, Valeo with modification

Valeo steering column switch modules **with** modification can be recognized by the three or two white support bands and **already cast-on protective ring**.

A cast-on protective ring can be recognized by the six square openings (**D, Figure 3**).
