<p>TO: Mercedes-Benz Dealer Principals, General Managers, Sales Managers, Service Managers, Parts Managers</p>	<p>FROM: Gregory Gunther, Department Manager, Vehicle Compliance and Analysis, Engineering Services</p>
<p>RE: Recall Campaign Phase 2 Launch Notification 2017110011 (Manual Steering Column) SCM Ground MY14-18 B-Class Electric, CLA-Class, GLA-Class (242, 117, 156)</p>	<p>DATE: January 19, 2018</p>

Campaign No. :	Campaign Desc. :	Install Steering Control Module Ground (Manual Column Adjustment)
2017110011 (Manual)	1709P46C59 (Manual)	
<p>This is to notify you of a Recall Campaign update for certain Model Year 2014–2018, Model 117, 156, 242ed platform vehicles (CLA-Class, GLA-Class, B-Class electric). Please review the recall information below. The Recall Campaign is visible on the www.safercar.gov website and may generate questions from the media or customers. Please note that this recall launch notification only applies to vehicles with mechanical steering columns affected by the recall in the first phase of launch. These vehicles were flagged in VMI as “OPEN” on January 19, 2018. All other vehicles affected by the recall will continue to remain flagged in VMI as “PENDING

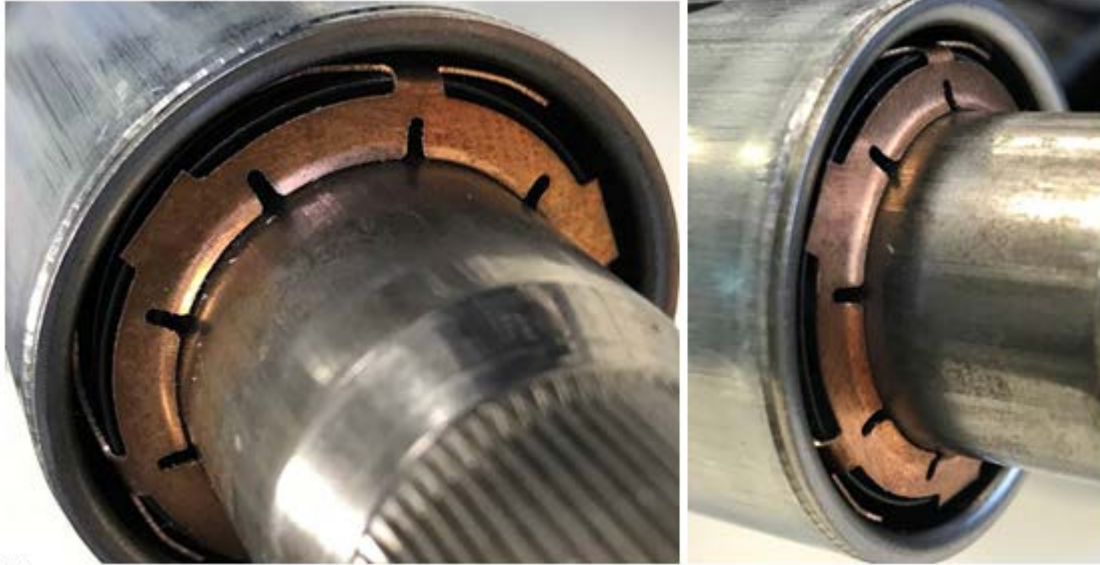
Figure 8

i **Figure 8:** Sample depictions of a contact bridge in final stop position on the steering column.

i The contact tabs disappear completely into the bearing outer race of the steering column!
