RE: **Recall Campaign Phase 7 Launch Notification**  
**2017120024 (Electric Steering Column)**  
**SCM Ground**  
**MY12-17 C-Class, E-Class, E-Class Coupe (204, 212, 207)**

Campaign No. 2017120024, June 2018

SUBJECT: **Model 204, 207, 212 Model Years 2012 - 2017**  
**Steering Column Module (SCM) Ground – electric steering column adjustment**

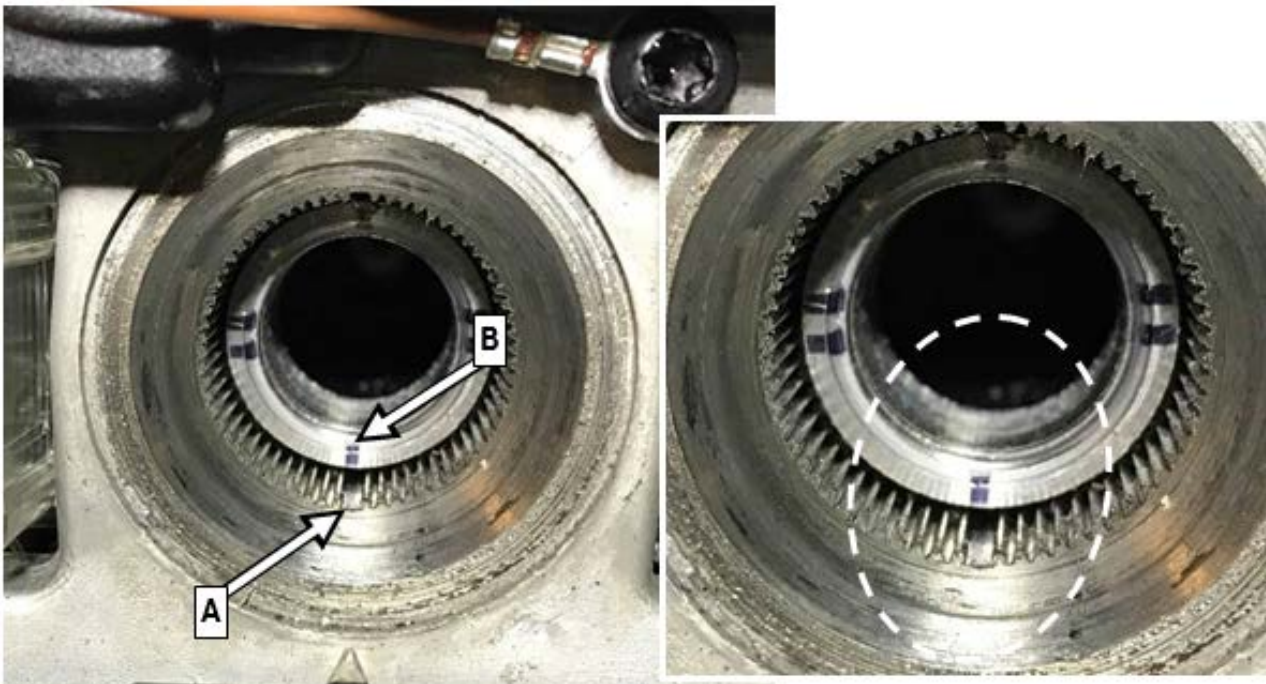
Figure 1

**i** The serrations (**A, Figure 1**) on the steering wheel must be aligned with the marking (**B, Figure 1**) on the steering shaft.
