**MERCEDES-BENZ USA, LLC**  
One Mercedes-Benz Dr.  
Atlanta, GA 30328  
Phone: (770) 705-0600  
Fax: (770) 705-0117  
MBUSA.com

| RE: <b>Recall Campaign Phase 5 Launch Notification 2018030018 (Manual Steering Column)</b><br><b>SCM Ground</b><br><b>MY15-17 CLA-Class, GLA-Class, B-Class Electric (117, 156, 242)</b> | DATE: April 20, 2018 |

Campaign No. 2018030018, April 2018

SUBJECT: **Models 242, 117 and 156 Model Years 2015 - 2017**  
**Steering Column Module (SCM) Ground – electric steering column adjustment**

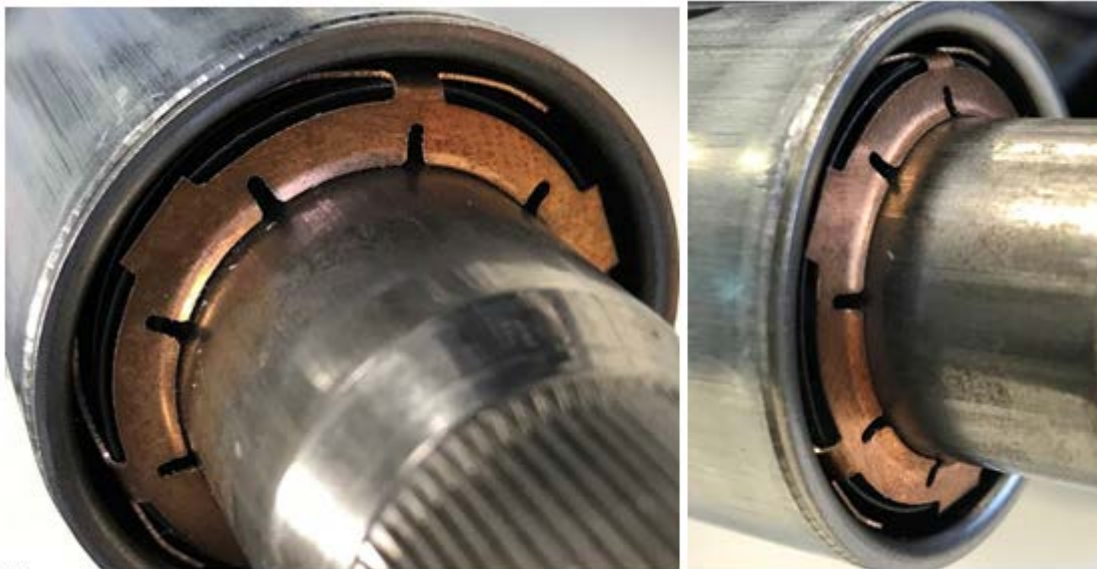
Figure 8

- i** **Figure 8:** Sample depictions of a contact bridge in final stop position on the steering column.
- i** The contact tabs disappear completely into the bearing outer race of the steering column!
