March 2018  
FL751A  
NHTSA #17V-628  
Transport Canada #17-488

## **Subject: Dana Front Steer Axles**

**Models Affected: Specific Freightliner Cascadia and Western Star 4900 model vehicles manufactured March 17, 2015, through September 29, 2015, and built with Dana steer axles.**

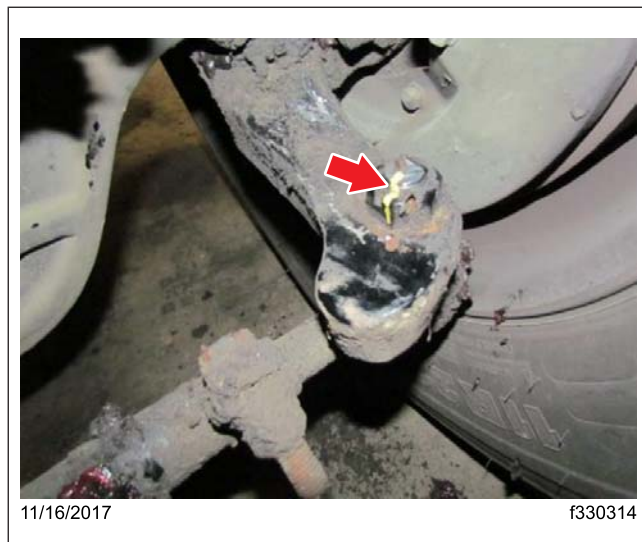
**Fig. 3, Paint Mark to Identify Nut Rotation**

6. Remove the cotter pins and check for proper nut torque. Put a paint mark across one side of the nut and the top of the stud. With a torque wrench and a 1-1/4-inch socket, torque the nut in a clockwise (tighten) direction until the nut just starts to rotate or you reach 130 lbf-ft (175 N·m). Record your findings in Step 2 of the inspection form. See [Fig. 3](#) and [Fig. 4](#).

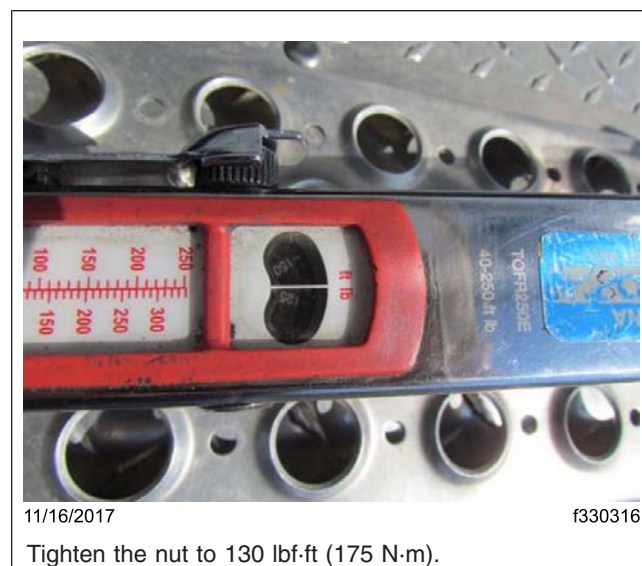
**Fig. 5, Tightening the Nut**

8. If you found rotation of the nut before you reached 130 lbf-ft (175 N·m), now tighten the nut to 130 lbf-ft (175 N·m). Using the paint mark, record the rotation of the nut in Step 2 of the inspection form. Example: Using the paint mark as the 12:00 position, if the nut rotates 1/4 turn to reach 130 lbf-ft (175 N·m), document the nut rotation at the 3:00 position. See [Fig. 5](#) and [Fig. 6](#).

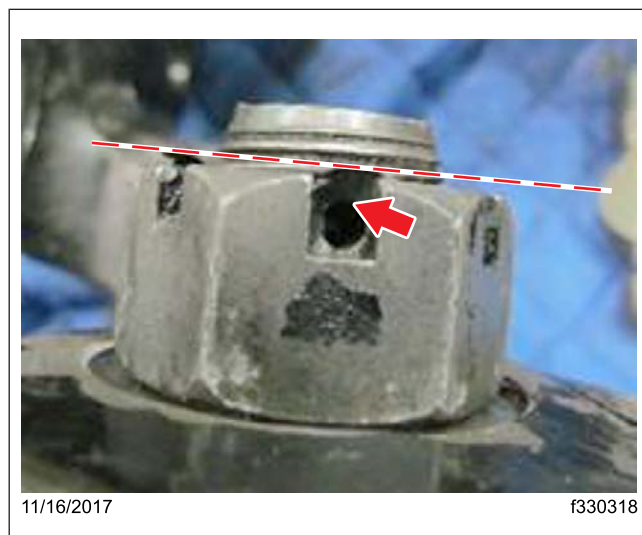
**Fig. 7, Good Cotter Pin Hole Position**

**IMPORTANT:** Never back the nut off to align the cotter pin hole to the nut slot. Torque may reach 170 lbf·ft (230 N·m) to obtain proper alignment. After the nut has been aligned with a slot in the nut, the cotter pin hole **CAN NOT** be above the top of the nut as shown below. Any cotter pin hole that is above the top of the nut surface will require the replacement of the knuckle and tie-rod end. See [Fig. 7](#) and [Fig. 8](#).

If there is **NO** movement, install a new cotter pin and the repair is complete. Clean a spot on the base label (Form WAR259). Write the campaign number, FL751, on a blank red completion sticker (Form WAR260) to indicate the work has been completed and attach it to the base label.

**NOTE:** Any tie-rod stud with movement after proper nut torque and alignment will require the replacement of that knuckle and tie rod.

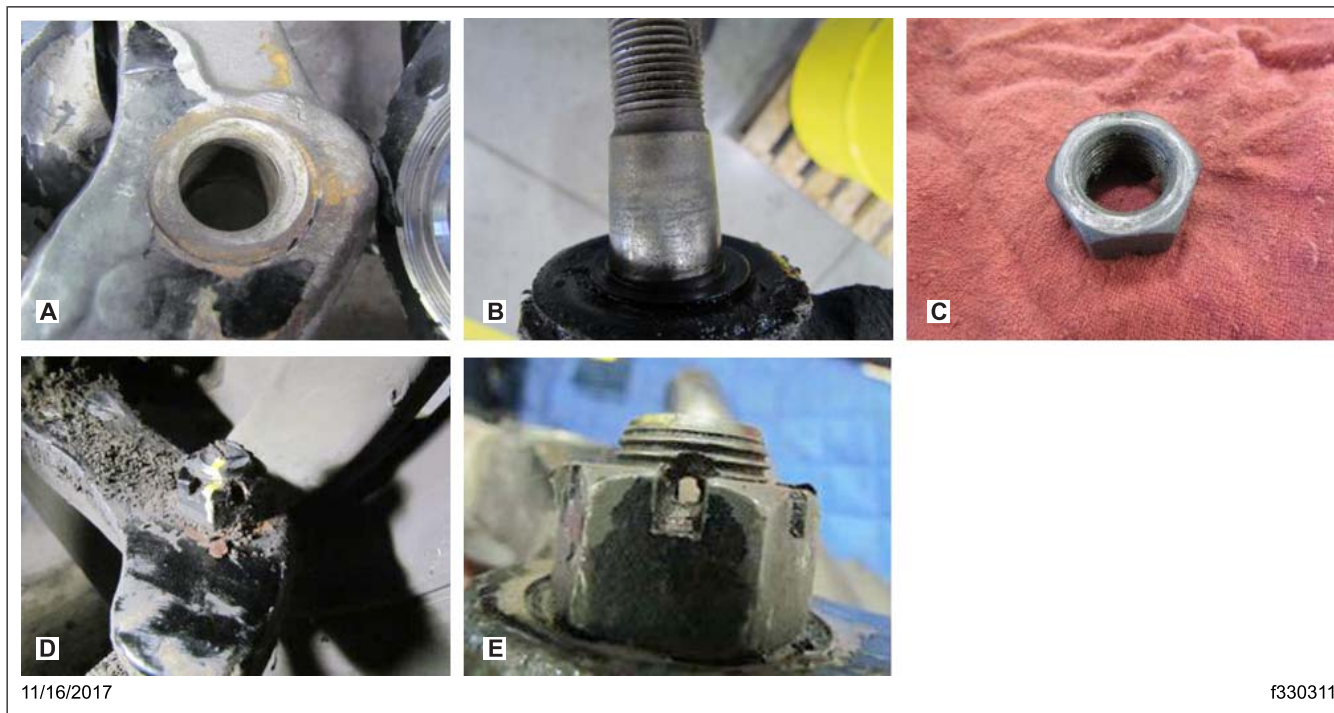
**Fig. 10, Sample Photos**

12. Take clear photos of the damaged parts and the position of the cotter pin.

If the photos are out of focus, too light, too dark, too far away, or too close up, the process will be delayed until new photos are submitted. Use the examples in [Fig. 10](#) as a guide.
